Fountain Hill Condo Association

## NOTICE OF UNIT OWNERS MEETING FOUNTAIN HILL CONDOMINIUM ASSOCIATION, INC.

# Fountain Hill Association

## Facility Report

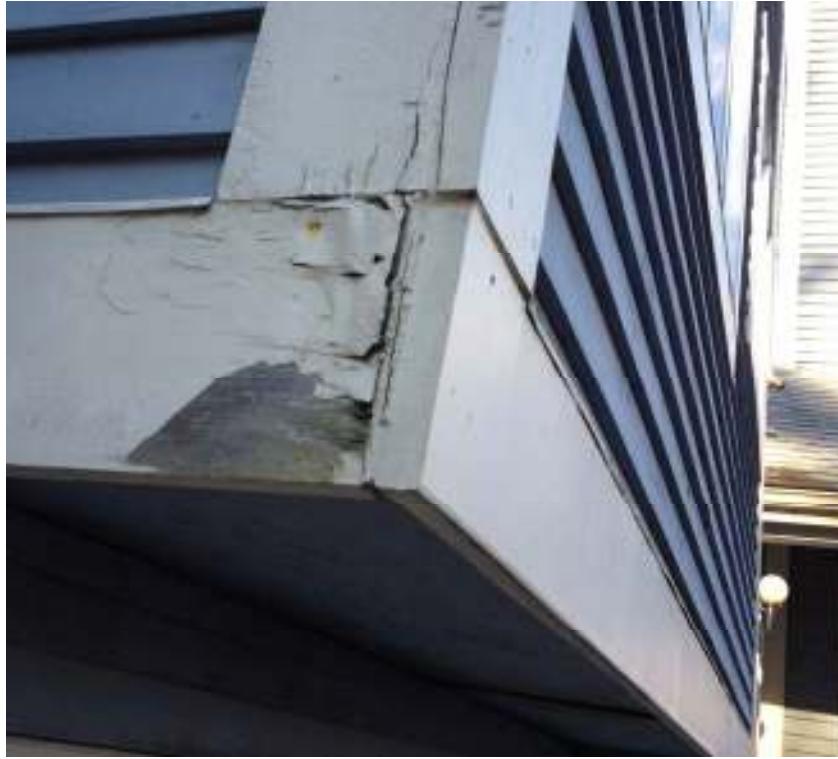
- Trim: incorrect installation is leading to water damage and rot.

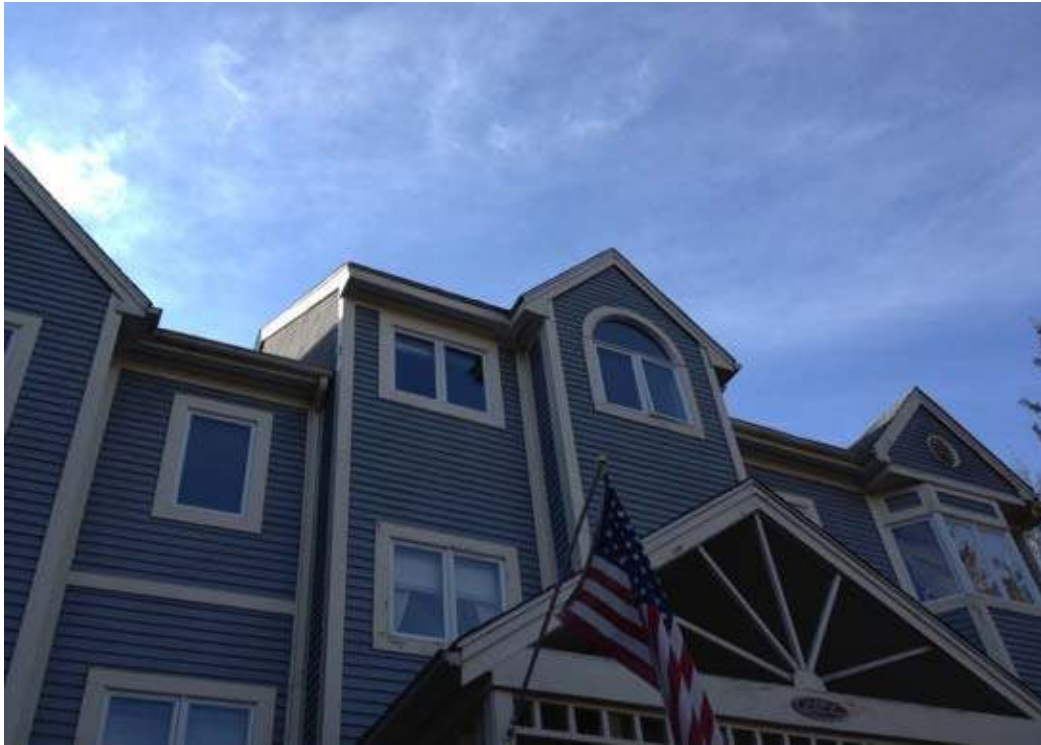
Condition Type G: Lack of Gutters.

- North side units especially lack roof gutters typical. This condition leads to roof component failure.
- Solution: Implement gutters and leaders that lead directly to subsurface drainage points.

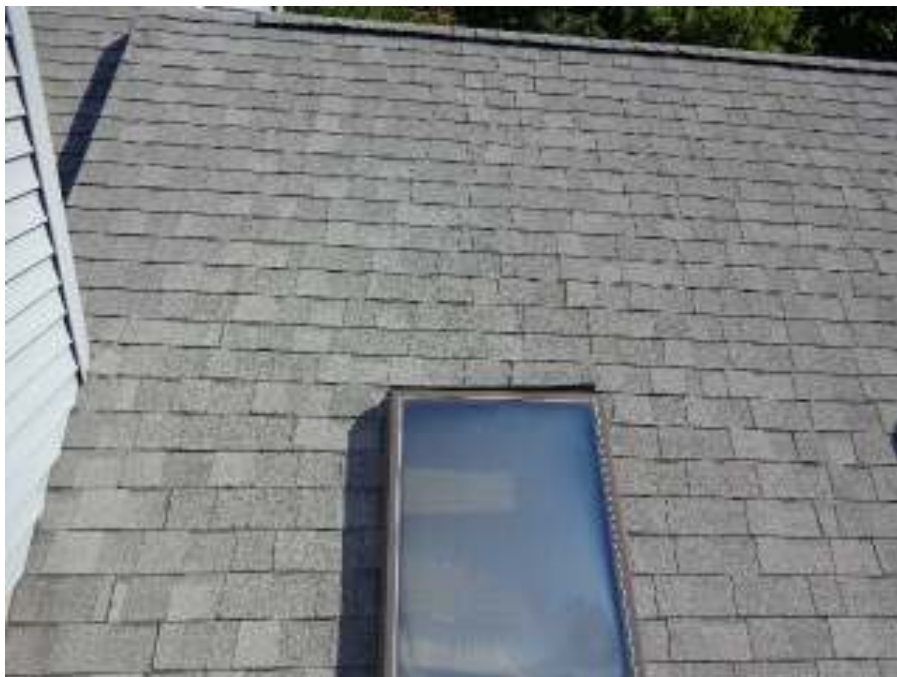
Photo #4

4. The few skylights we viewed showed signs of age and should be replaced in the near future. Please note photo #4.

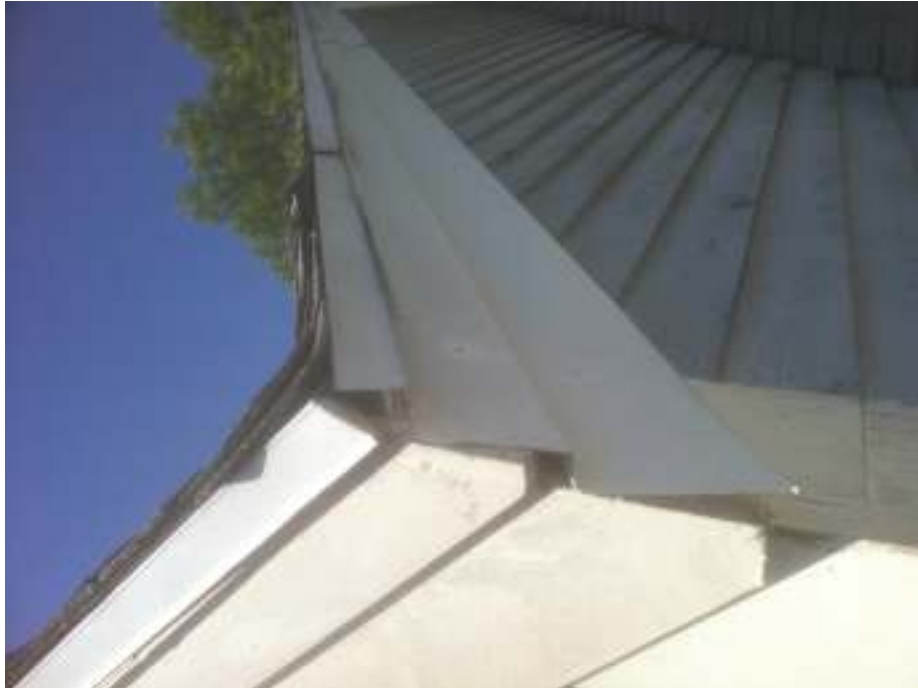
Photo #5

5. There is evidence of wind-damaged trim metal that should be replaced or at least removed. Please note photo #5.

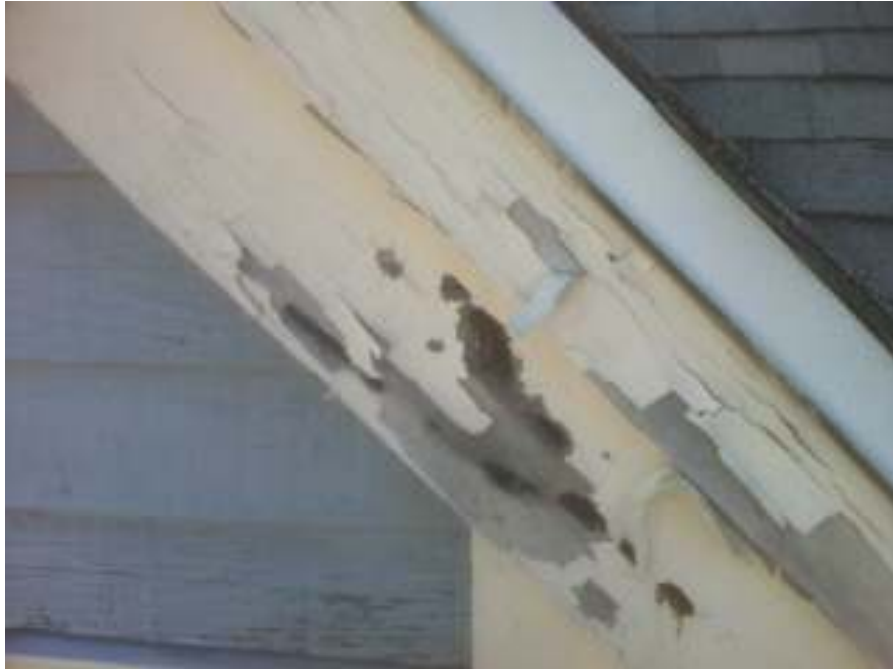
Photo #7

7. There are a few locations of "Wood Bee" attach on rack trim board. Please note photo #7.

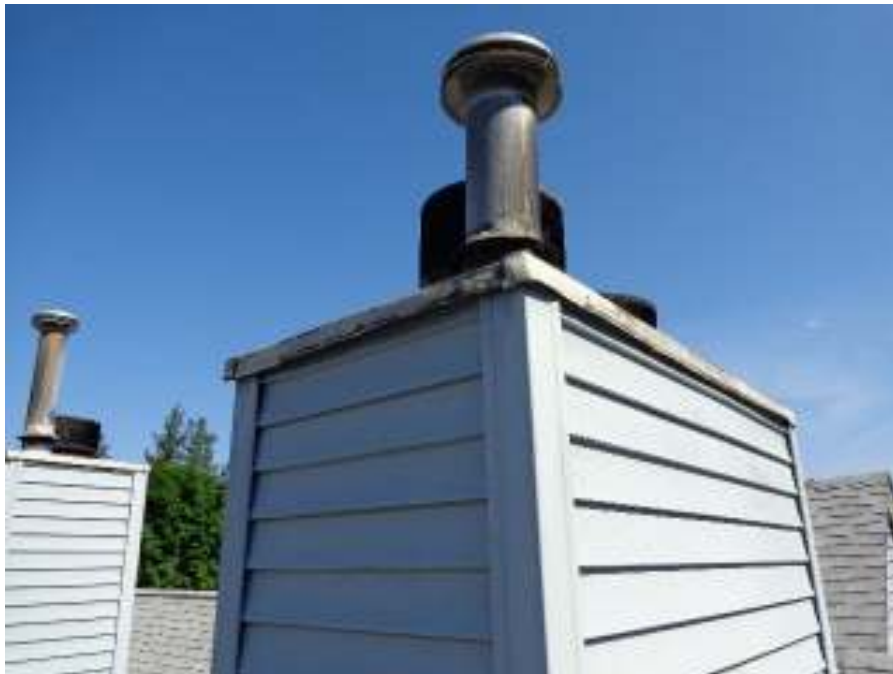
Photo #8

8. There is evidence that the metal chimney's have been repaired with sealant over the years and may still be an issue. The metal cap flashing is also poorly installed as you can see from these photo's. Please note photo's #8, #9

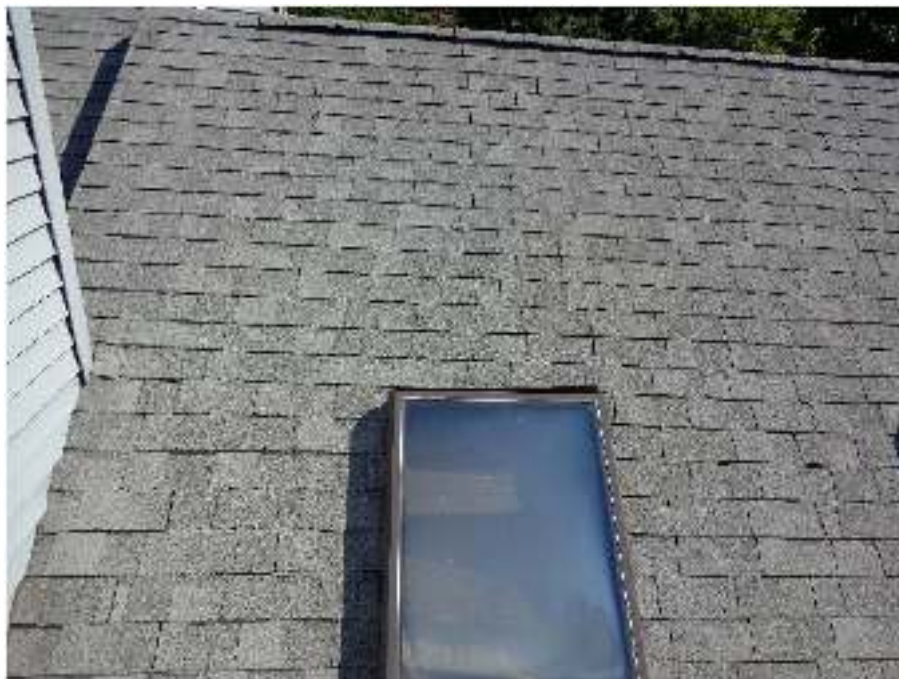
Photo #4

4. The few skylights we viewed showed signs of age and should be replaced in the near future. Please note photo #4.

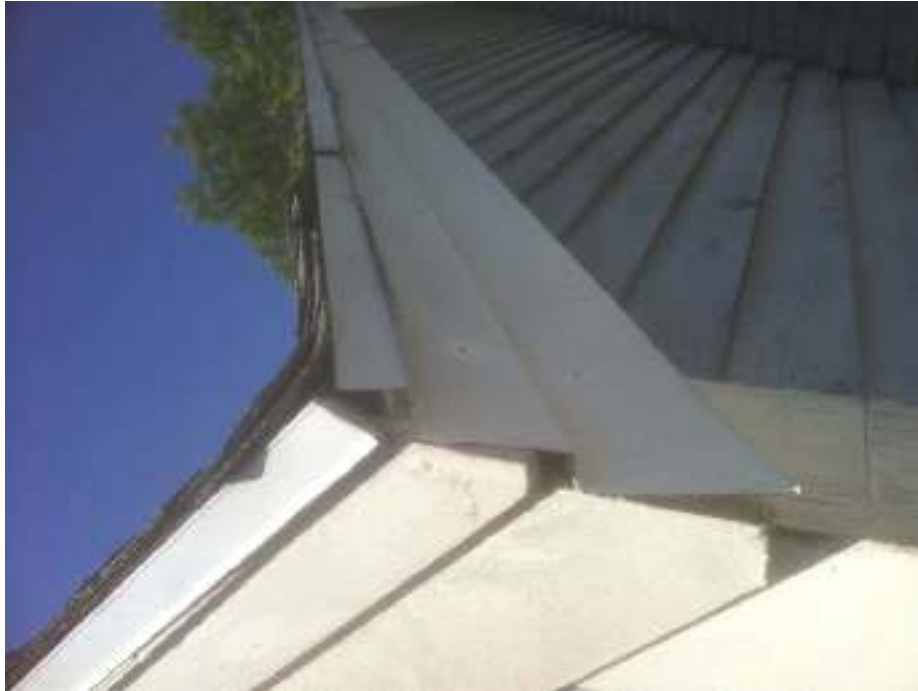
Photo #5

5. There is evidence of wind-damaged trim metal that should be replaced or at least removed. Please note photo #5.

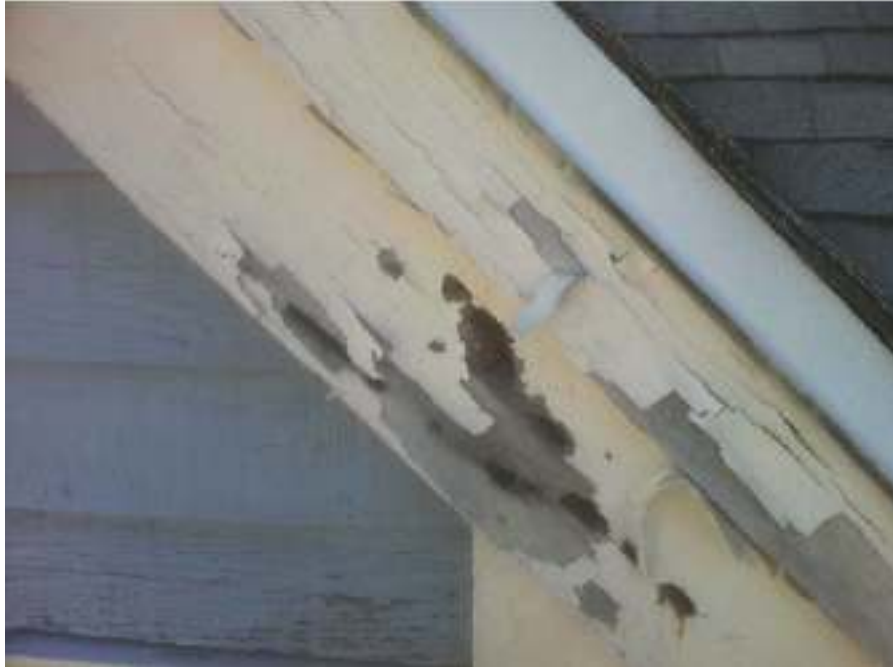
Photo #7

7. There are a few locations of "Wood Bee" attach on rack trim board. Please note photo #7.

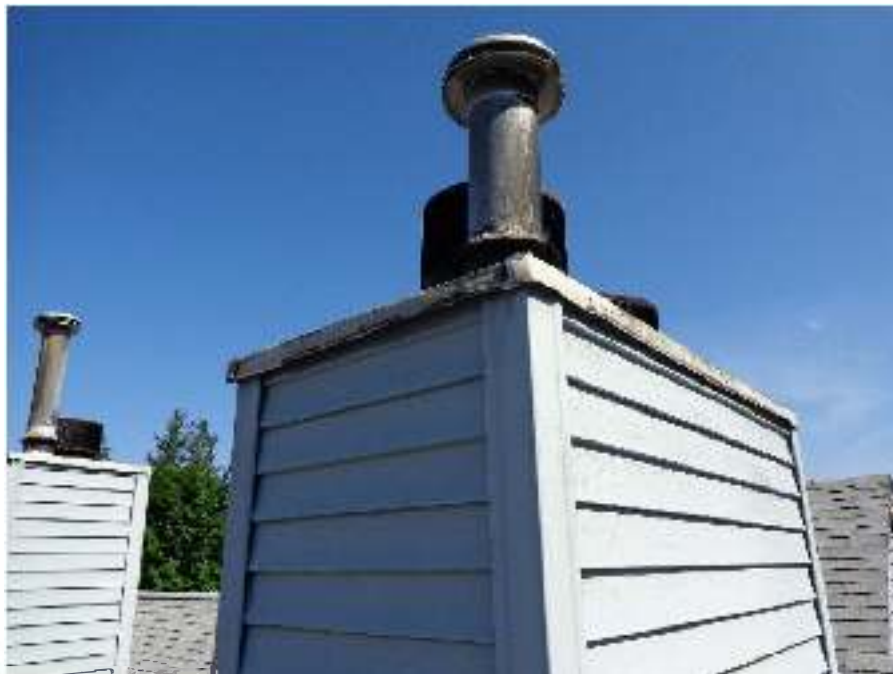
Photo #8

8. There is evidence that the metal chimney's have been repaired with sealant over the years and may still be an issue. The metal cap flashing is also poorly installed as you can see from these photo's. Please note photo's #8, #9

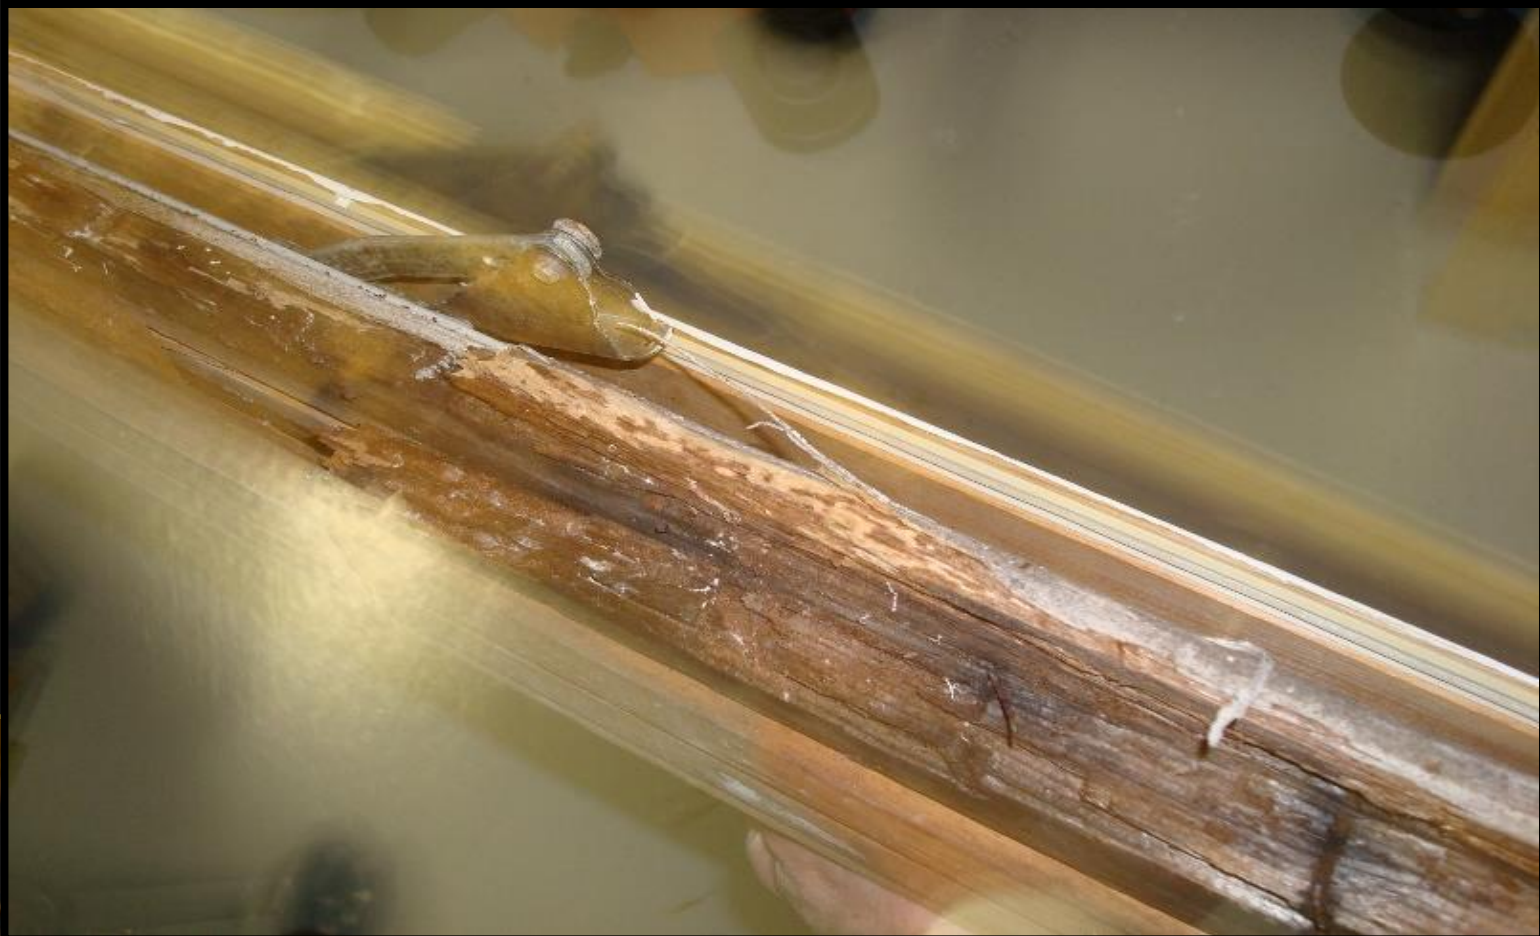
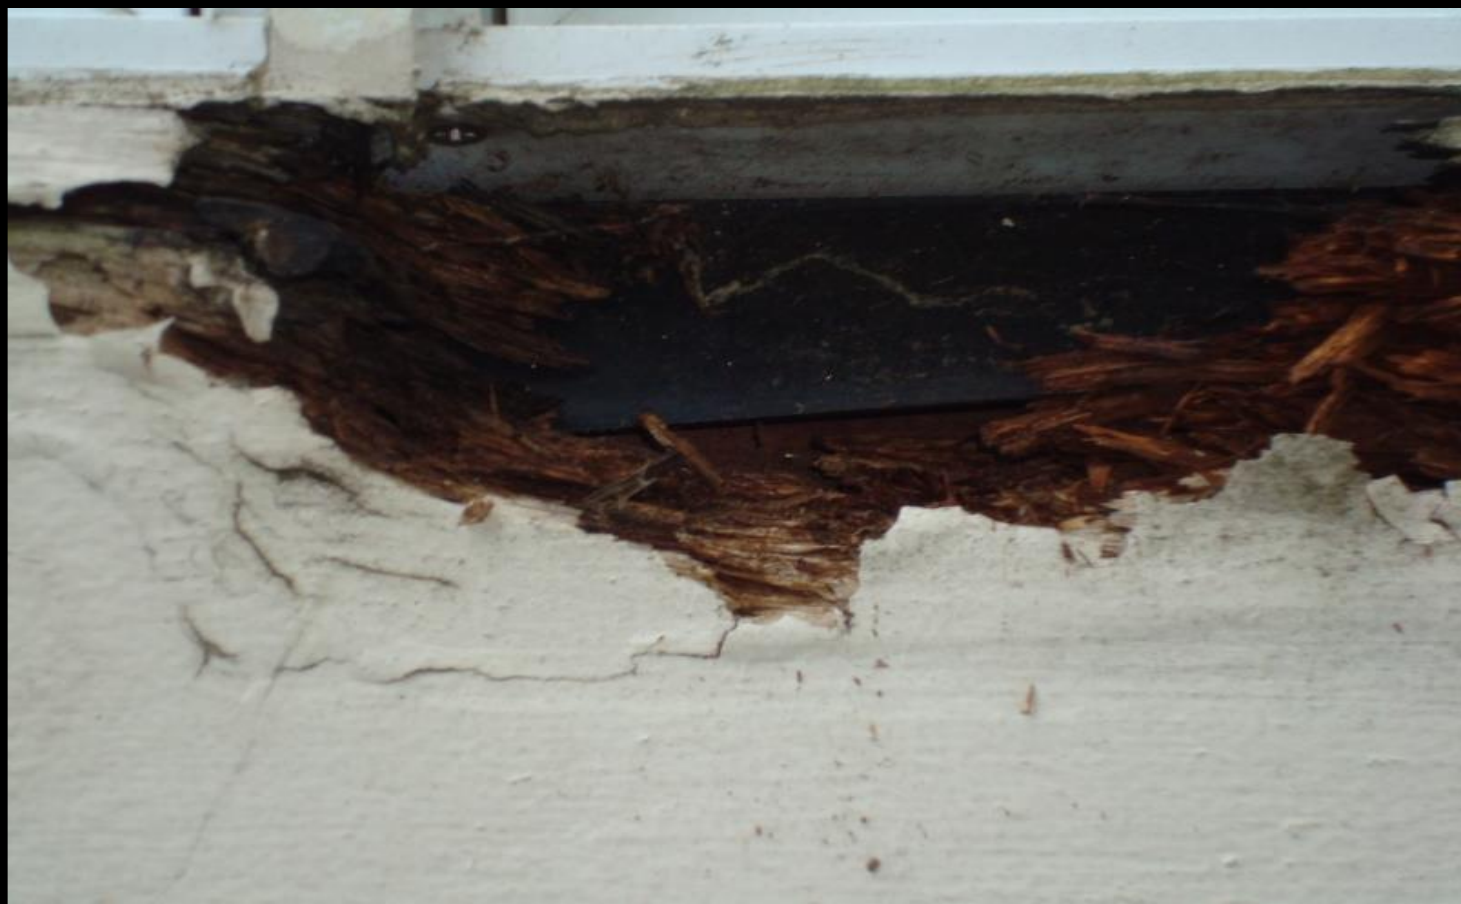
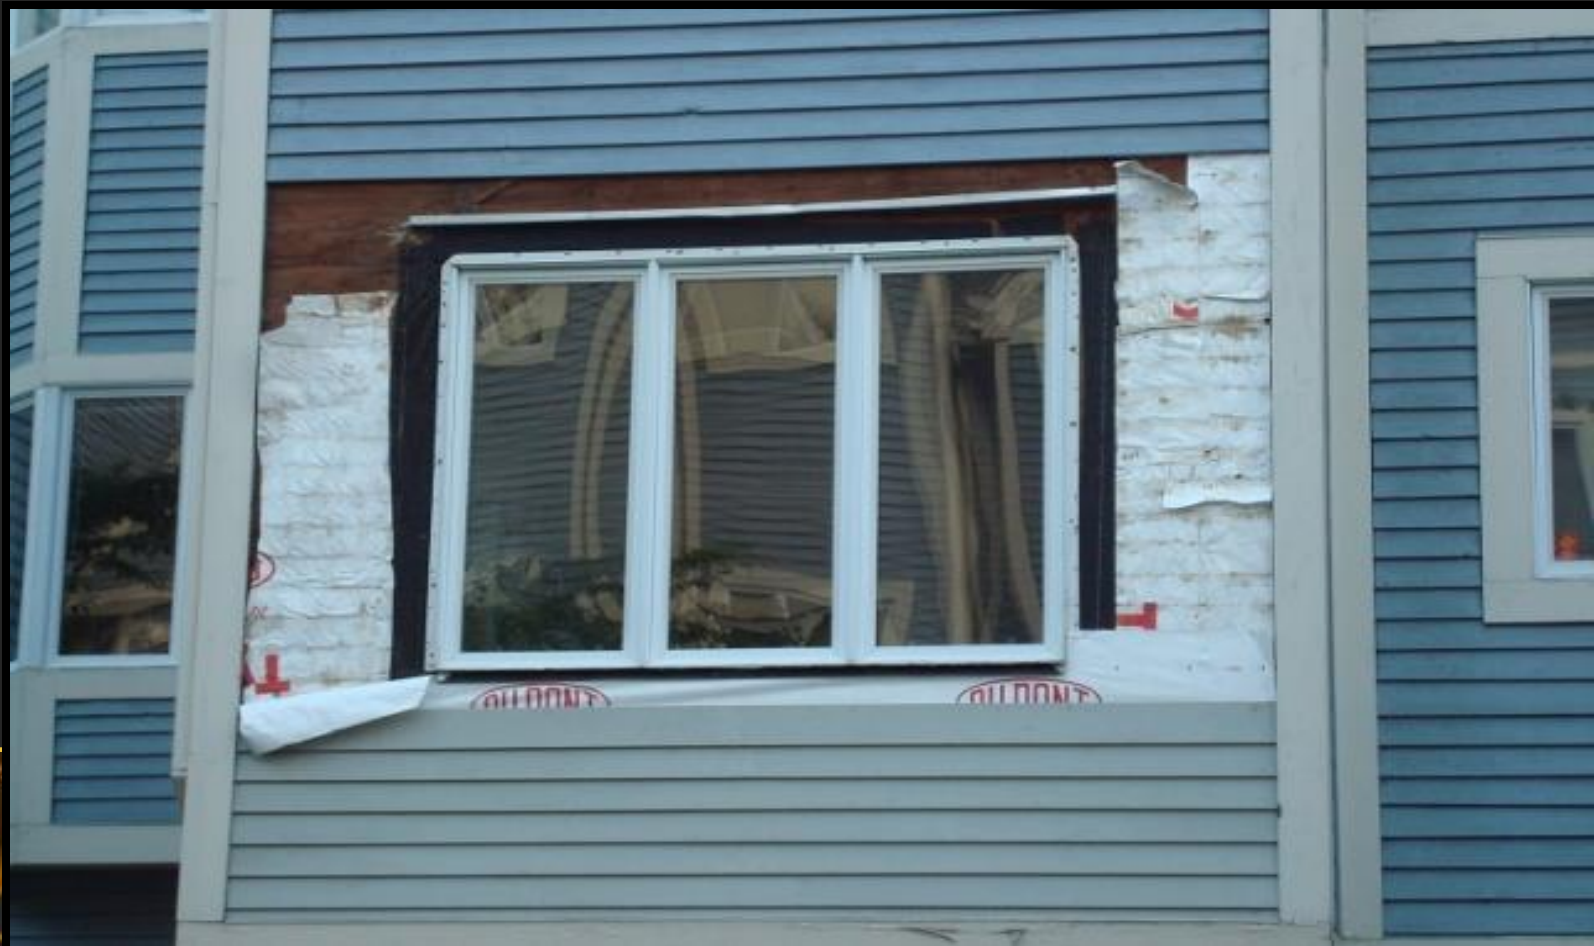
Window sills have significant water and insect damage. Many windows do not open.

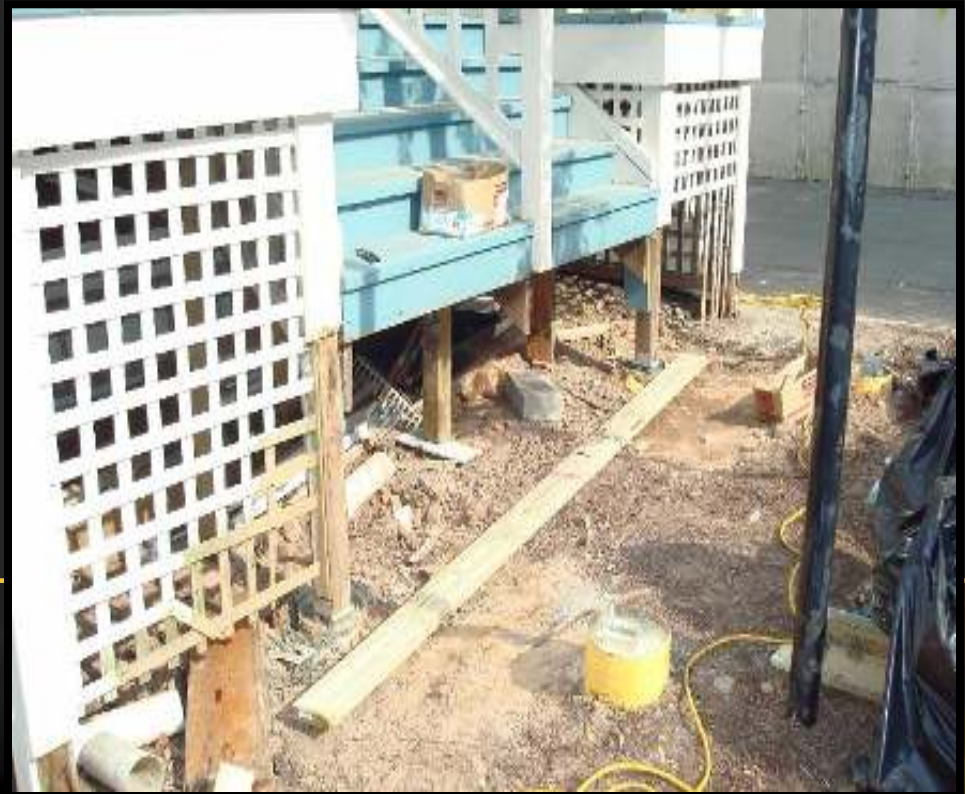
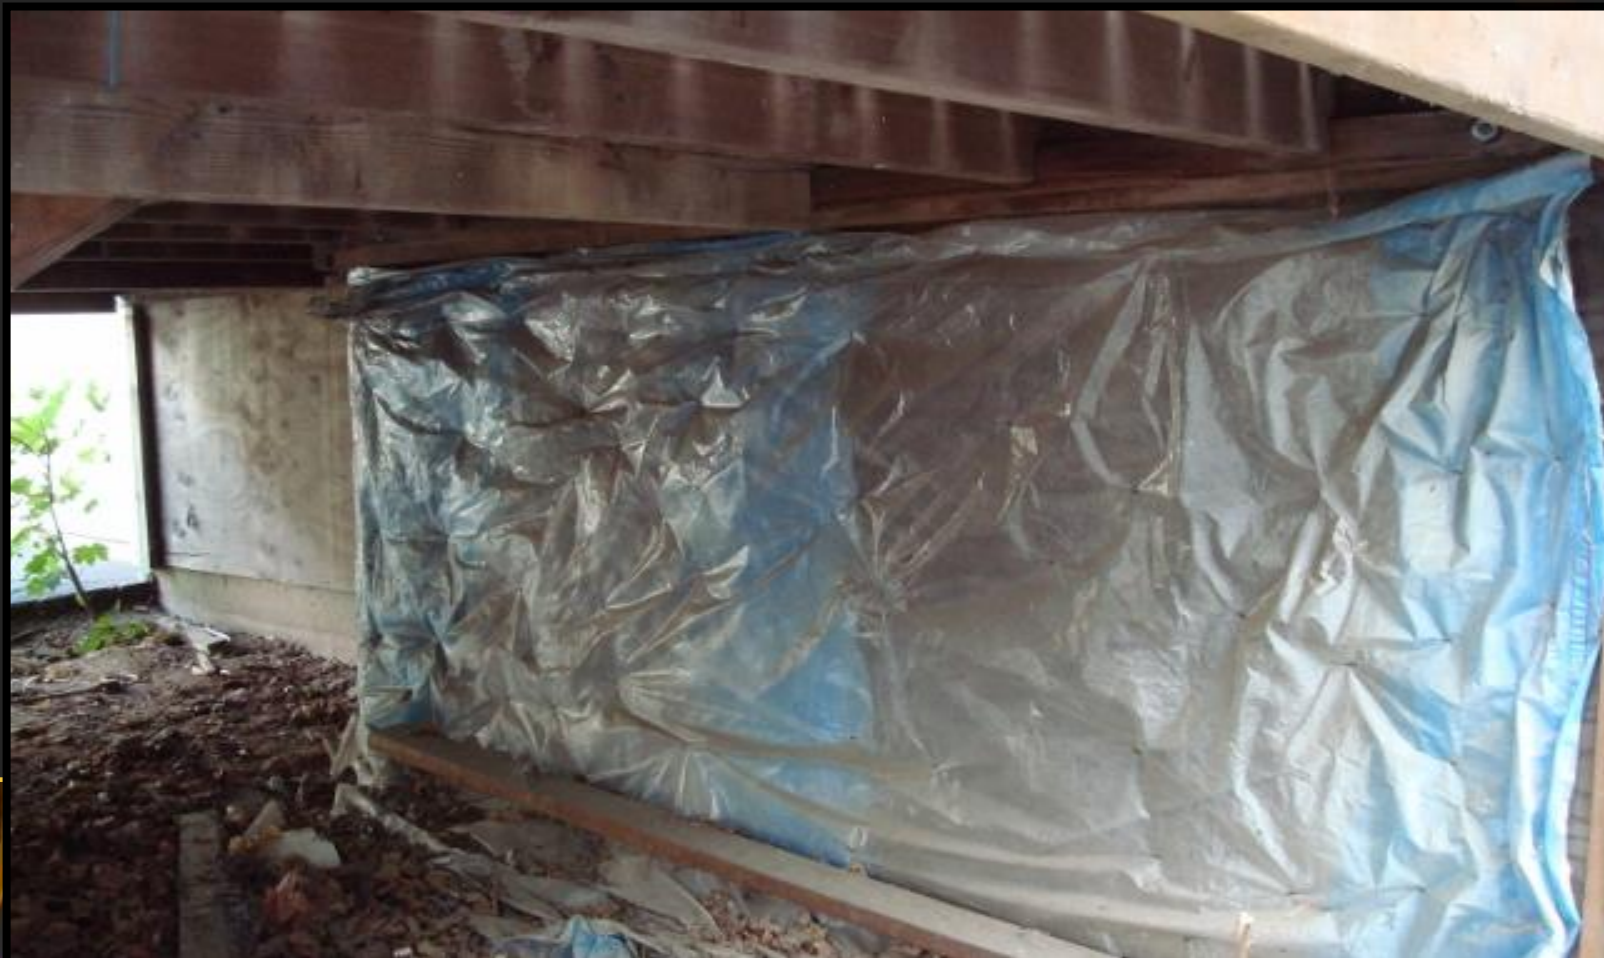
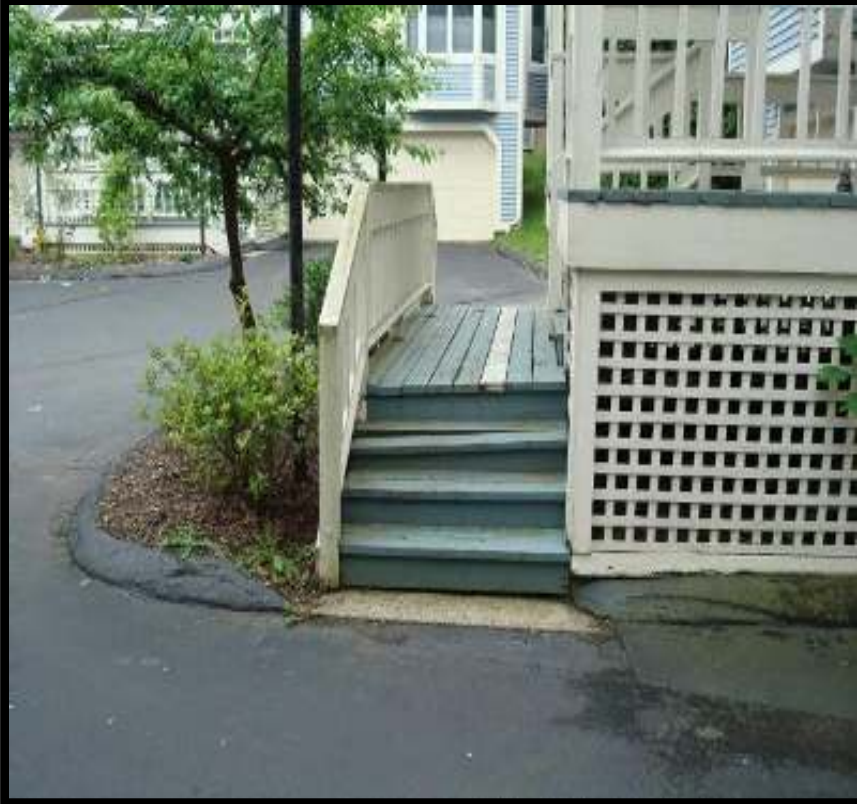
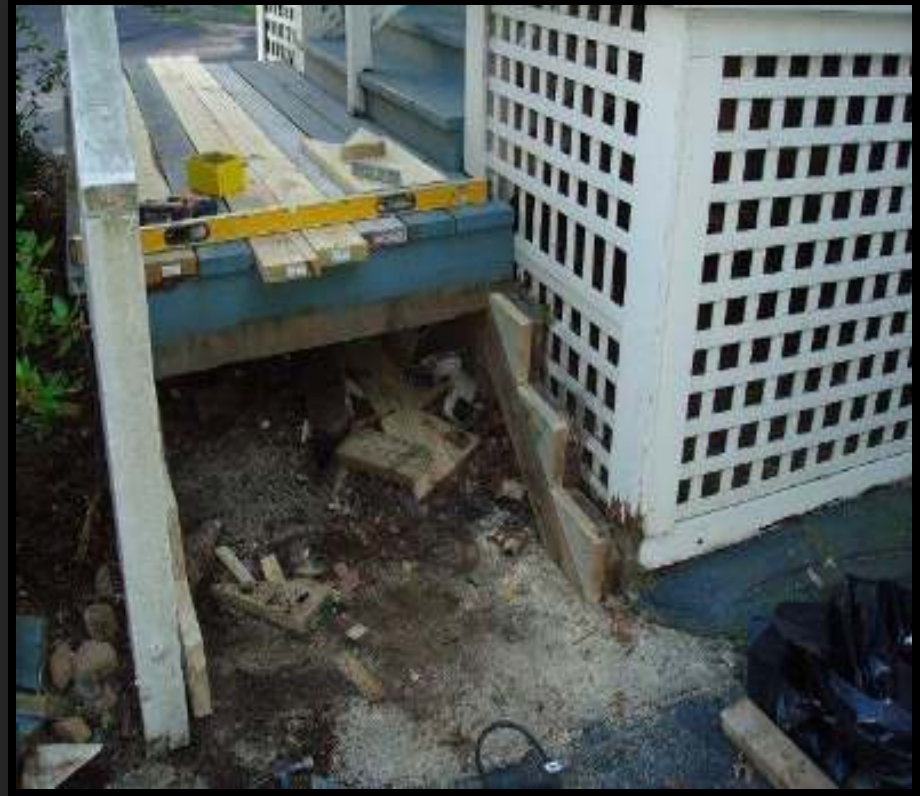
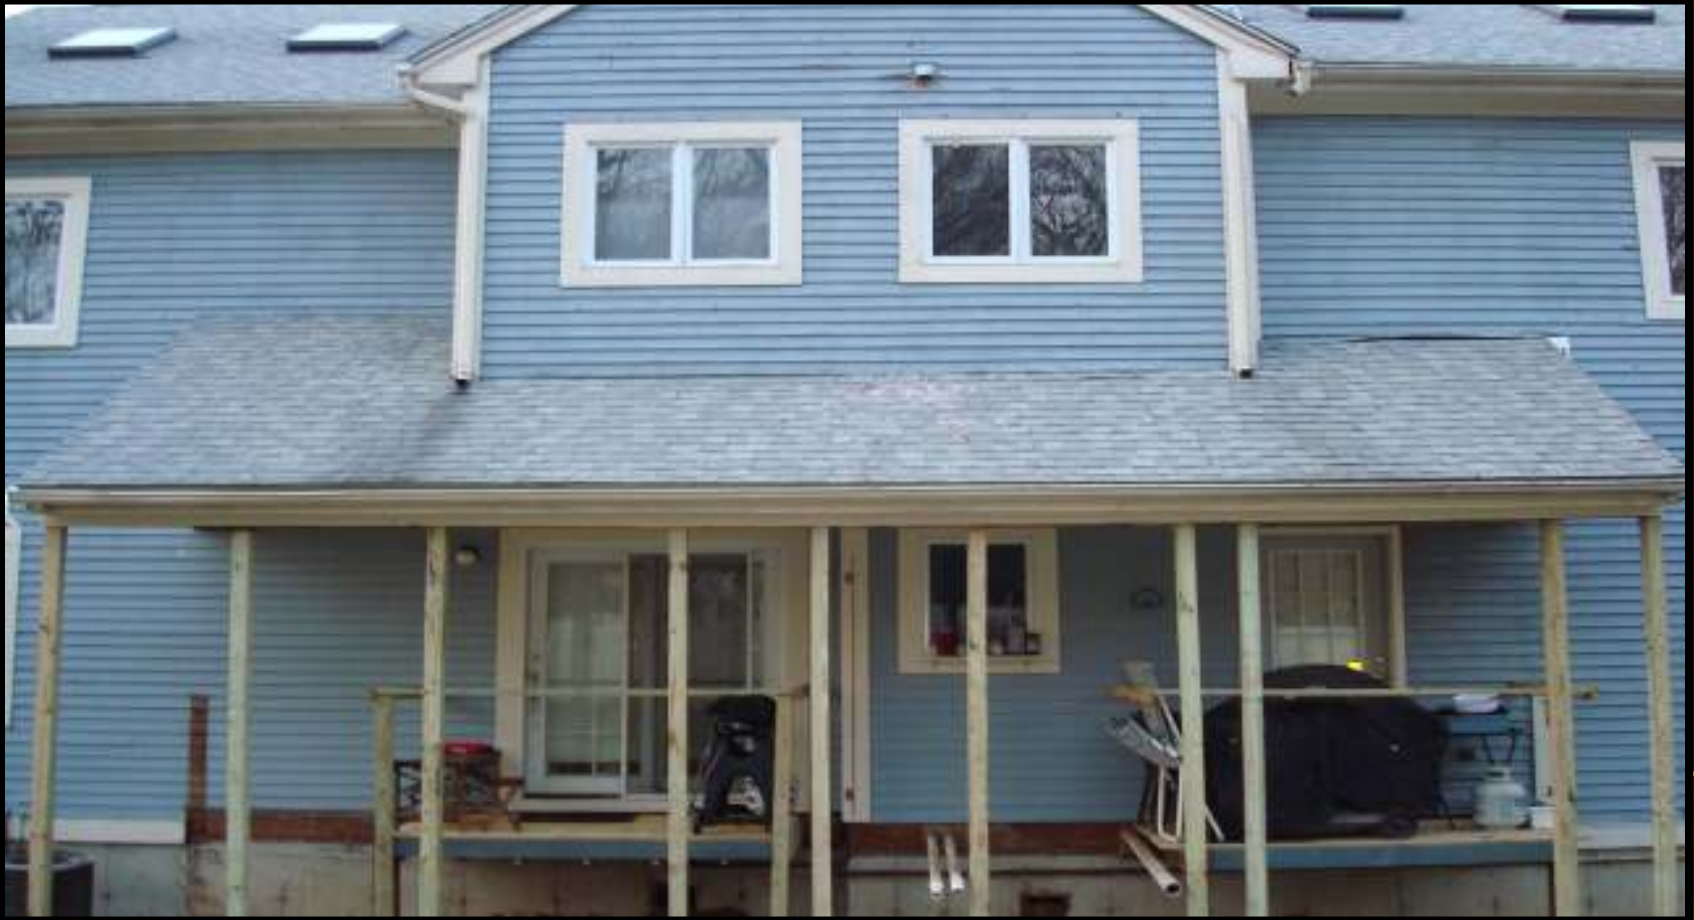
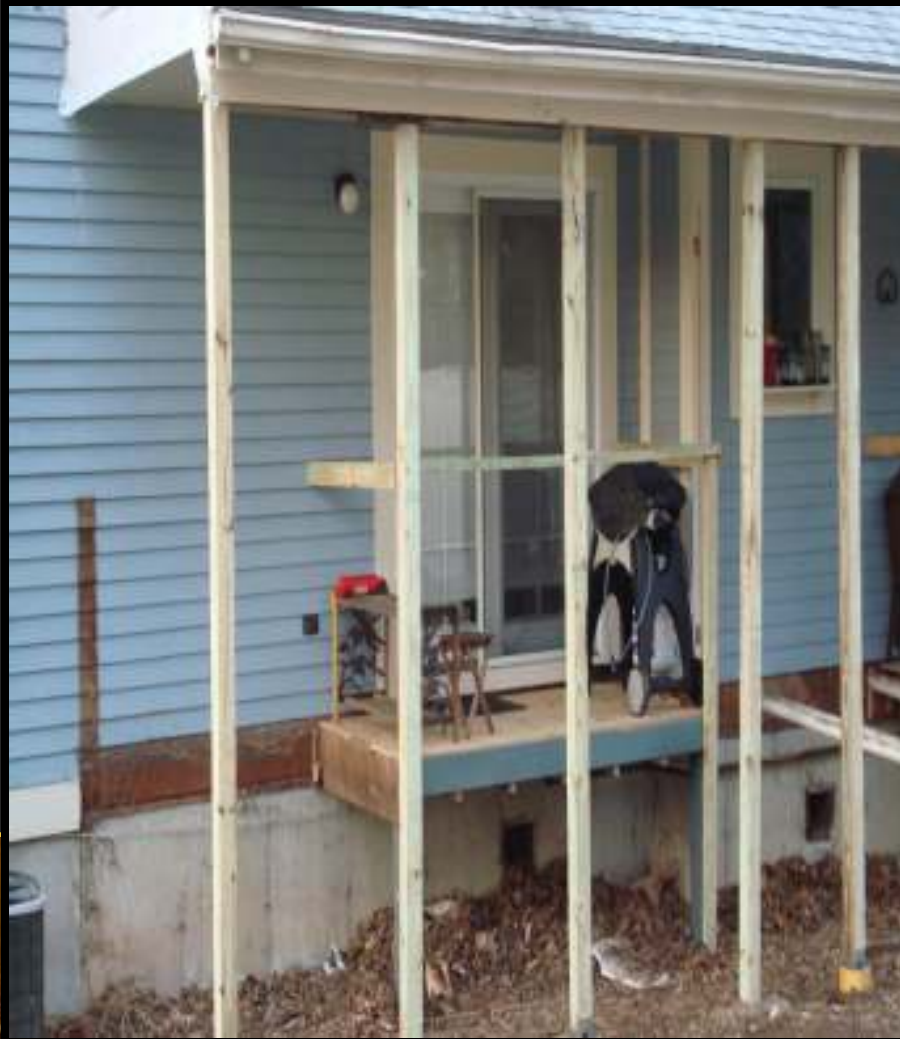
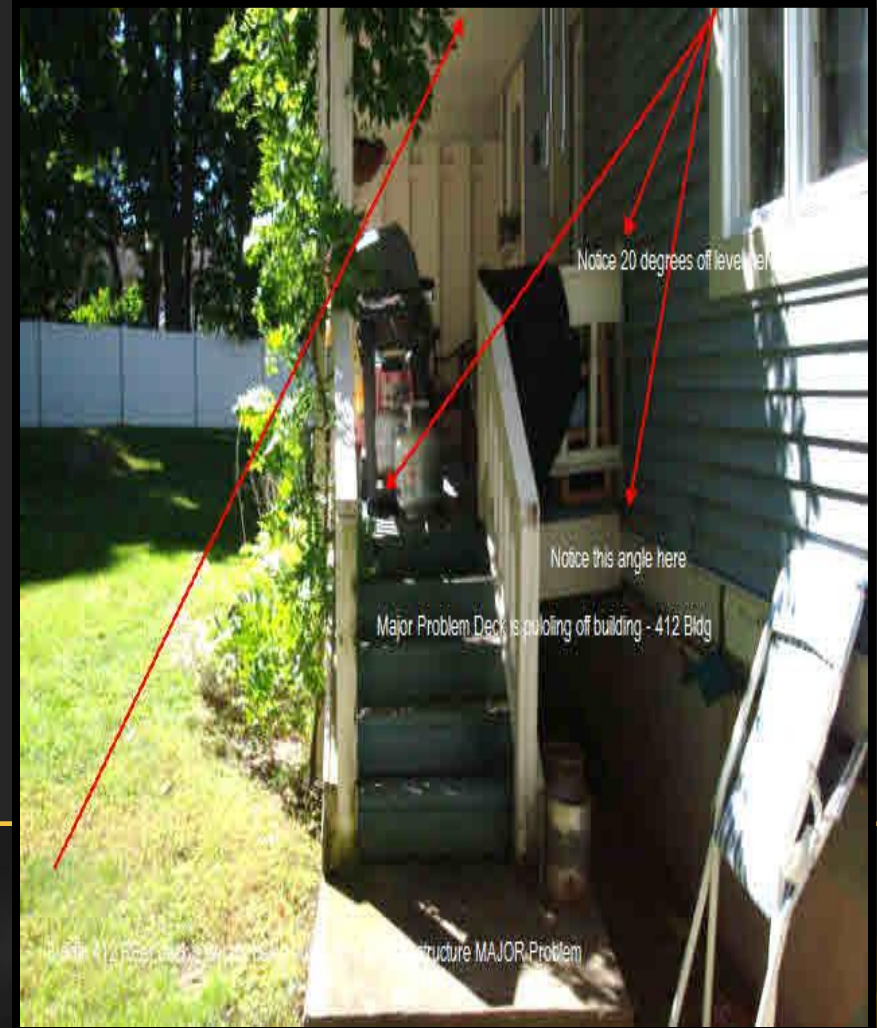
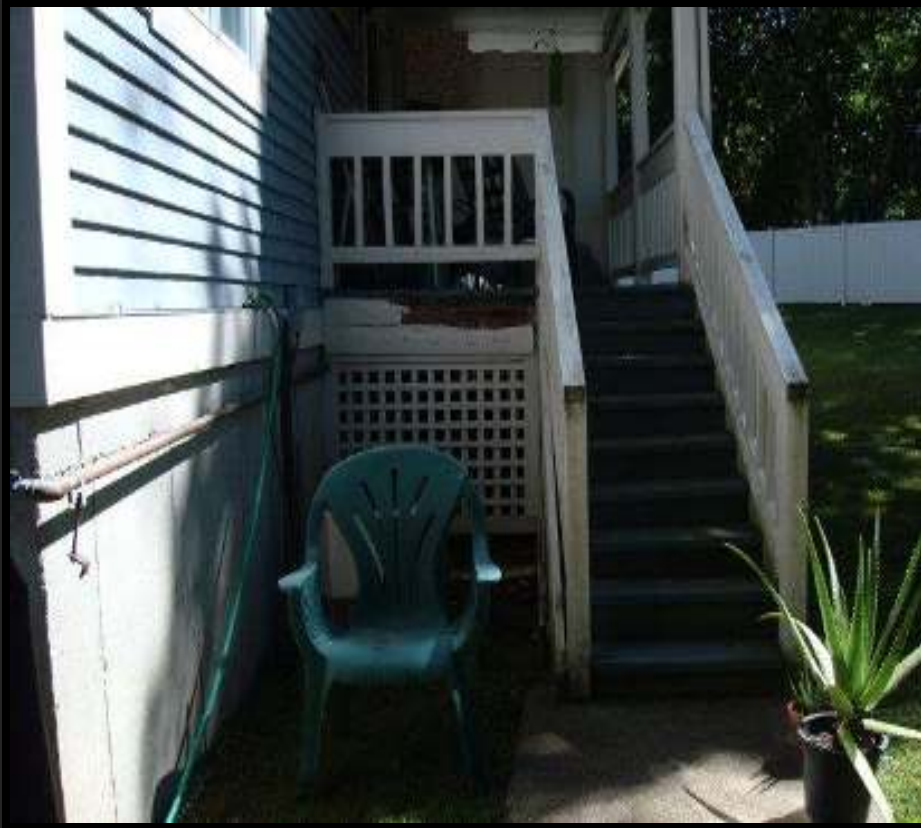
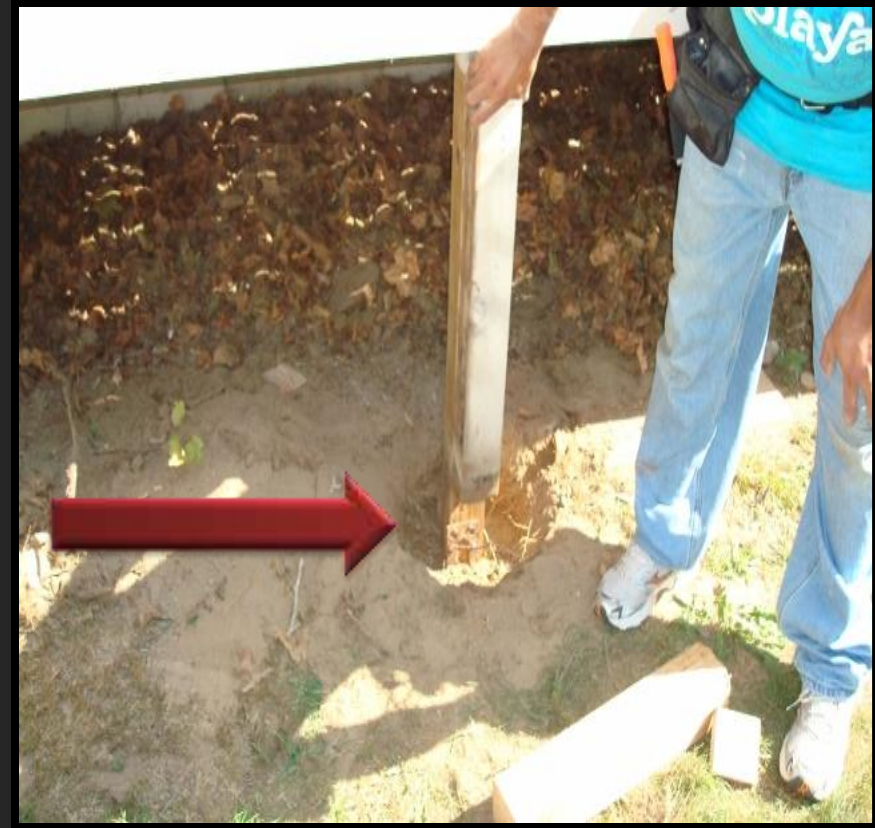
Front and rear decks were improperly built without adequate structural support and continue to cause damage to the buildings. Front and rear decks rotted shortly after the first owners arrived and have been replaced several times. Every front and rear deck needs to be rebuilt correctly with adequate structural support to prevent further damage.
