Fountain Hill Condo Association

## NOTICE OF UNIT OWNERS MEETING FOUNTAIN HILL CONDOMINIUM ASSOCIATION, INC.

# Fountain Hill Association

## Facility Report

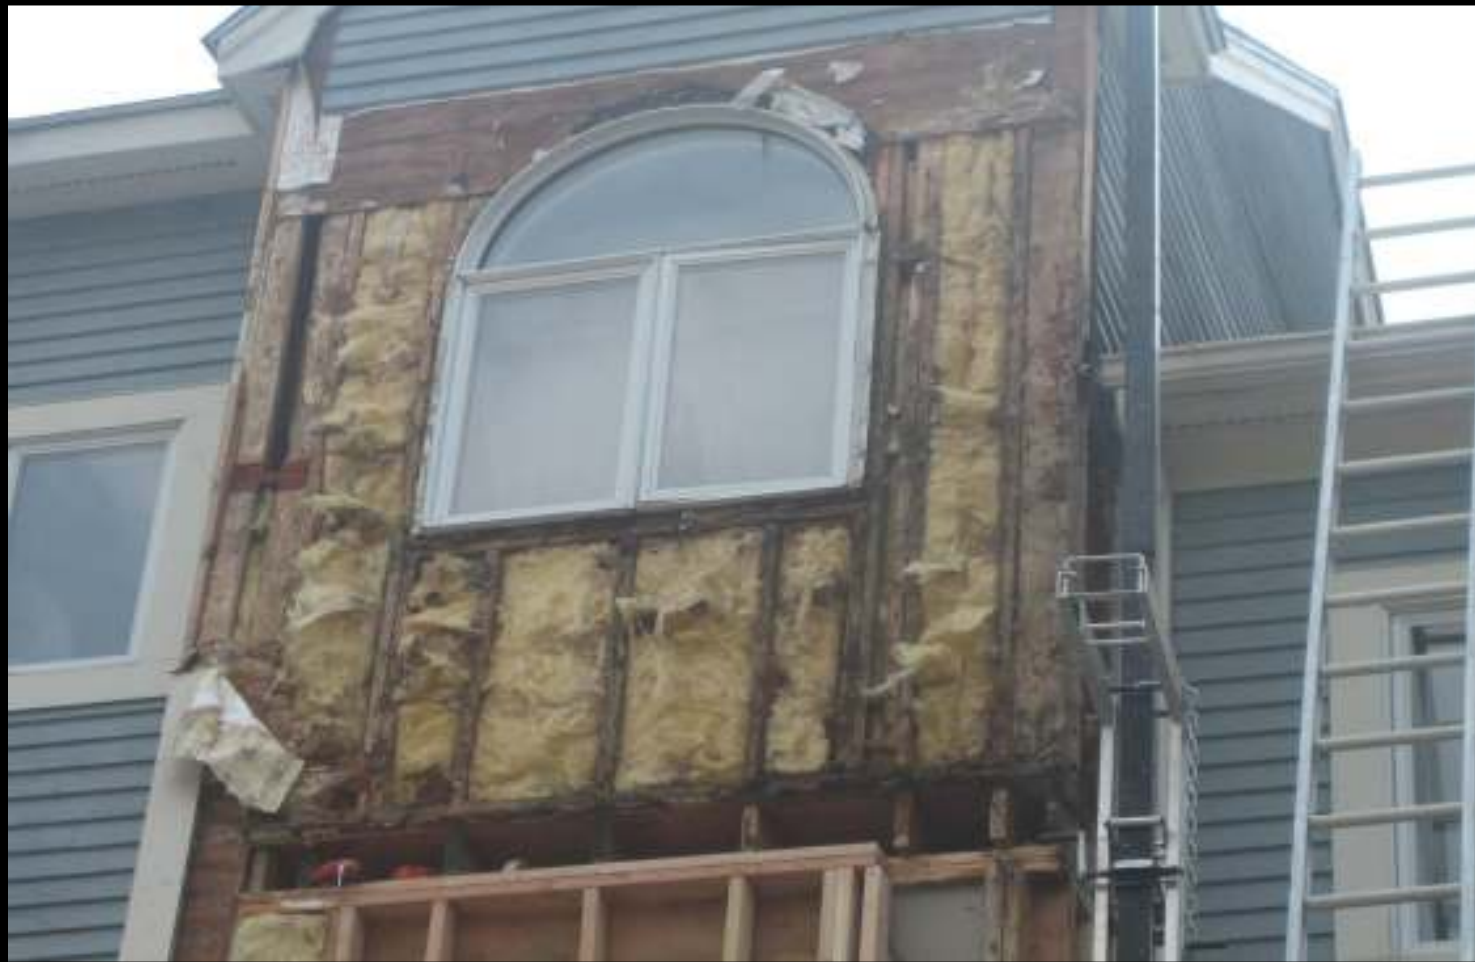
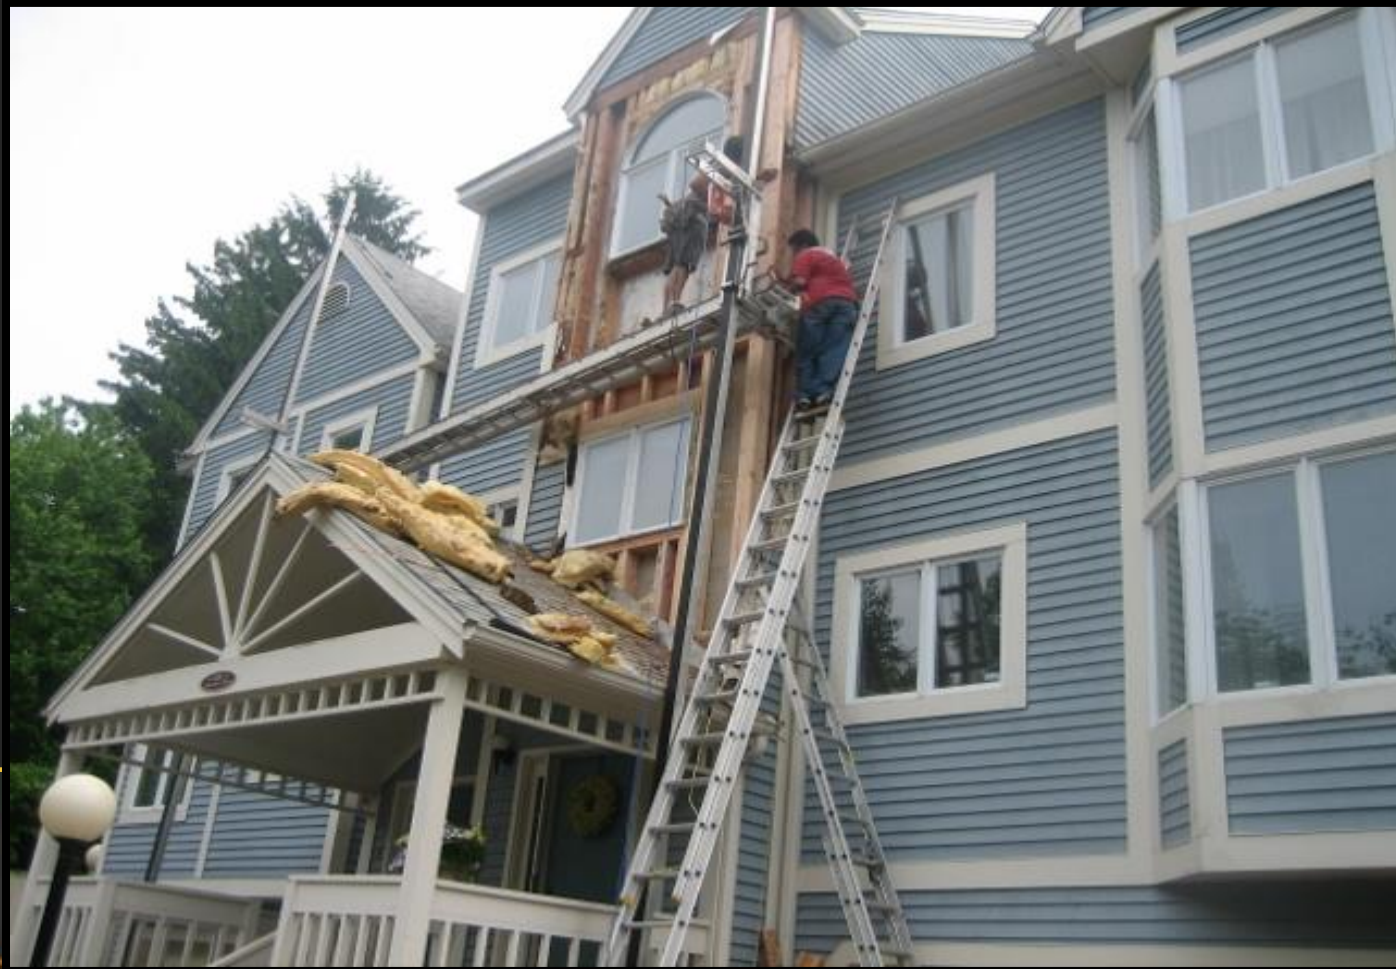
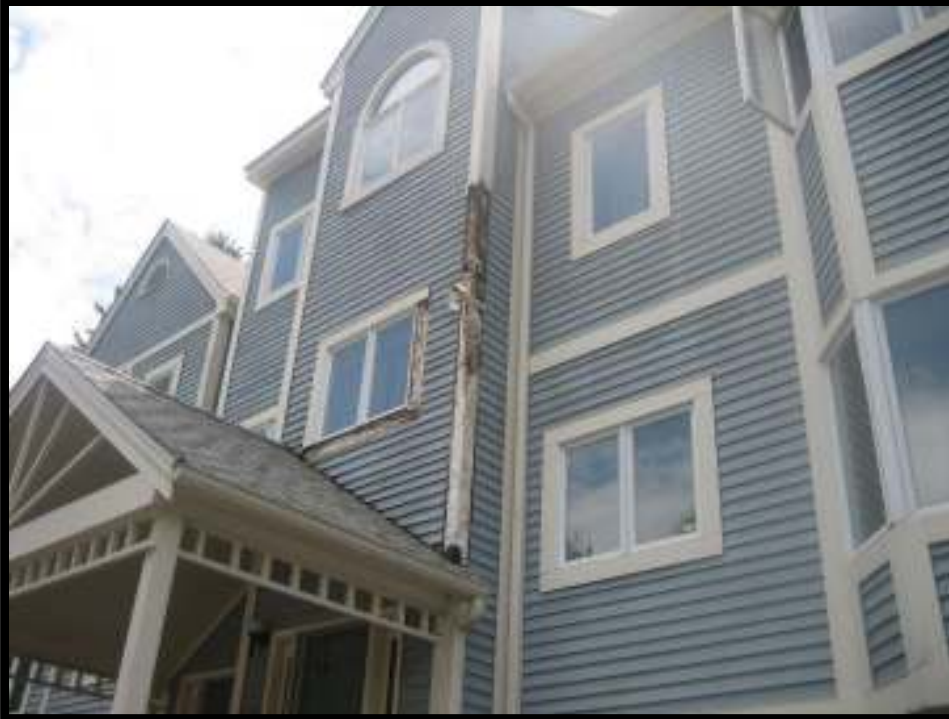
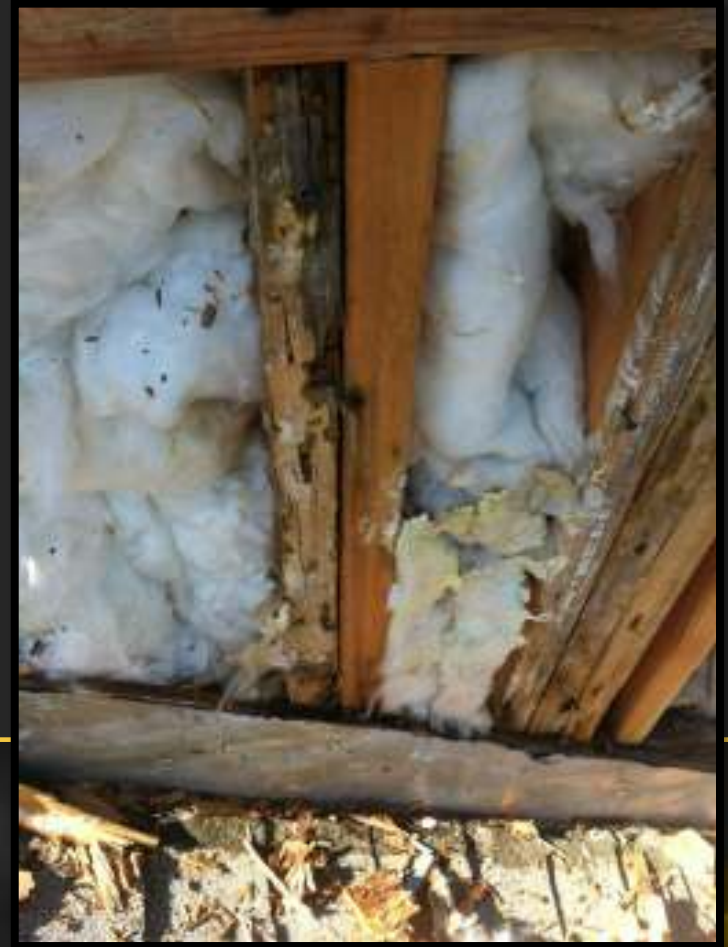
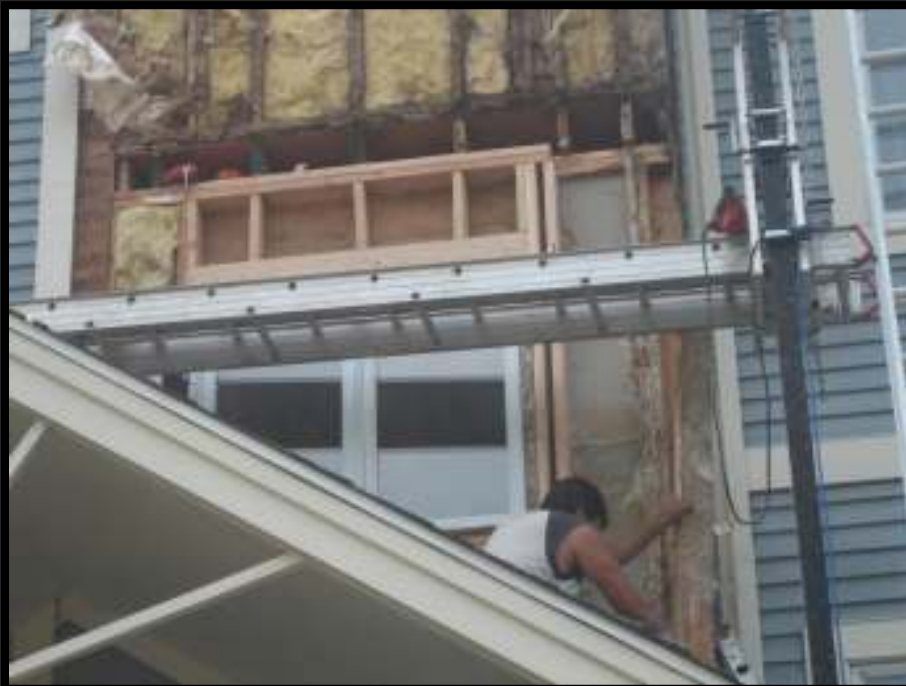
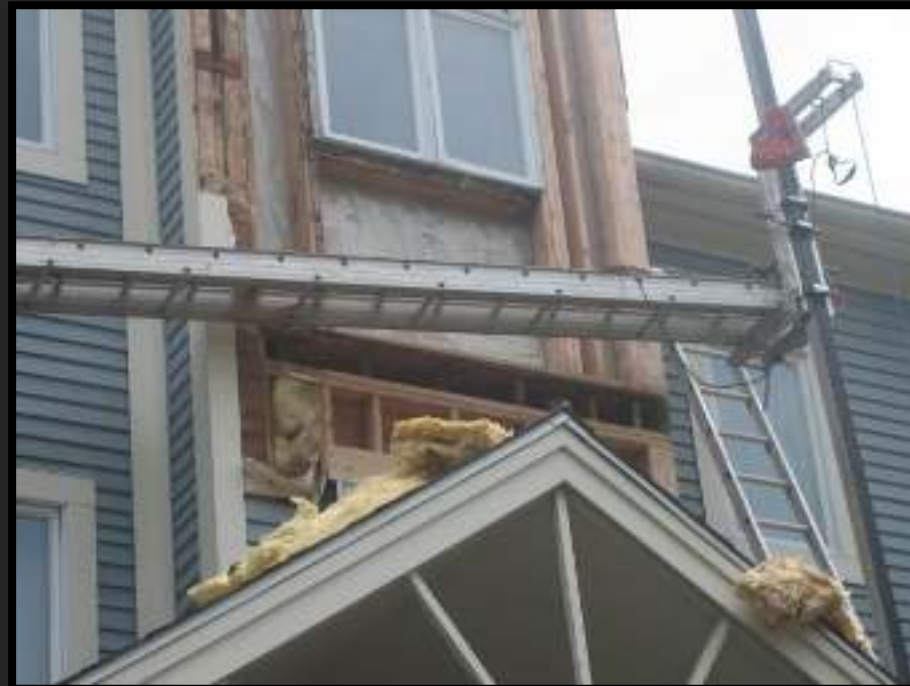
Each year, carpenter ants and bees cause extensive damage to the wood siding and to the structural wood frame beneath the siding.

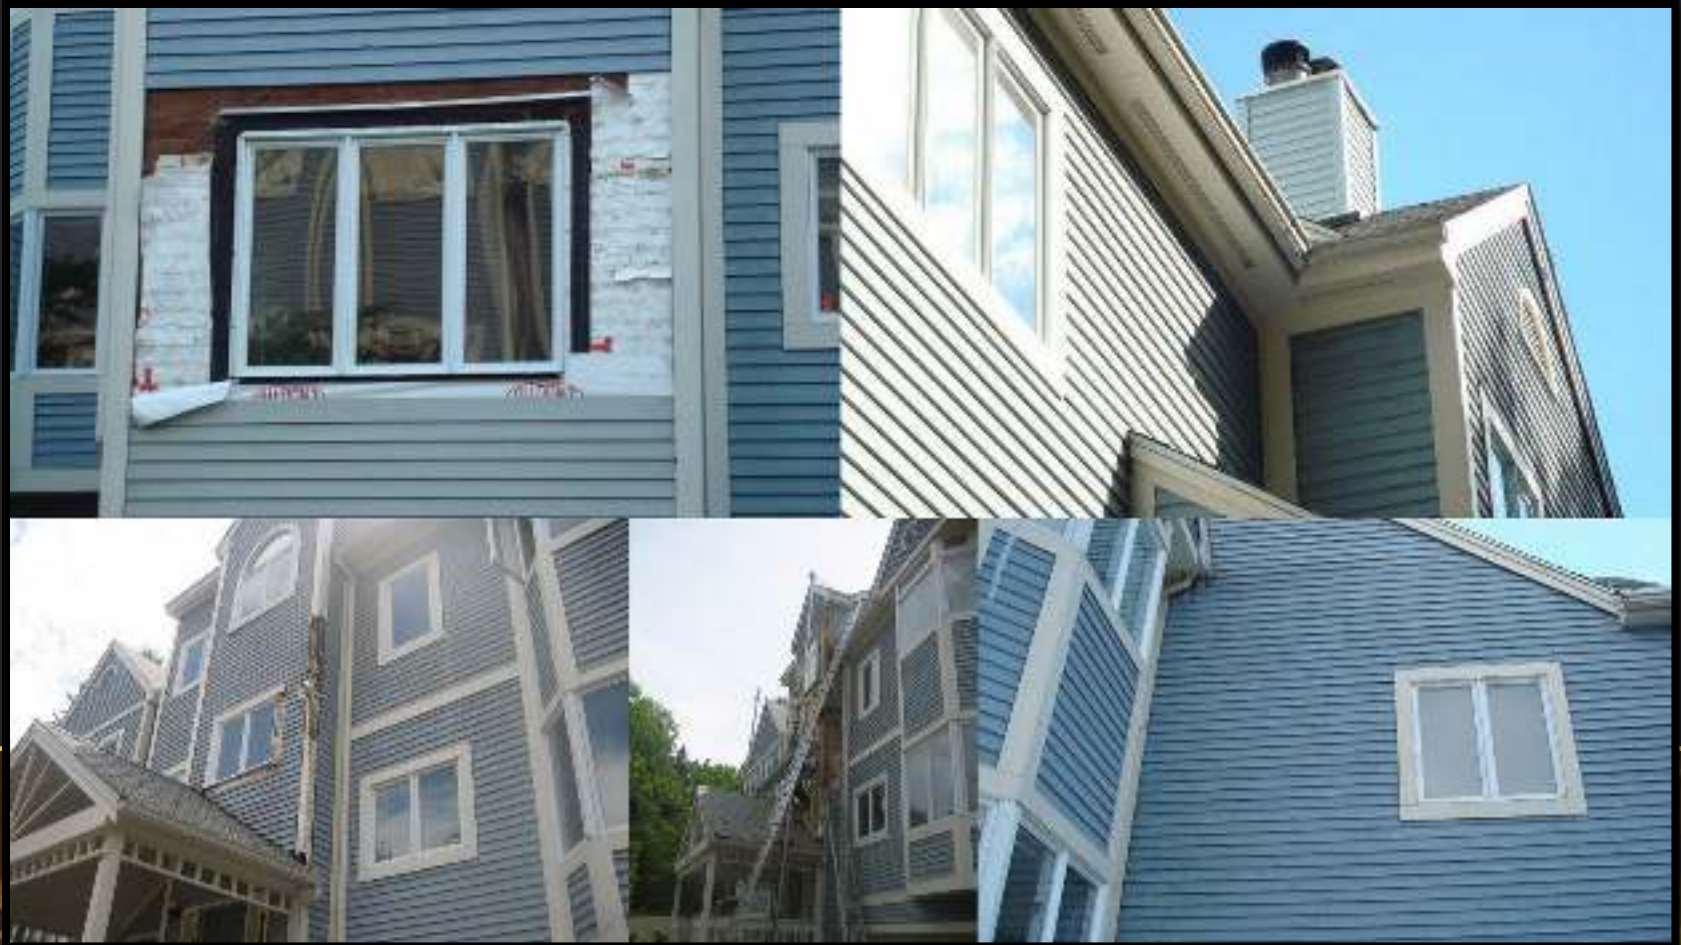
Each year, a percentage of the cedar siding must be replaced due to warping and rotting.

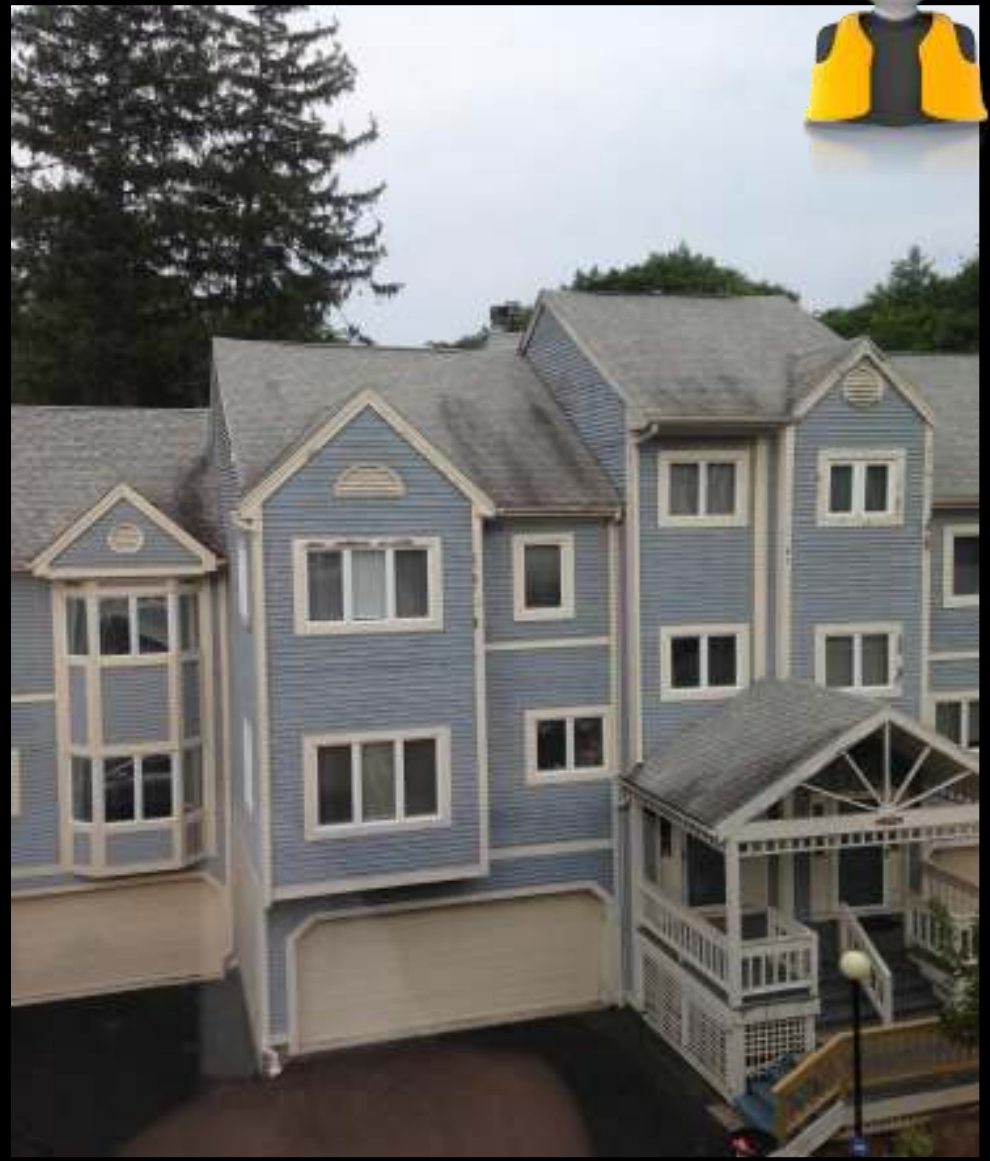
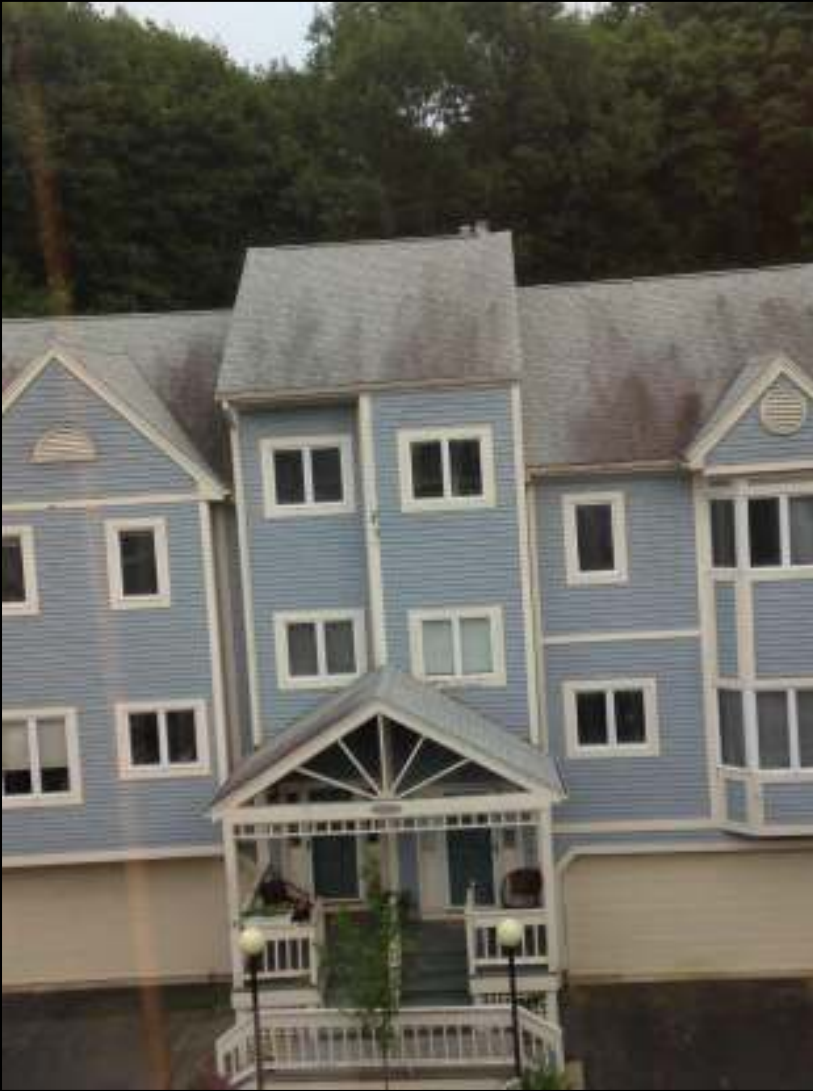
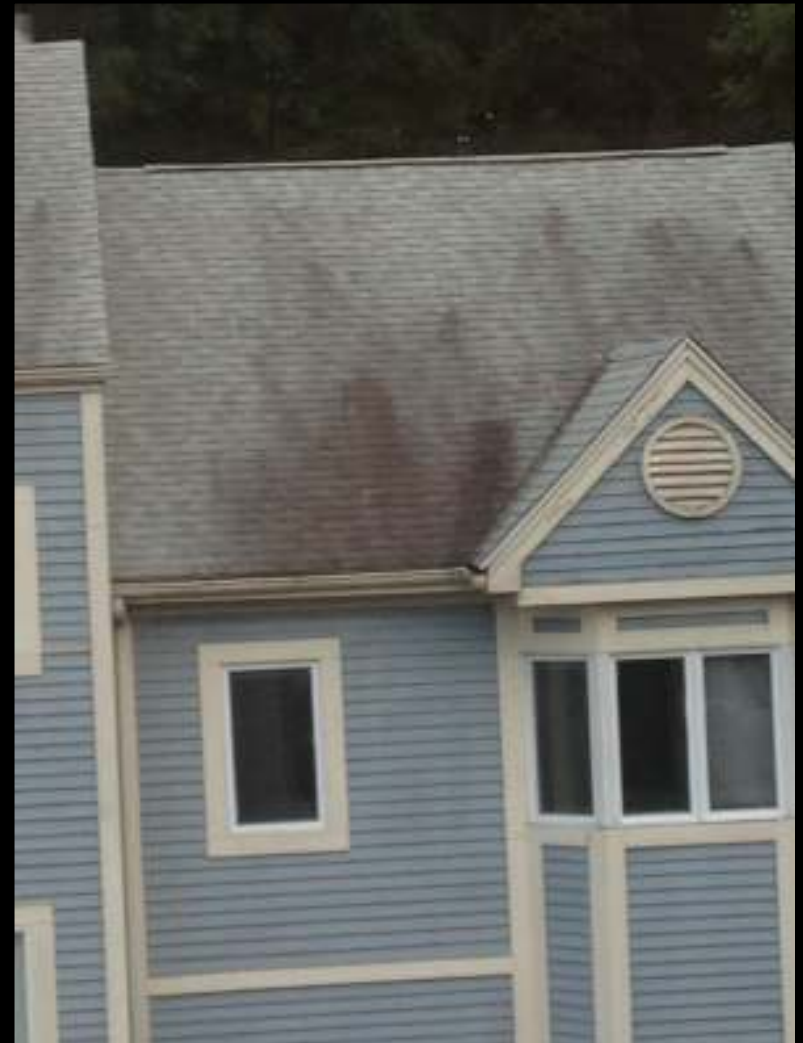
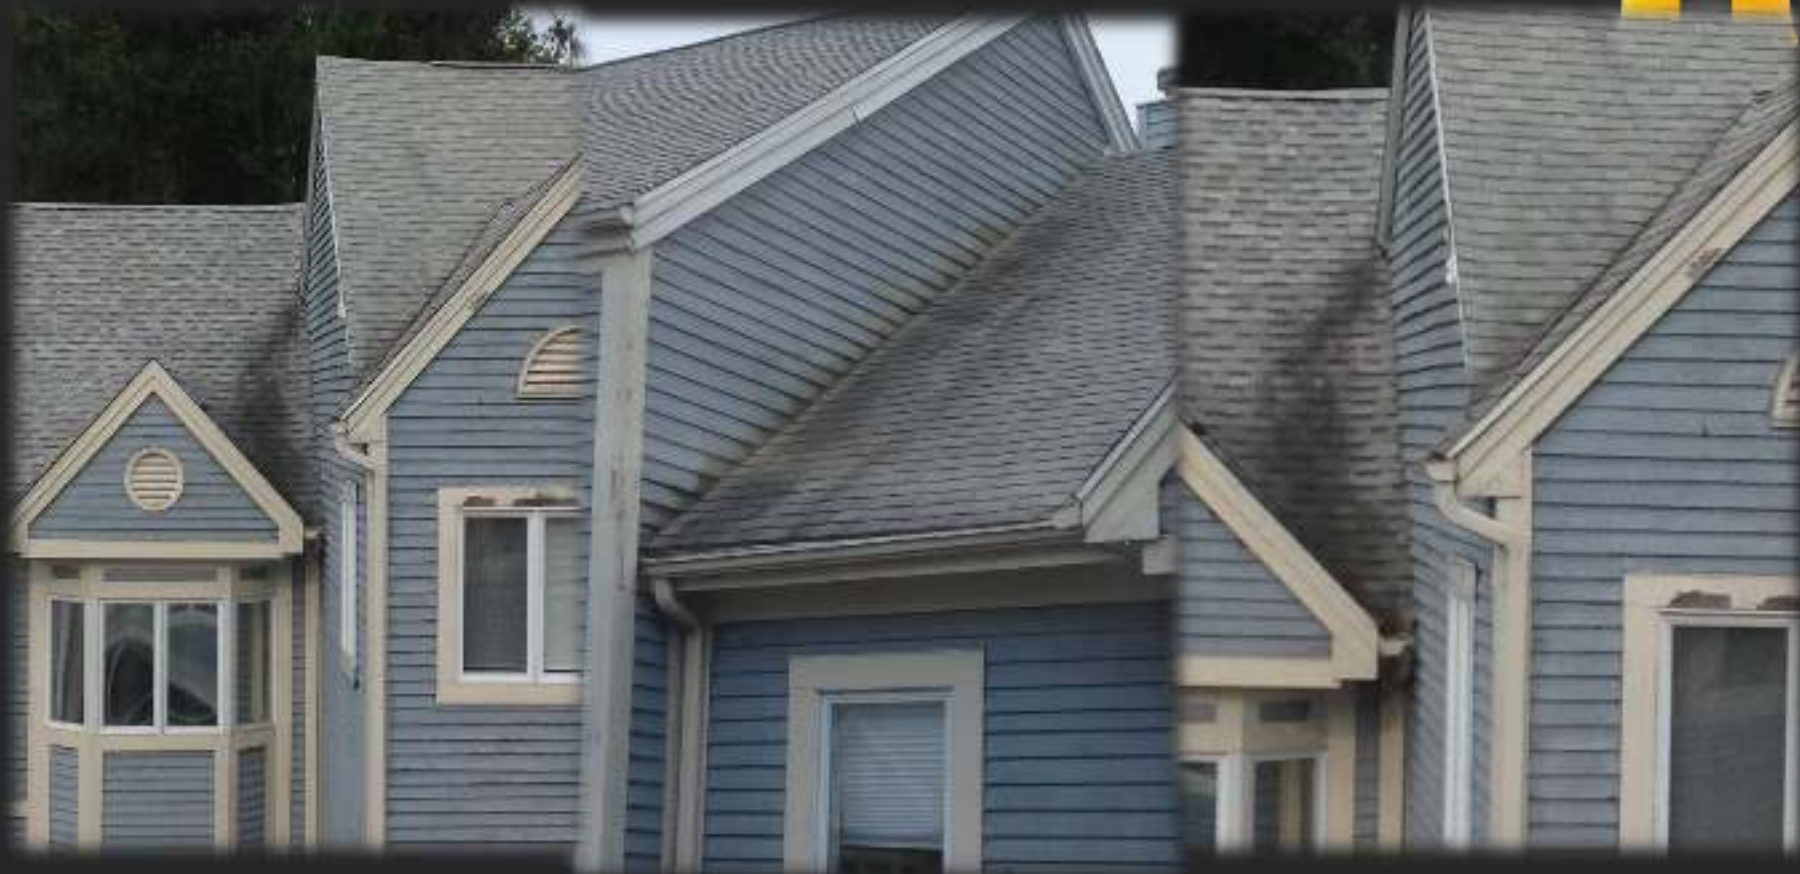
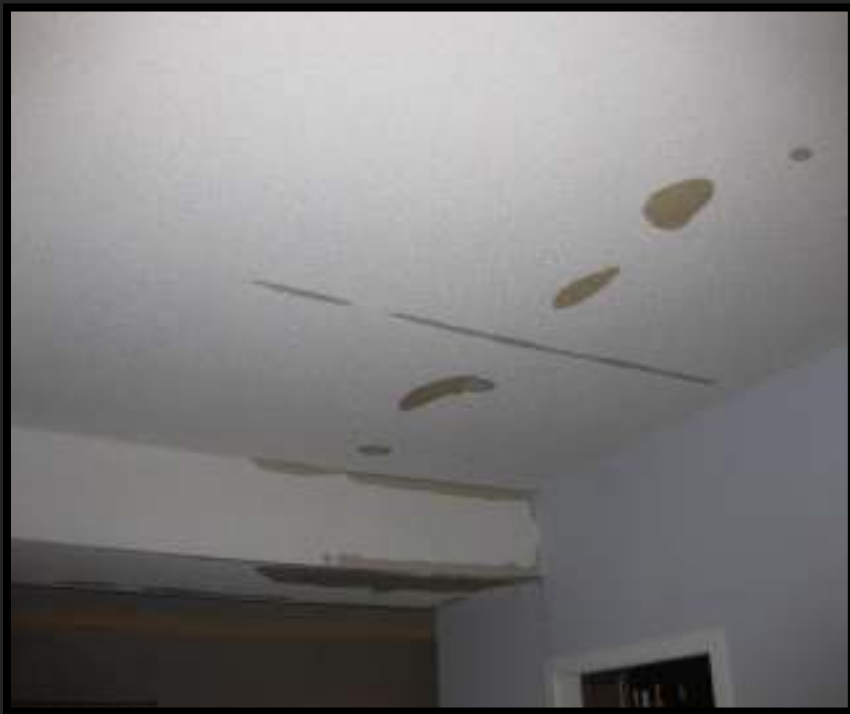
Complaints about leaky roofs began shortly after the first owners moved in. Ten years ago, in an attempt to correct the problem new shingles were added to the old roof without correcting flashing and other known issues underneath the original roof. The entire roof needs to come off, damaged and rotted wood underneath needs to be replaced, proper flashing needs to be corrected before a new roof is installed.

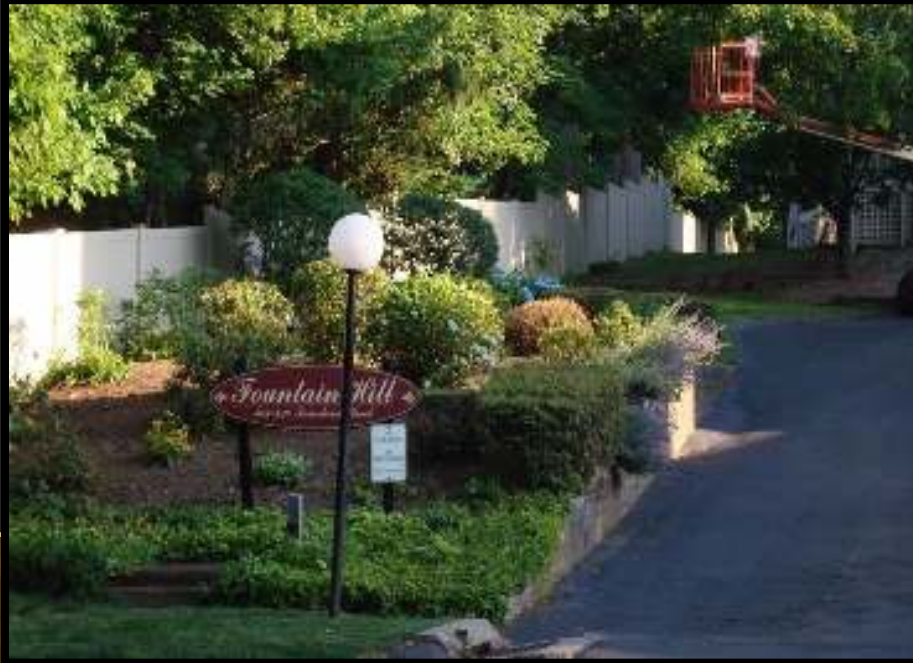
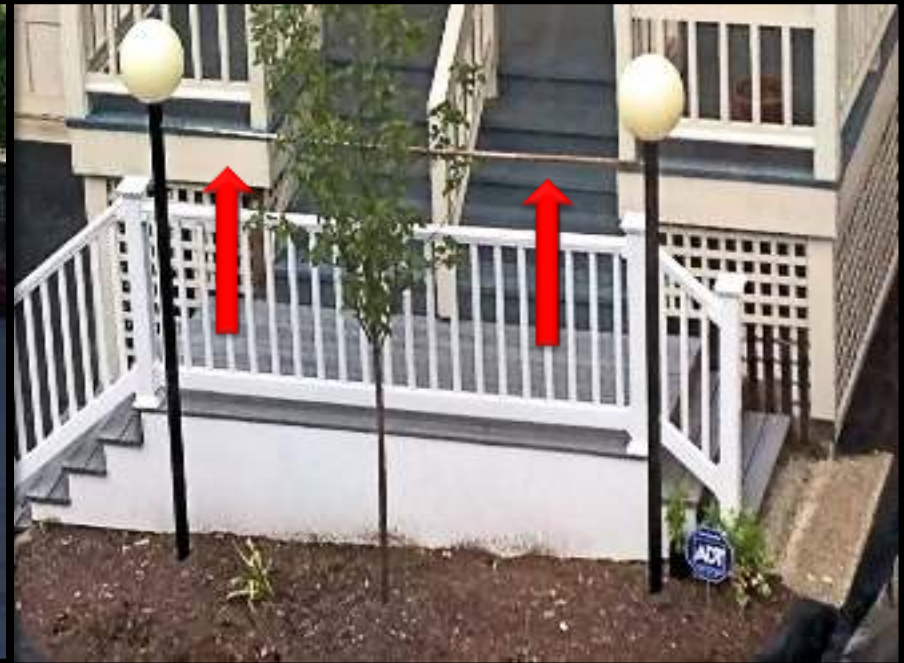
Much of the exterior lighting is no longer functional. Numerous attempts to repair the wiring have been unsuccessful. The inefficient fixtures are rusted and broken and the unprotected underground wiring needs to be replaced and protected from the elements.

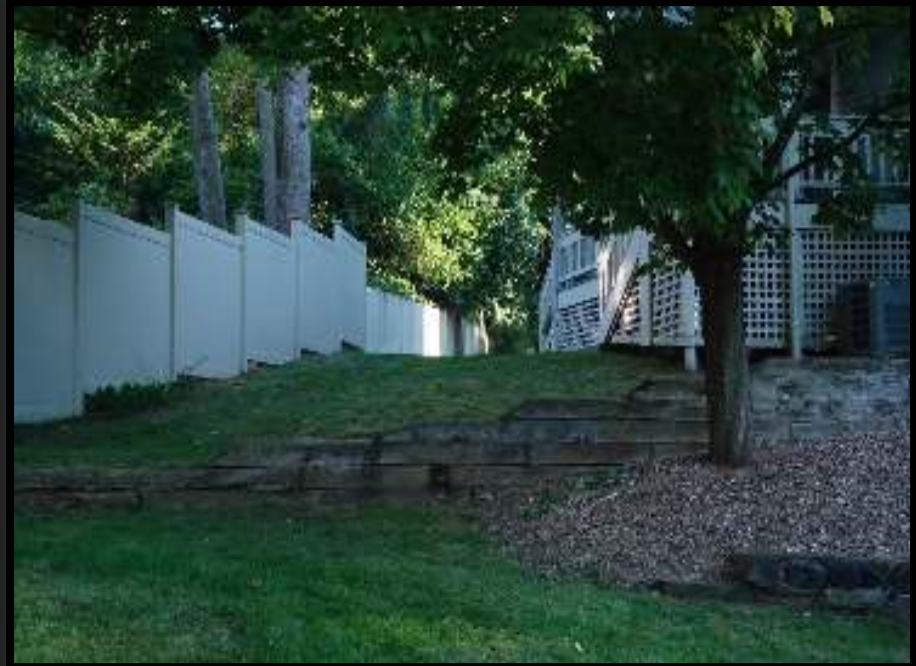
Wooden retaining walls have rotted and should be replaced with stone or removed.

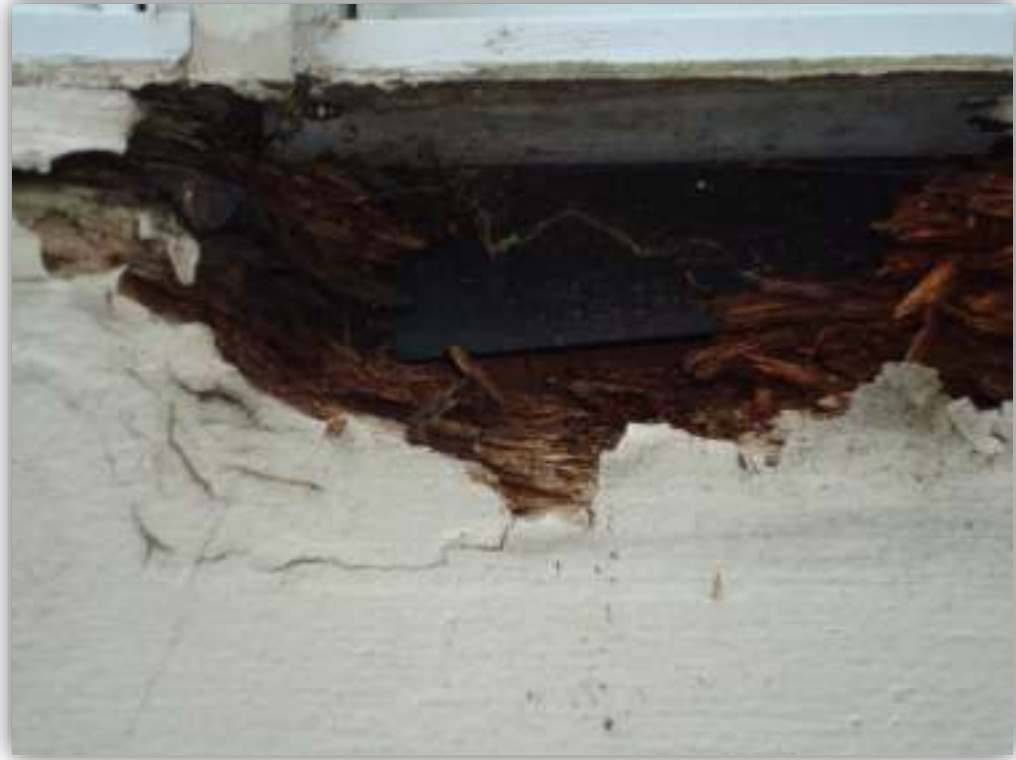
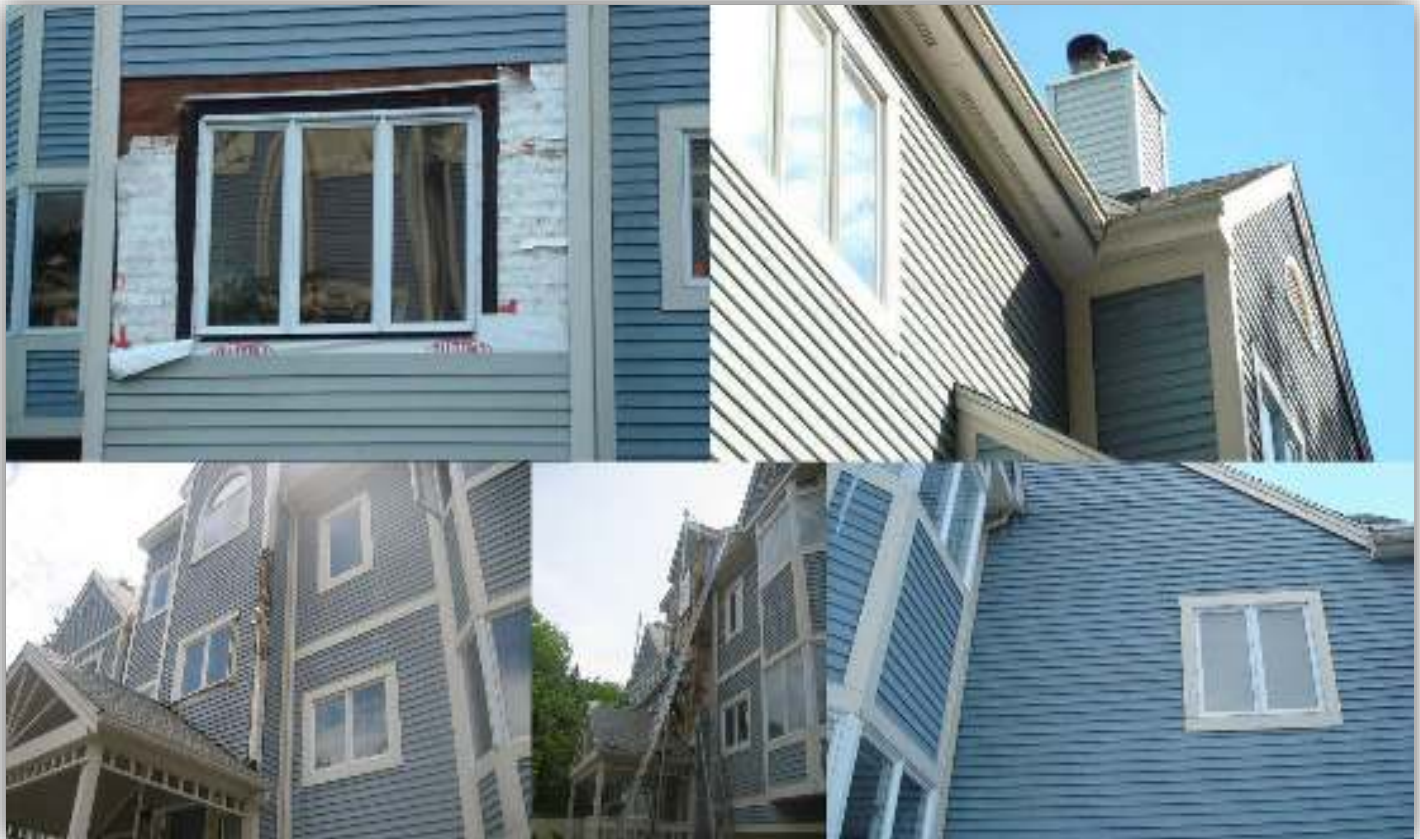
Window sills have significant water and insect damage. Many windows do not open

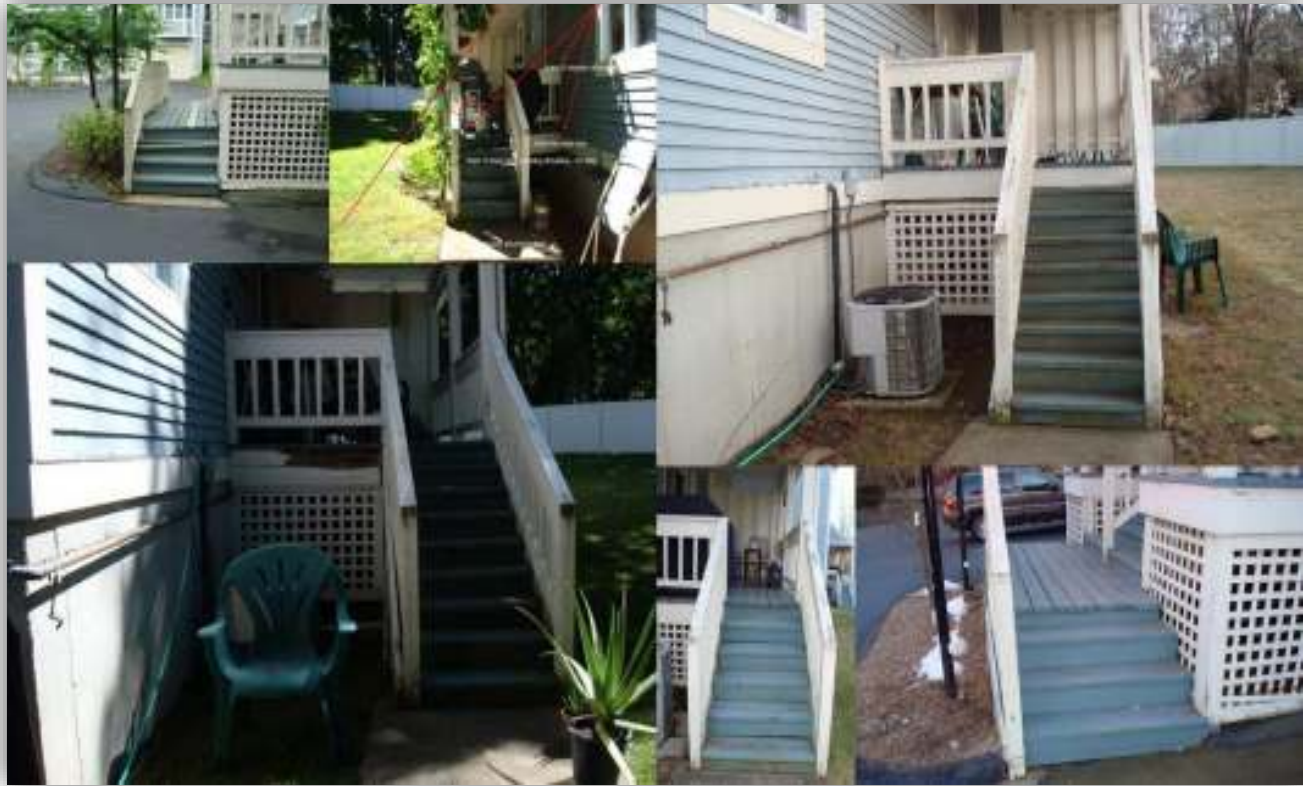
Front and rear decks do not have adequate structural support and are causing damage to the buildings

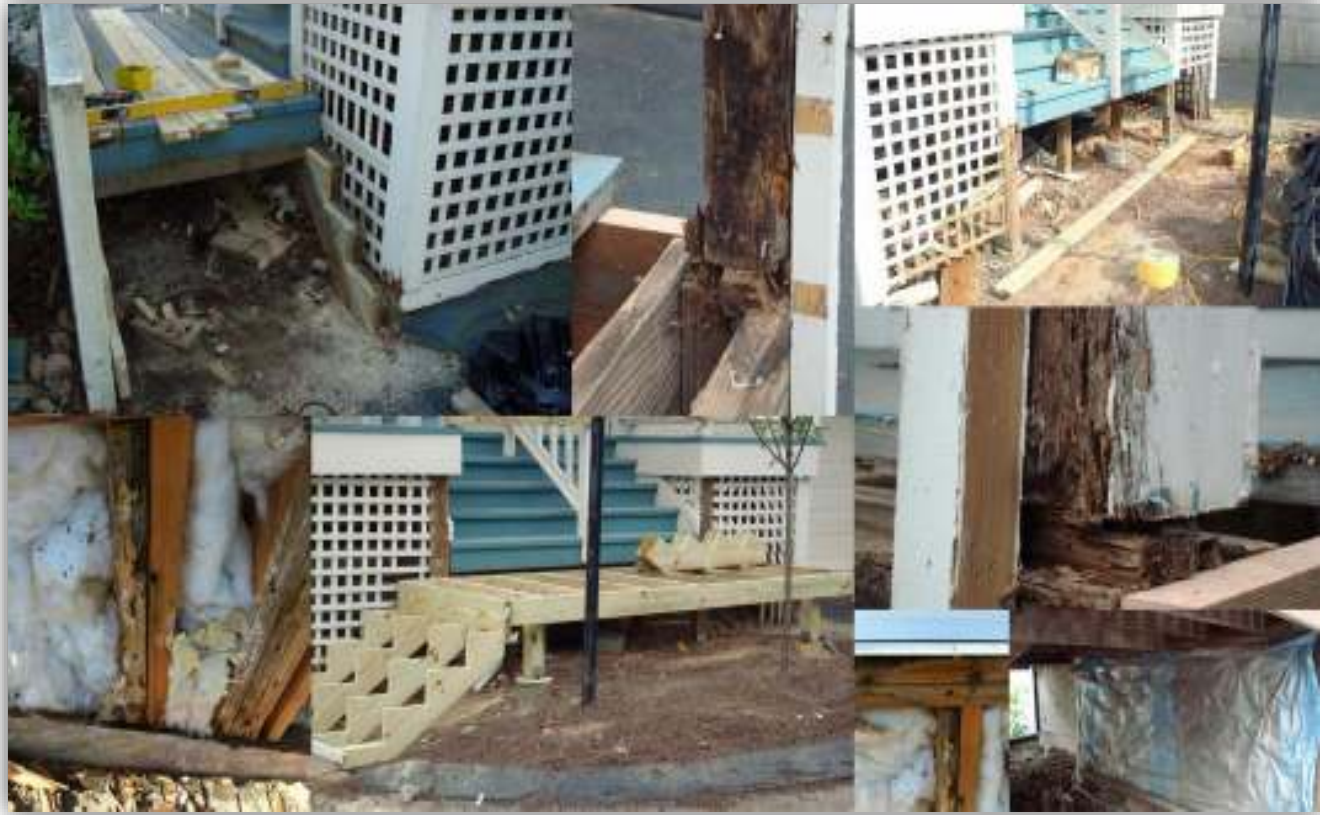
Carpenter Ants and Bees cause  
extensive damage each year

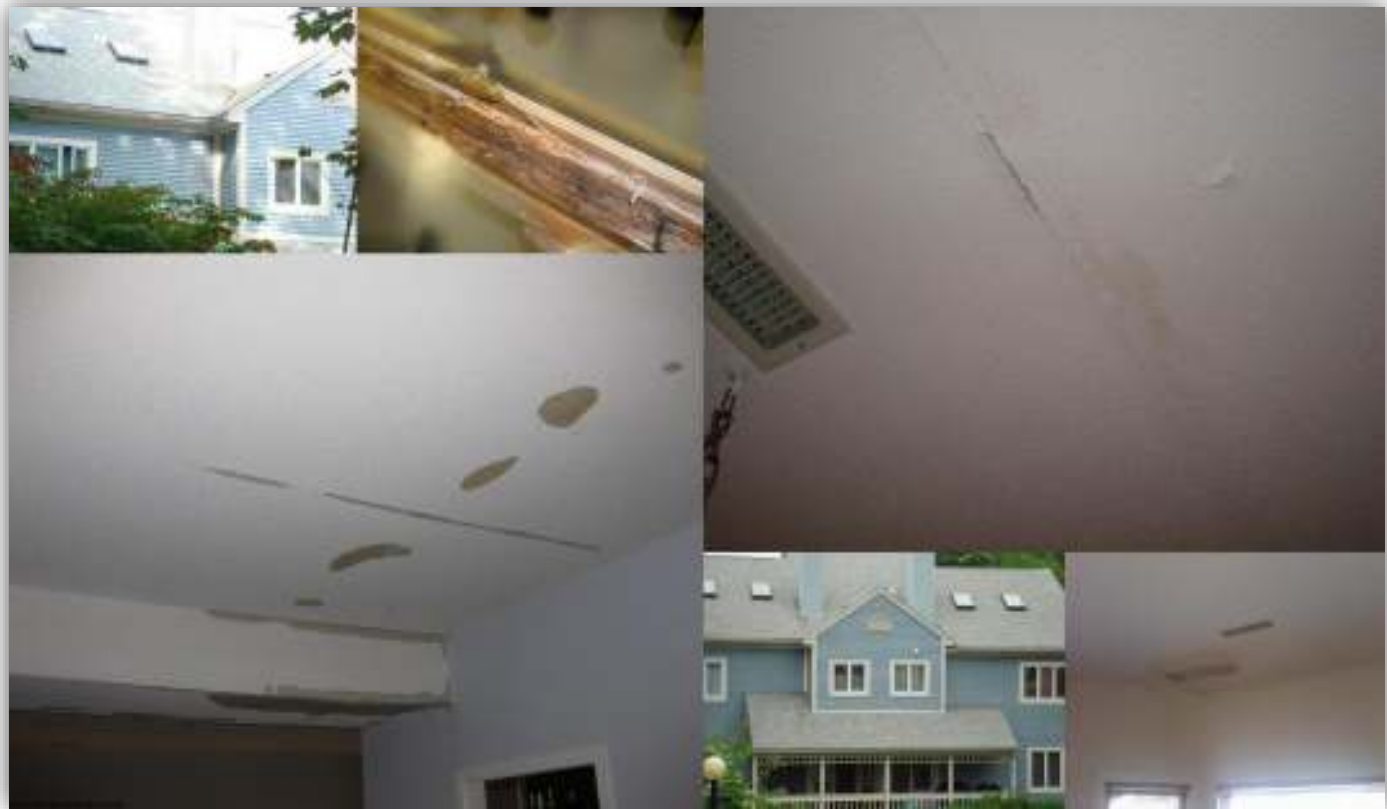
Roof Leaks Continue To Cause  
Damage
