Fountain Hill Condo Association

## NOTICE OF UNIT OWNERS MEETING FOUNTAIN HILL CONDOMINIUM ASSOCIATION, INC.

# Fountain Hill Association

## Facility Report

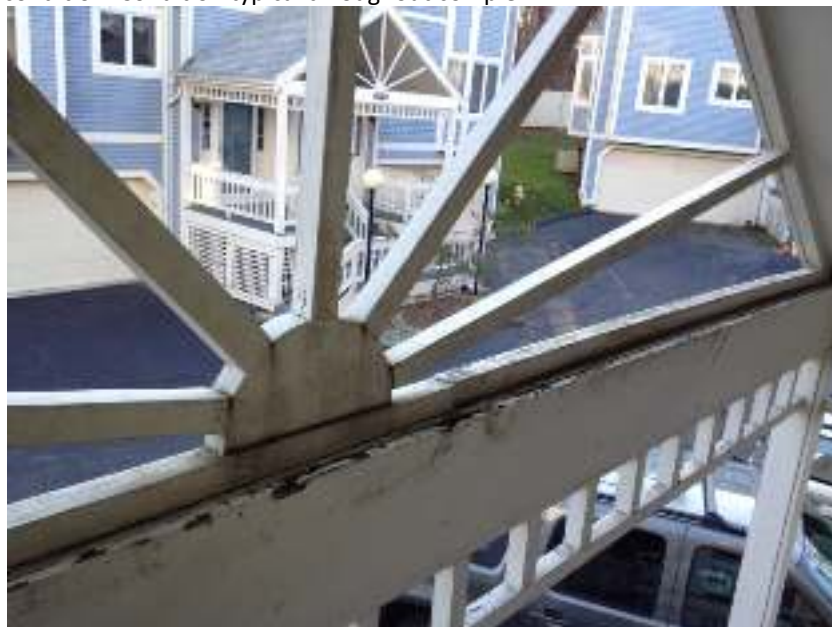
- Front Porches:
  - Structure: Rotting away, constructed incorrectly.
    - Beams: Rotting to the point of dry rot. Beam cap not installed per drawings. Rotted wood at beam can be pulled away with ease by hand. Lack of cap or flashing is causing condition. Condition typical throughout complex.

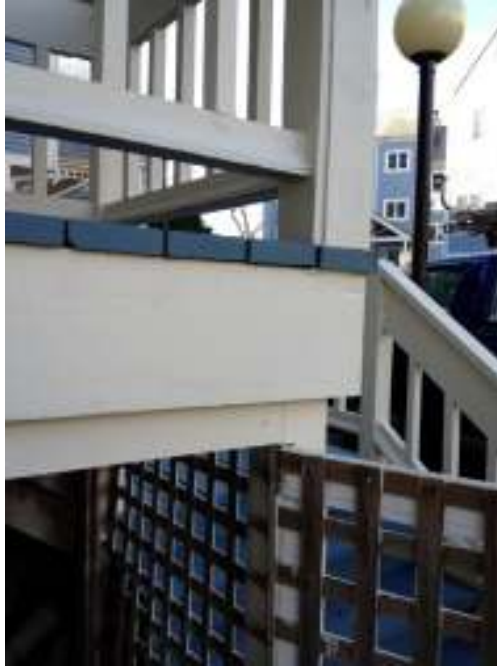
- Posts: posts not constructed continuously vertically per drawings. The sections of posts as constructed are constructed in a non-continuous manner. This non-aligned condition does not transfer vertical load path correctly and compounds the issue of posts not hitting concrete piers below.

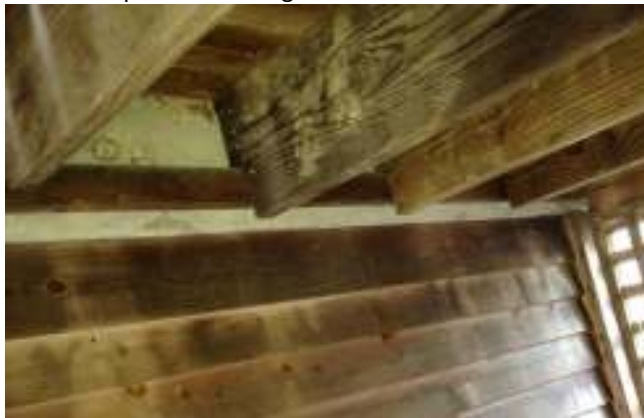
- 
- Joist Hangers: Joist hangers not used or not employed correctly. Inadequate nailing used with inadequate or no ledger boards.

- With ledger board.

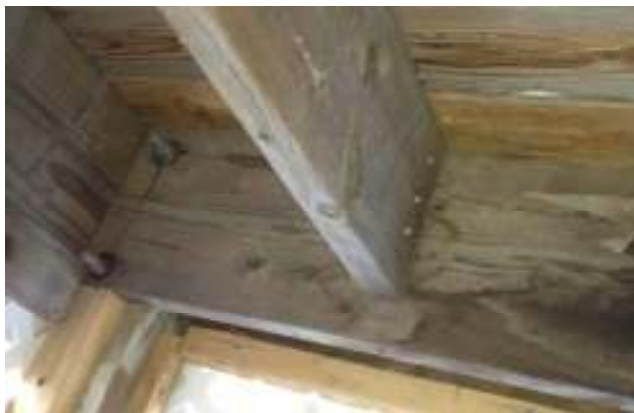
- No ledger board.

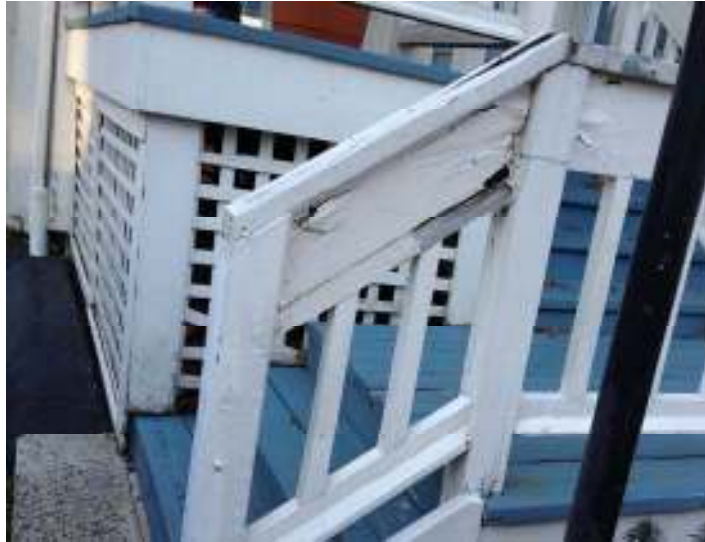
- Railings: Rotting.

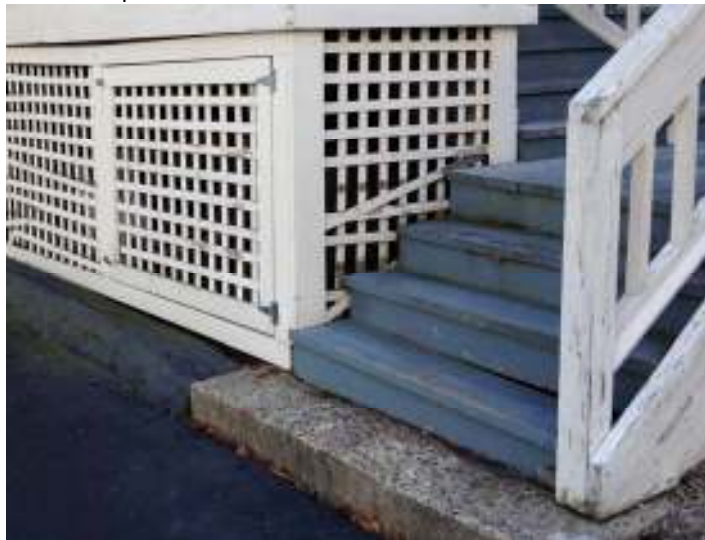
- Stairs: Not plumb.

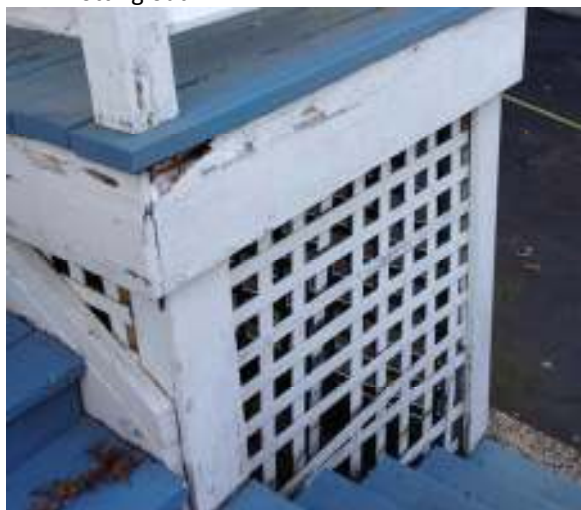
- Trim: Rotting out.

- Paint: peeling to reveal wood beneath.

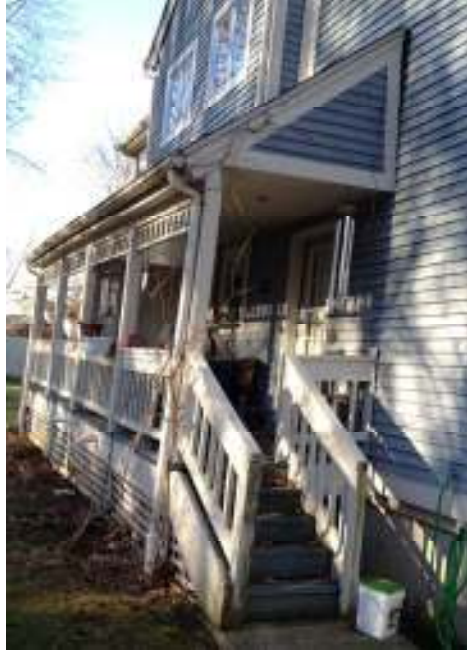
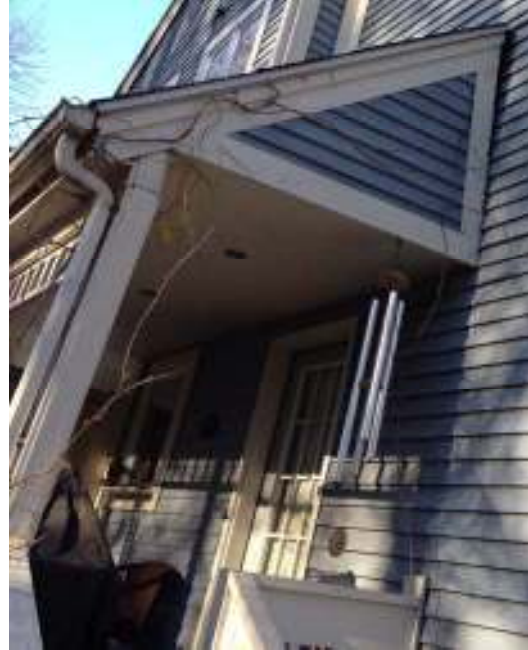
- Porches: Pulling off of main building, including roof.

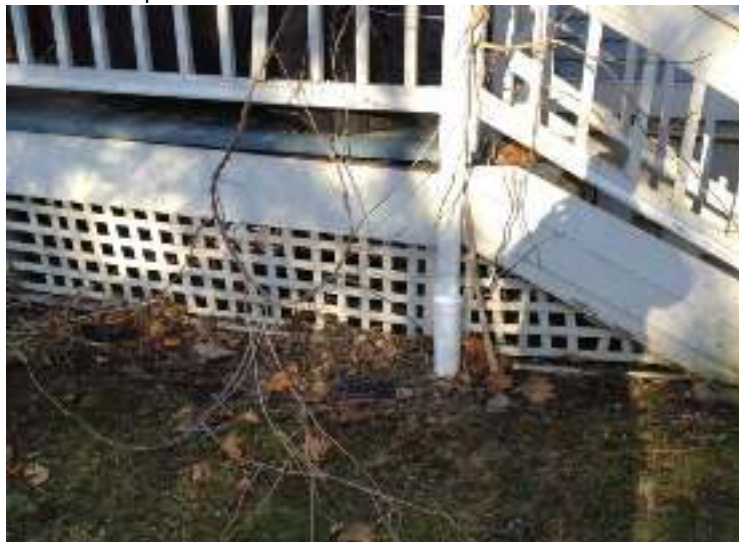
- Structure: in disrepair.
- Trim: in disrepair.

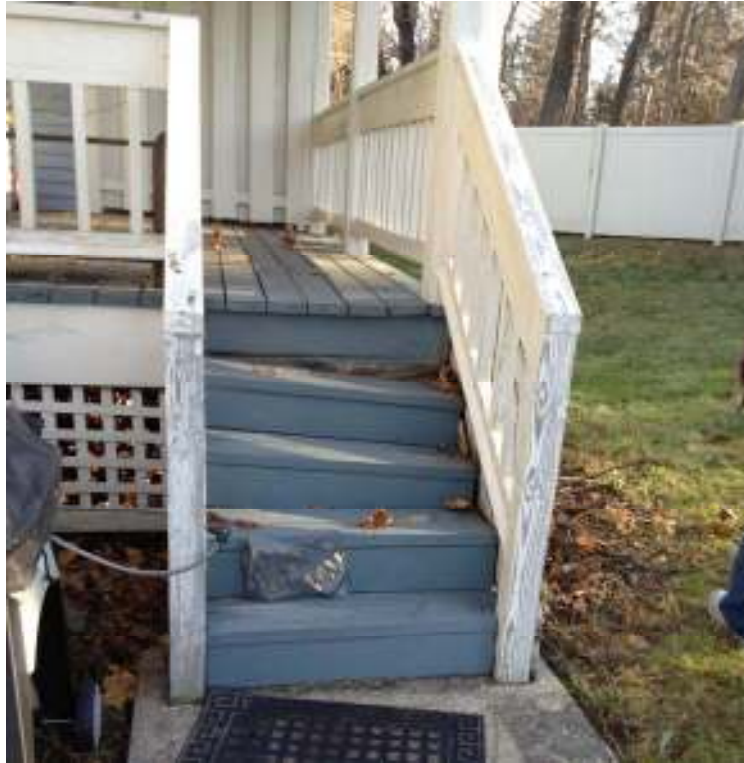
- Stairs: falling down or off porch, stairs not plumb.

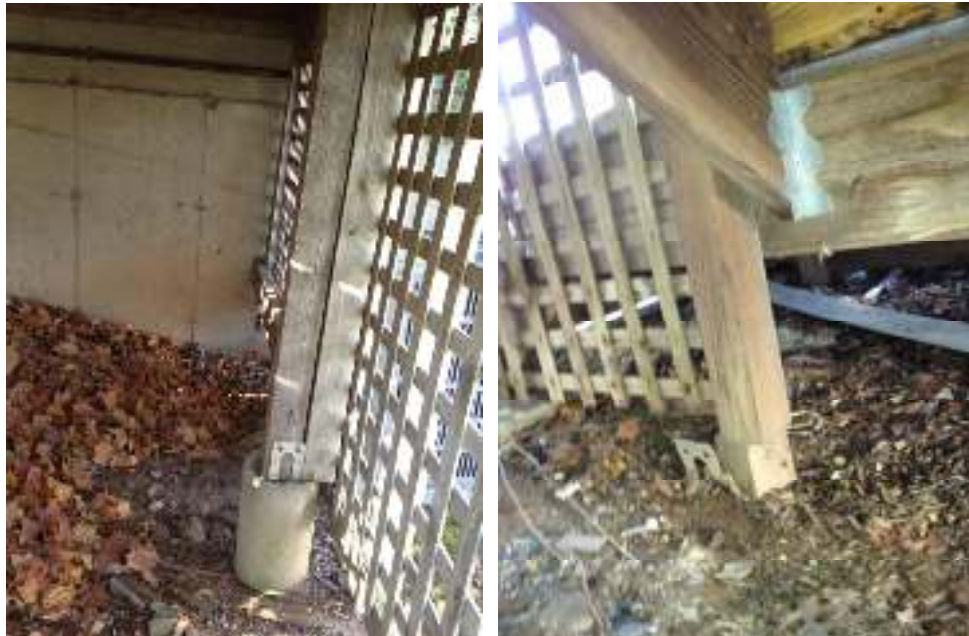
- Posts: Posts do not hit concrete piers below and rest of earth. Posts are not installed per drawings in that they are not continuous. Post lower and upper portions are misaligned as installed. Examples include posts sistered to hit concrete piers and posts resting on earth.

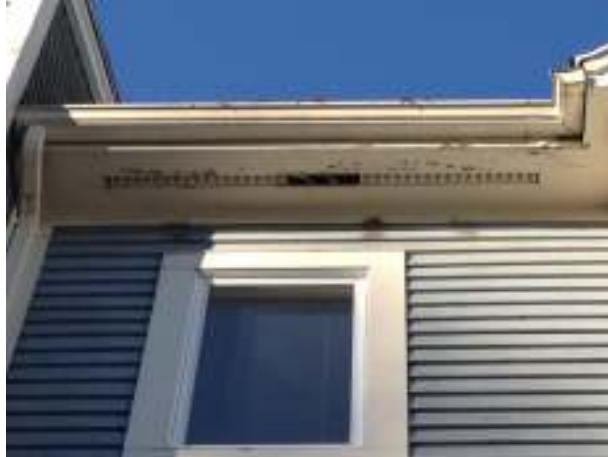
- Soffits: soffits and soffit vents in disrepair.

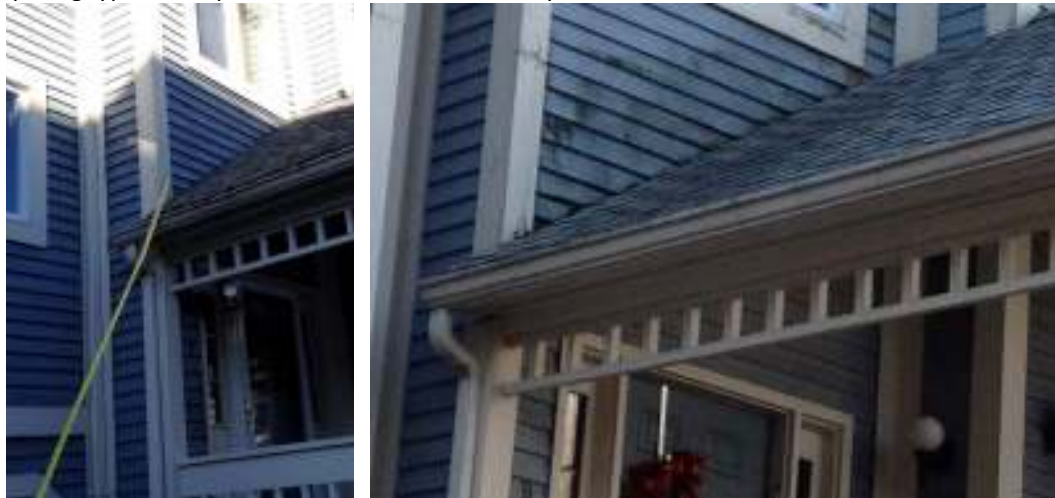
- Lack of Sidewall, step or counter-flashing typical. Roof shingles butt sidewall without adequate spacing typical except for roof areas remediated by contractor.

- Solution: Implement industry standard step flashing throughout at applicable roof to wall junctures. Because of the intent to fully replace all clapboards this is a highly appropriate time to perform this upgrade.

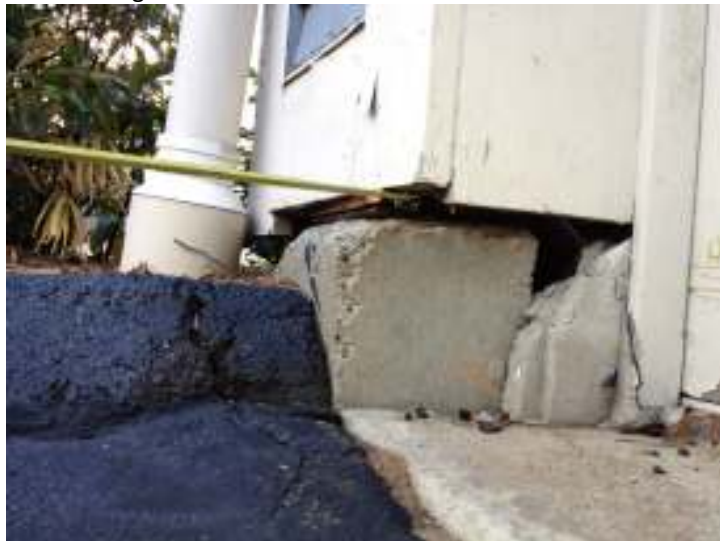
- Problematic base trim termination, requires flashing. Structure sitting on steel plate that is deteriorating.

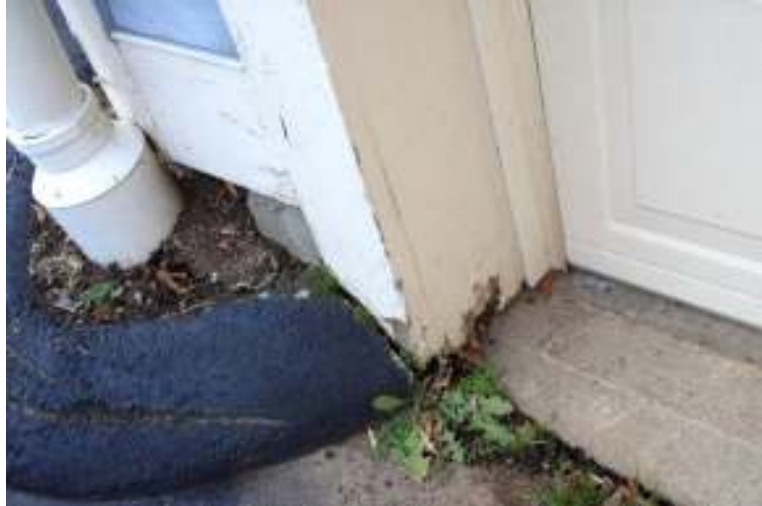
- Trim: Inadequate distance between wood base trim and grade, lack of flashing is causing (excessive) deterioration.

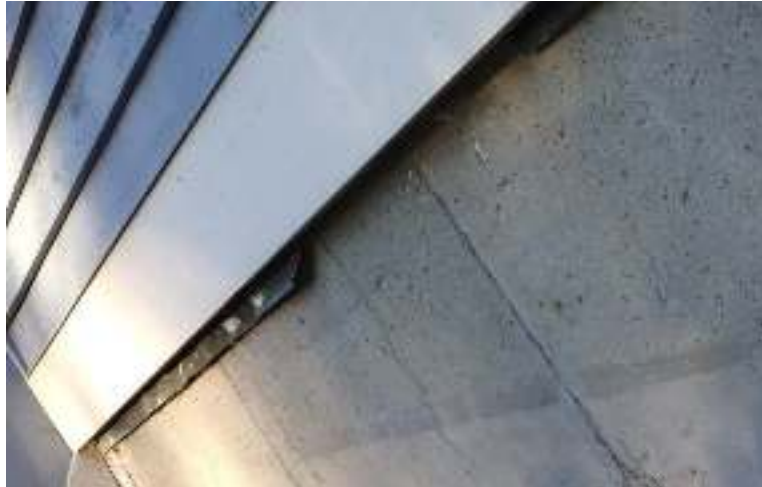
- Flashing: Missing flashing at base of clapboards and trim typical throughout.

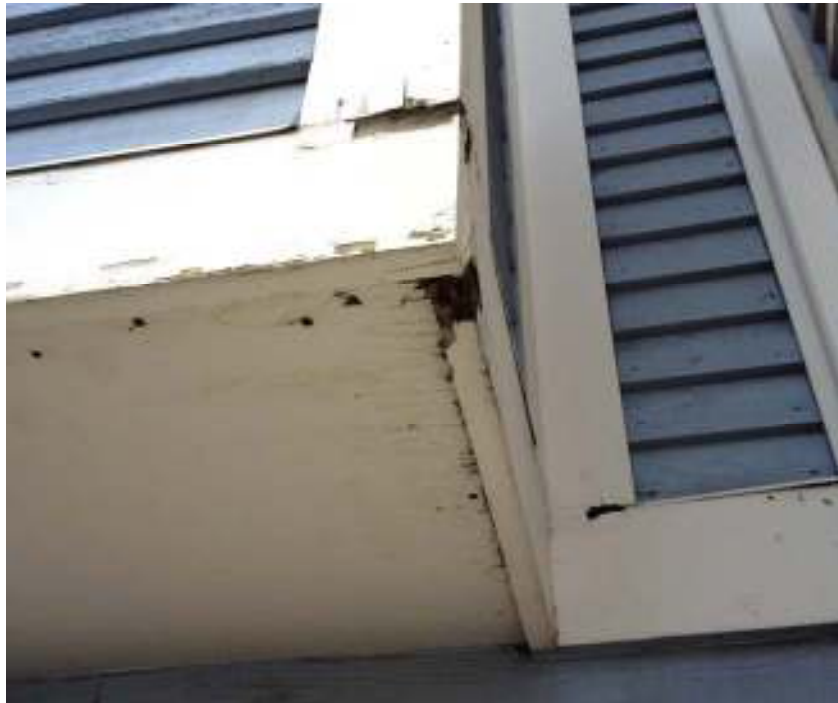
- Trim: incorrect installation is leading to water damage and rot.

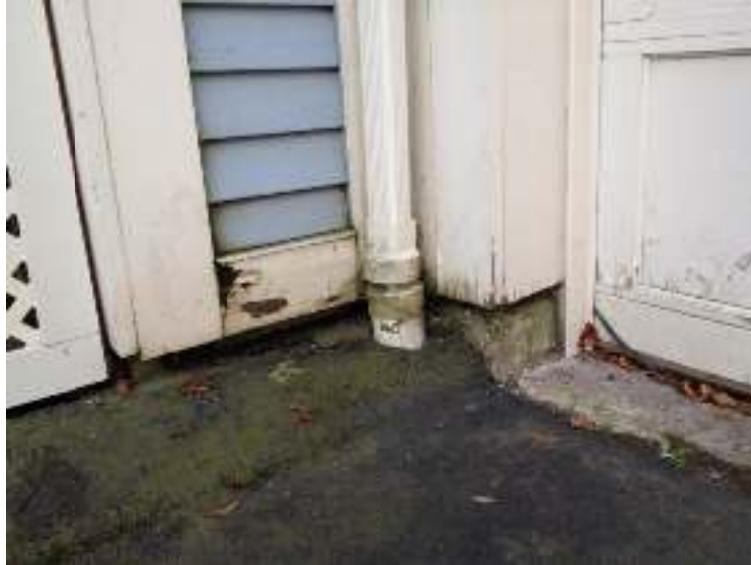
- **DRAINAGE:** Leaders terminate before reaching drainage at grade; subsurface drainage not always available at grade; surface drainage not adequate or problematic (view during weather event).
  - Site Drainage: anecdotal and visual evidence of poor drainage at parking and adjacent building base.

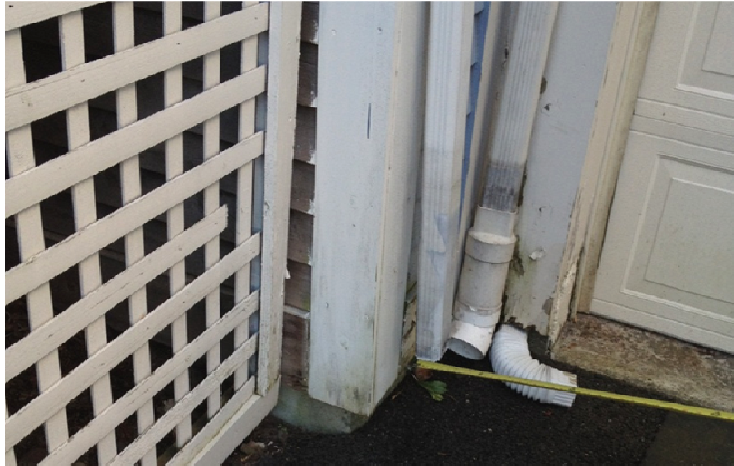
- Leaders: Do not terminate at subsurface drain points – discharge roof drainage to parking lot. Will likely lead to icing conditions during winter.

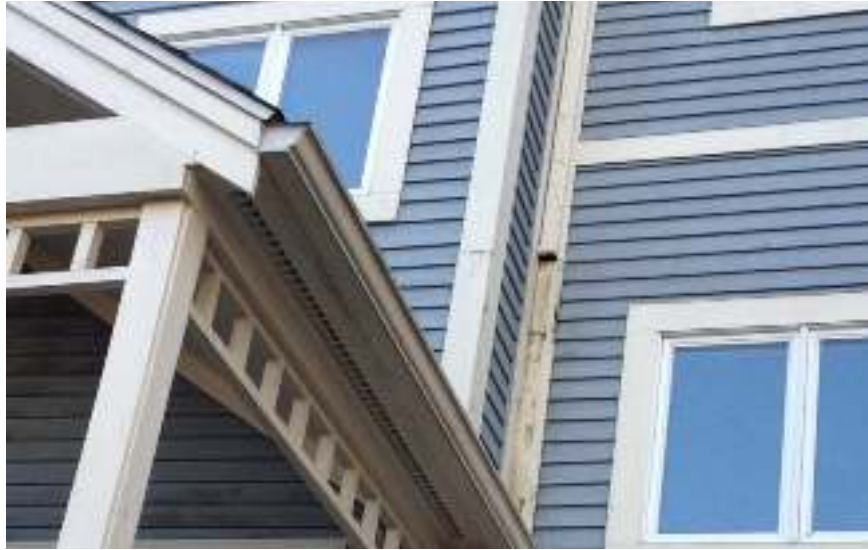
- Leader: Terminates before reaching drainage point at grade.

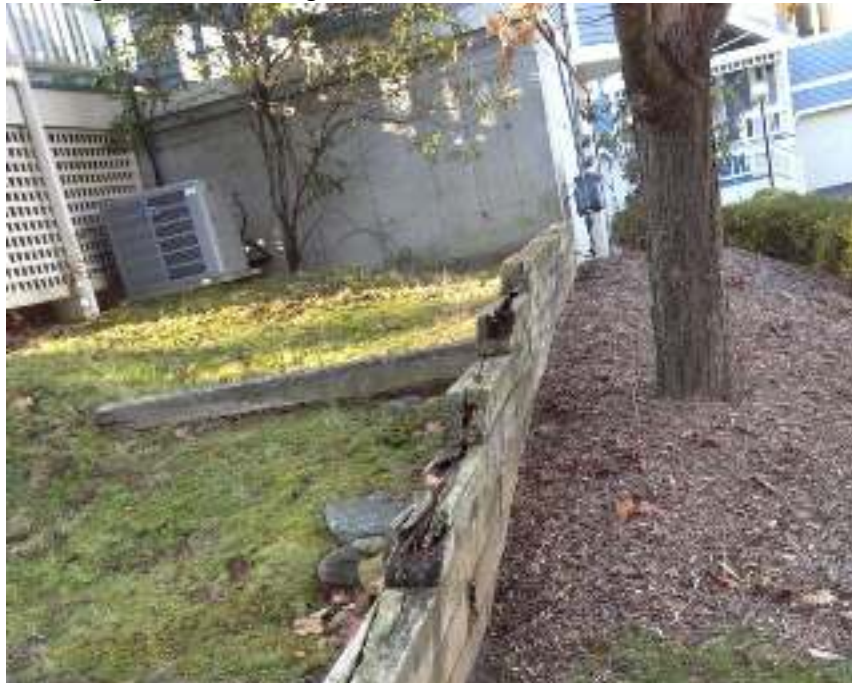
- Retaining Walls deteriorating.

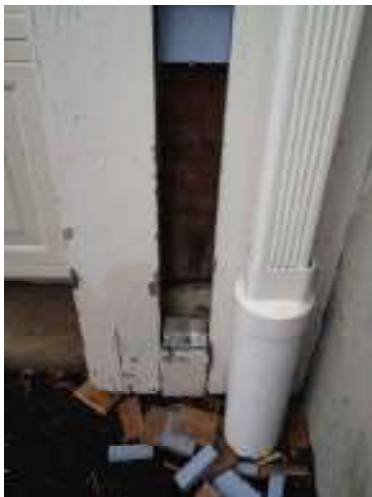
### Condition Type A: Inside Corner Sheathing.

- Location: Unit 16 C right side of garage:
  - Contractor pulls clapboards to in order to observe an instance typical of a tight corner condition between a garage door or window trim and an inner corner in building. This type of tighter, inner corner condition requires correct house wrap, flashing, roof drainage, etc. in order that the building envelope perform correctly. As observed below, the envelope implementation is insufficient to a degree resulting in localized sheathing failure.
  - No housewrap is found in place.
  - The sheathing is moist and soft, and ½" or greater gaps are found in the sheathing.
  - Potential moisture in insulation. Add projected percentage based on condition type for wall insulation allowance.
  - Likely solution to include sheathing replacement, house-wrap, base trim and sheathing termination flashing. Add projected percentage to sheathing allowance

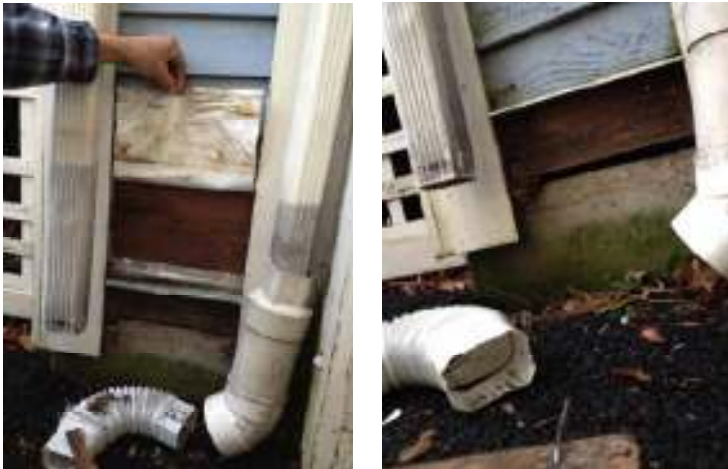
Condition Type B: Base Trim.

- Location: Trim 90 degrees from and adjacent to unit 16 C garage.
- The base trim pulls off the building with little effort by hand – indicating inadequate fastening and failure of substrate.
- The sheathing is found to be most and soft.
- Flashing terminates above trim board but no flashing, water management or termination assembly is found below the trim to inhibit water wicking up into the envelope from base of sheathing.
- House wrap is found partially installed in the local area, likely correlating with previous partial clapboard replacement.
- The gap between the base of the sheathing and the top of foundation indicates a lack of overlap and incorrect termination of envelope.
- Green discoloration below base trim indicates local moisture issues.

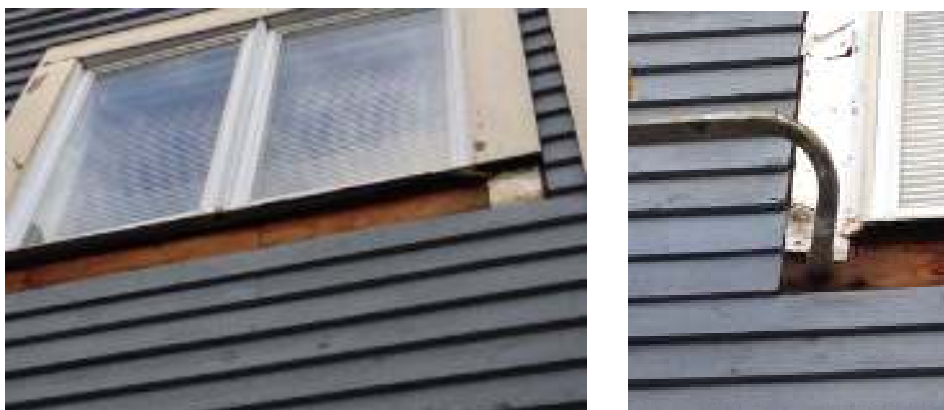
Condition Type C: Window Protection.

- Location: Window at unit 408D.
- Plywood sheathing below window found to be soft and damp.
- Likely solution to include cutting back and replacing plywood 24 inches to adjacent stud, remove sheathing to adjacent building corners, check and replace insulation as required at windows.

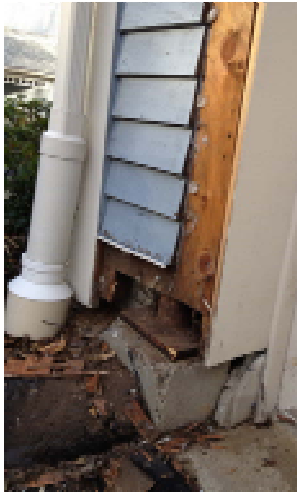
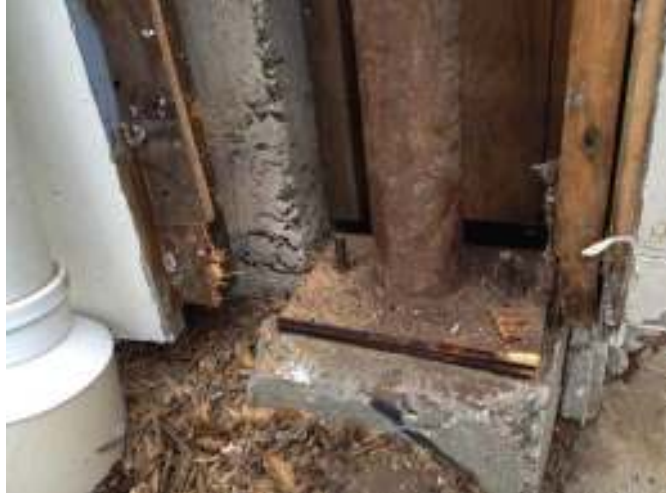
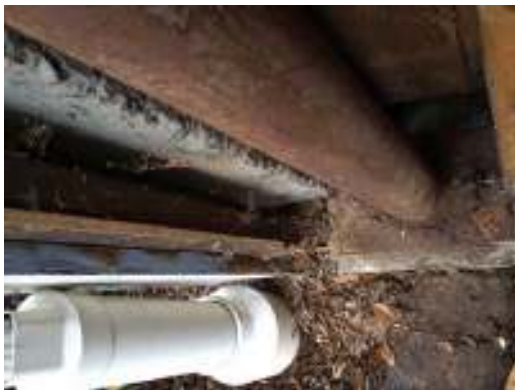
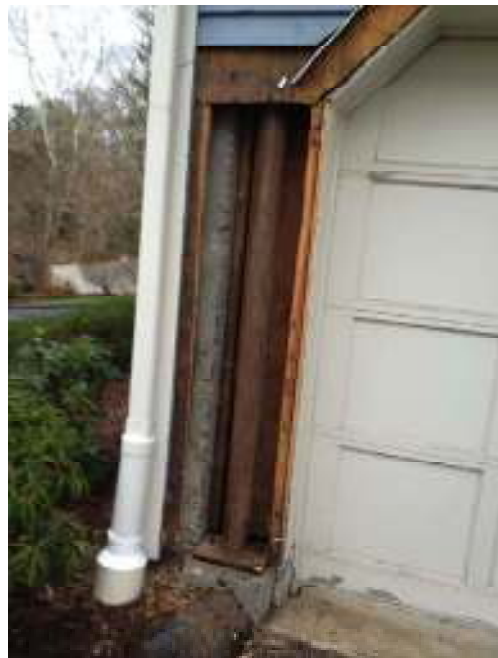
Condition Type D: Building Outer Corners.

- Metal posts found at garage corners typical throughout.
- Gap found at base of sheathing exposing post base plates to weather.
- Area adjacent to metal column fully open with no insulation. Gap between wall base interior exposes garage interior to weather. Lack of blocking observed between building corner trim and stud wall. Local studs found floating.
- Solution to include:
  - Provide blocking as required to secure sheathing and trim to concrete wall.
  - Implement base trim and sheathing blocking, flashing termination in order to secure metal column and wall cavity. Implement wall insulation. Secure garage interior from the exterior.

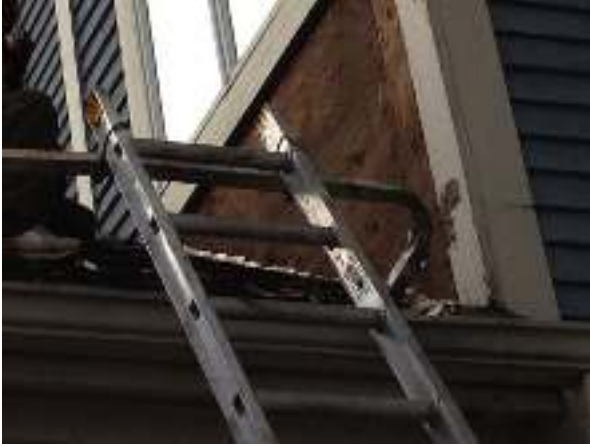
Condition Type E: Porch Steep Sloped Roof sidewall step flashing.

- Roof sidewalls have inadequate step flashing typical throughout. At front porch roofs this is causing leaks at front porches and entrance hallways at the interior.
- Solution: Install step flashing install grace ice and water shield as required.

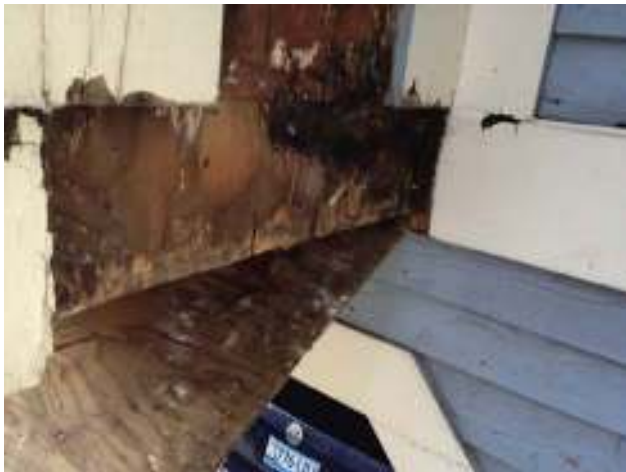
Condition Type F: Bumpout Base Trim.

Location: Base of sidewall at unit 416D kitchen bumpout.

- Trim boards and sheathing behind are rotten, mouldy and smelling at 416D kitchen bump out.
- This is assumed to be a typical condition at all kitchen overhangs. Replace throughout with correctly detailed and flashed installation throughout, typical.

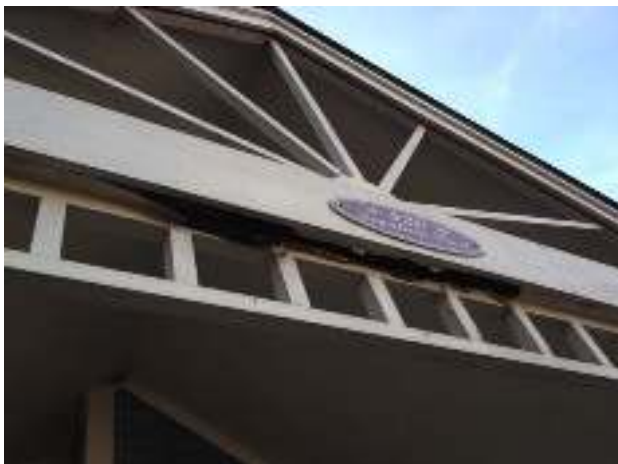
Condition Type H: Porch Beam Failure.

- Beam on unit 420 portrait rotted out. Condition found to be typical based on construction detail of beam cap not being implemented at any porch.

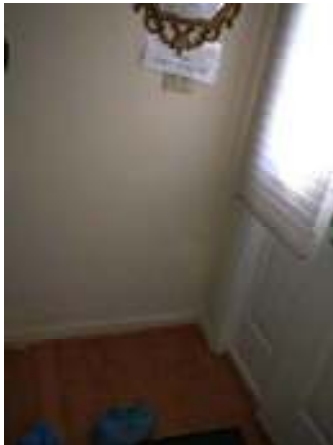
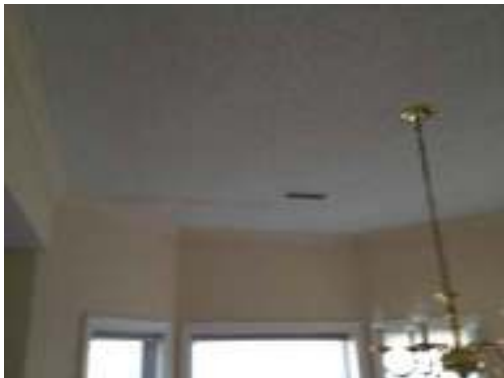
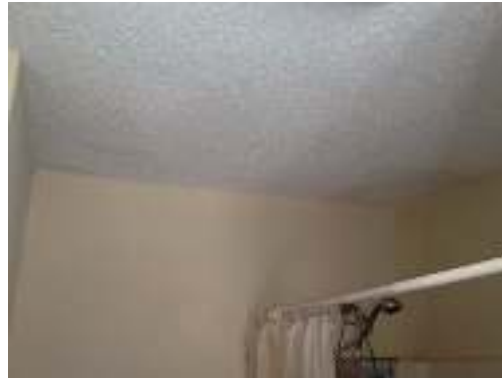
## Condition Type I: Unit 414 A Interior Leaks.

- Leak in kitchen ceiling.
- Leak in bathroom ceiling.
- Leak at front entrance due to porch roof failures. Assumed lack of flashing.
- Contractor believes that roof failures due to collar failure at PVC pipe penetration above leaking areas in 414A.

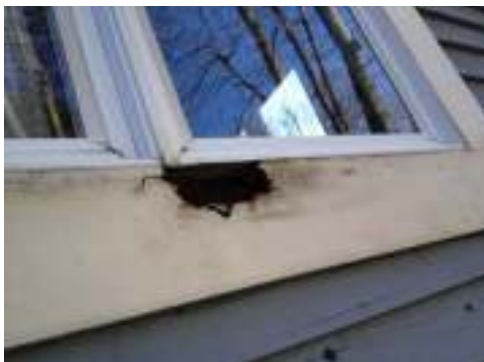
## Condition Type J:

### Unit 414A window trim rotting out.

- Wood at window rotting out. Additional easily removed by light abrasion.

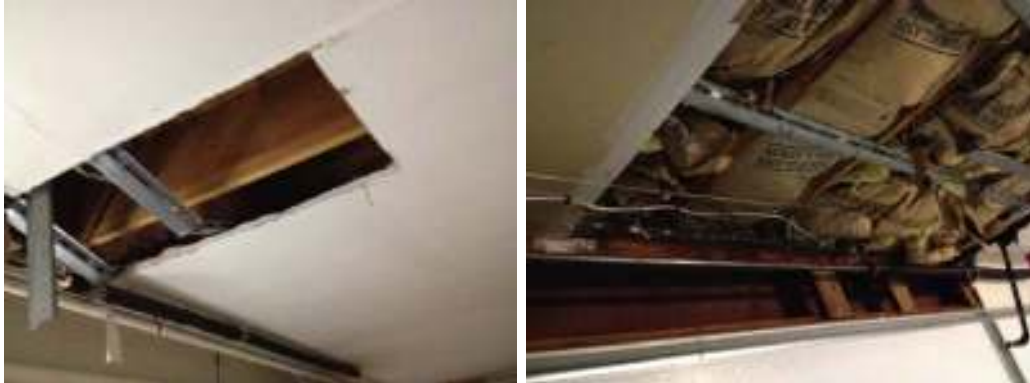
Condition Type K: Garage Ceilings.

Location: Garage ceilings at interior.

Observed: Openings in ceiling observed, verify type of gypsum install.

Solution: Implement rated gypsum ceiling to code at all units.

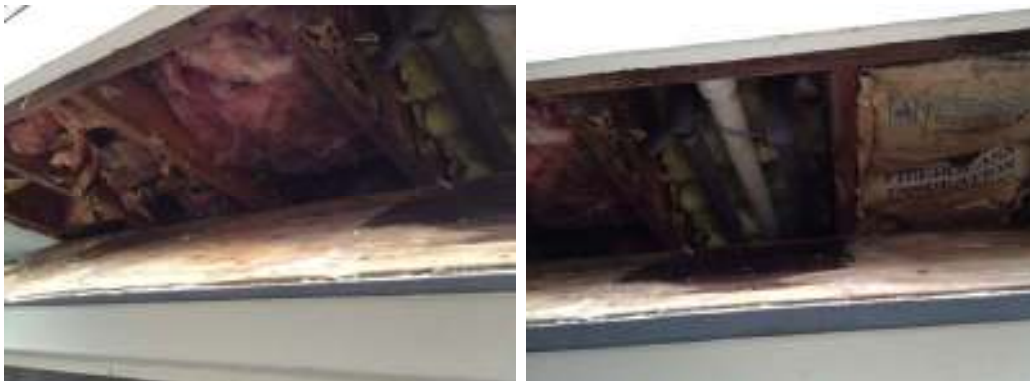
Condition Type L: Garage Soffits.

Location: Kitchen Soffits at Garages.

- Insulation at kitchen soffits damp and with some mold.
- Owner provides anecdotal evidence that pipes typically freeze in this area and that he has installed electric heat tape.
- Possible solution: Icynene MD-C-200 Closed cell foam at all cells except for the one with the plumbing in order to mitigate any moisture issues and in order to achieve a higher R value. Install fully gasketed removable access panel at plumbing cell with 2" rigid foam board or Icynene MD-C-200 closed cell foam with profile of plumbing cut out. Possible relocation of kitchen supply plumbing.

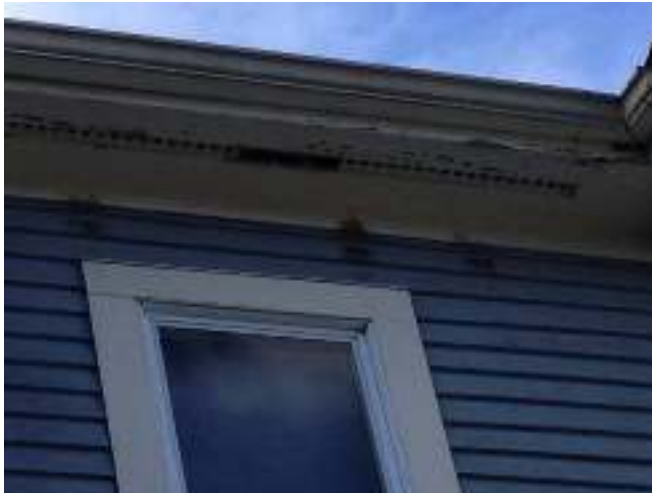
Condition Type M: Upper Soffits.

- Soffits and Soffit Vents Rotting throughout – typical.
- Replace with new soffits and soffit vents per system chosen.
- Install larger gutters, typical.
- Verify that attic venting baffles are in place in attic to bring vented exterior air to roof ridge. Verify attic insulation. Attic insulation installation or lack of insulation could be contributing to roof problems.

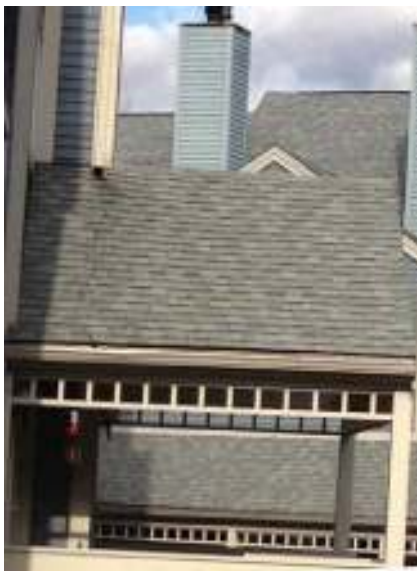
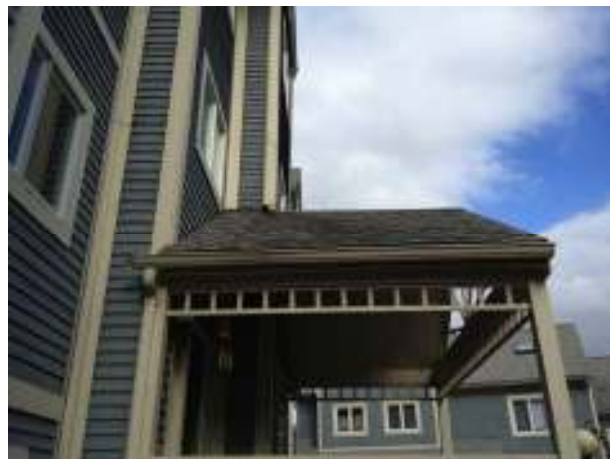
Condition Type N: Porch Roof sheathing failure.

- Condition: All areas where roof leaders release to lower roofs show some level of failure at the lower roof.
- Solution: Run roof leaders directly to drainage points at ground or to splitters above those drainage points. Replace shingles, check for sheathing and structural failure or give in those areas in order to determine replacement.
- Change gutters two and leaders to 6 inch gutters and leaders.

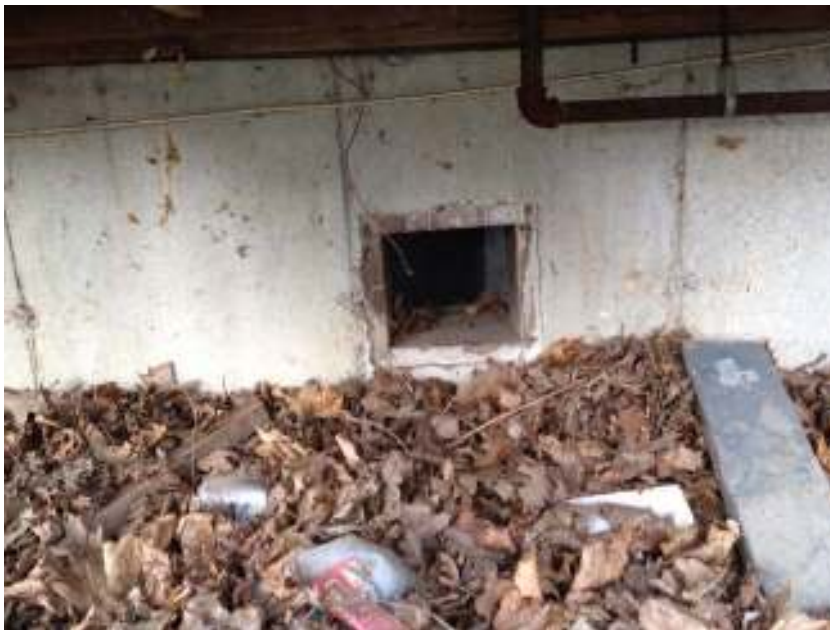
Condition Type Q: Basement mechanical room venting.

Location: Basement level mechanical vents typical.

- Owner asks why there are vent openings at basement. PEK replies that they were put in place to provide air exchange for the mechanical rooms. Owner asks if vents can be plugged or replaced with windows.
- KA to review code for venting of mechanical rooms.

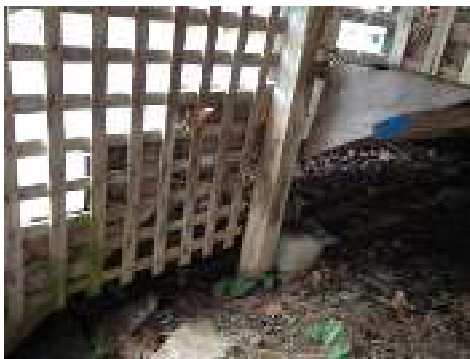
- Typical Condition 2: **The wood columns do not connect to the concrete piers, and rest on grade.** This is an unacceptable condition in that there is no possibility for correct anchoring. Vertical loads are not transferred correctly to the footings below. This can result in damage to the primary structure and to the porch roof (as evidenced recently at the back porches) to which the porches are attached because of the resultant inevitable movement of a porch not resting on footings. Because the columns are not anchored correctly, they are subject to possible adverse lateral loading and uplift forces. Because the wood columns rest on the ground, moisture wicks at the column bases and future moisture damage is inevitable. One typically finds additional members sistered to the primary columns in an attempt to hit the piers below, but these connections are slipshod and do not transfer loads appropriately, are not adequately anchored, and are showing various levels of decay caused by moisture. Almost all of the sistered instances displayed excessive moisture although atmospheric conditions were dry during observation.

○ Post off of pier condition.

- Solution: During construction, the GC will determine whether or not the new wood posts will align on center with the existing concrete footing piers. If they do align, then install new post base anchors as required. If they do not align, remove the existing concrete piers, install new concrete piers and post base anchoring mechanisms on center alignment with the new wood posts.

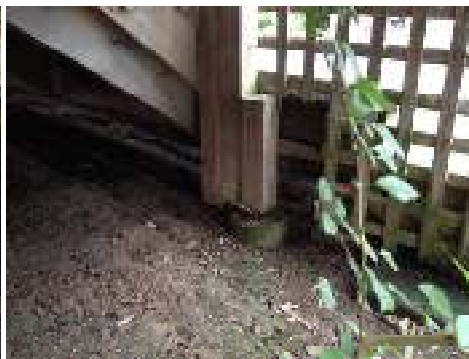
Post off of pier sistered condition.

- Typical Condition 3: **The wood columns are partially resting to the edge of the piers, and are sistered to another wood member in order to make full contact with the piers.** This is unacceptable in that it is difficult to assess whether such an ad hoc sistered condition meets vertical, lateral and uplift load resistance. This is compounded by the fact that none of the post base anchor flanges have been correctly engaged with acceptable fasteners. When proximal to grade, this condition is prone to moisture damage as well by the member that overhangs the concrete pier or rests completely outboard of the pier.

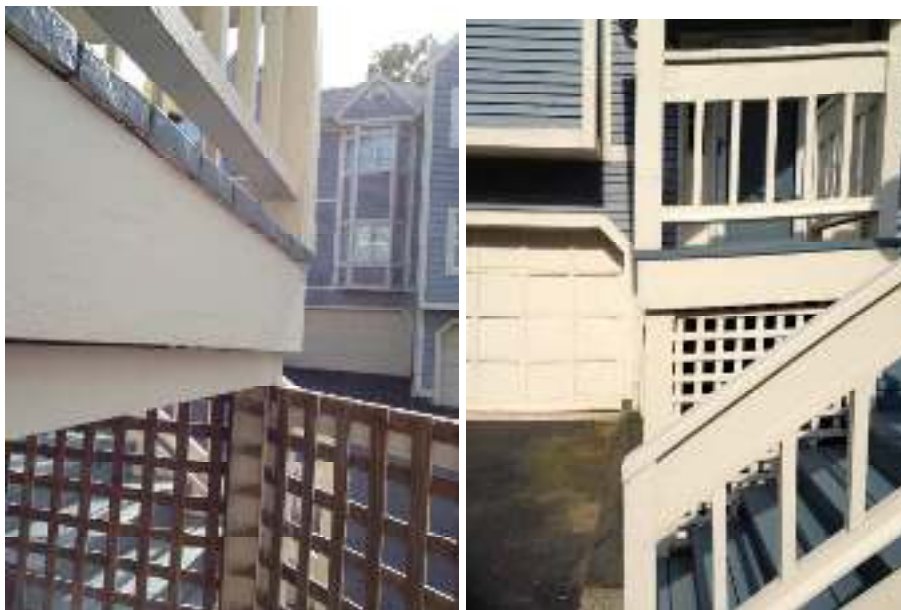
- Typical Condition 5: **The outer wood columns were not constructed continuous from the concrete footing to the underside of roof,** as shown in the original drawings. Instead, the columns are constructed in two parts, the upper section resting on the outer edge of the porch decking on the porches. The lower sections are not aligned with the upper sections. For a goal of 30 year construction, this is not an acceptable configuration for the upper section. Because of the lack of alignment between upper and lower column sections, correctly aligned vertical load paths are not established. In addition, there are no discernible anchors fastening the columns to the decks. This is detrimental for adequate resistance to lateral and possible uplift forces. In addition, moisture will inevitably wick from the bases of the upper sections where they make contact with the wet deck surface – leading to future structurally relevant damage to the bases of the upper sections. Such moisture can also attract insects such as carpenter ants and termites.

○ Out of alignment corner post condition.

- Solution: Install a continuous 4x4" wood column per the original drawings with rim joists attached accordingly. Determine in field whether or not new posts align from existing roof connections to the concrete footings below. If they do not align, replace footing piers to meet correct alignment. An allowance should be provided for this contingency.

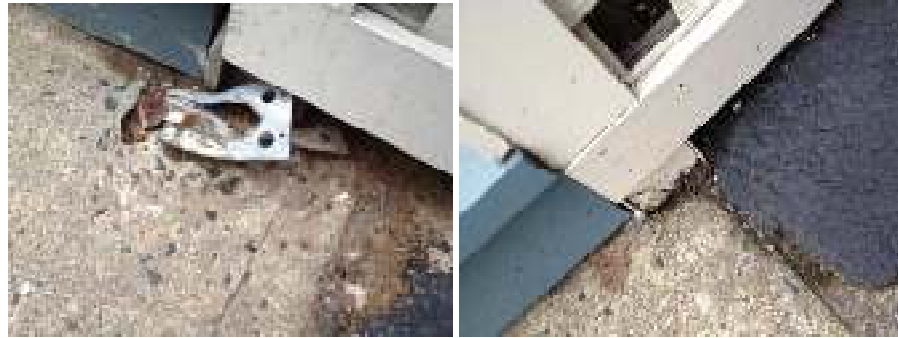
- Typical Condition 6: **The lower sections of the two part, outer, wood columns rest directly on grade level concrete (stair slab base) or on grade without anchors or correct anchoring.** Moisture damage is evident at the bases of the outer columns throughout the complex. This damage is evident to the extent that one can push the wood in or pull it out with one's fingers at certain column bases. If there are post base anchor ties at the column base locations, their flanges are typically turned down or are not aligned with the columns for anchoring. Wood posts should ever sit directly on the ground or surface at grade that will remain moist over periods of time.

- 
- Solution: Install full height columns from slab at stair or concrete footing piers to the underside of the roofs. Install new, dry concrete installation, 'standoff post bases', such as the Simpson Strong Tie ABU series bases. These anchor bases are installed as retrofits for existing construction. These will supply the required base anchoring and raise the base of the posts off of the ground, thereby mitigating moisture issues and allowing for the post bases to dry correctly.

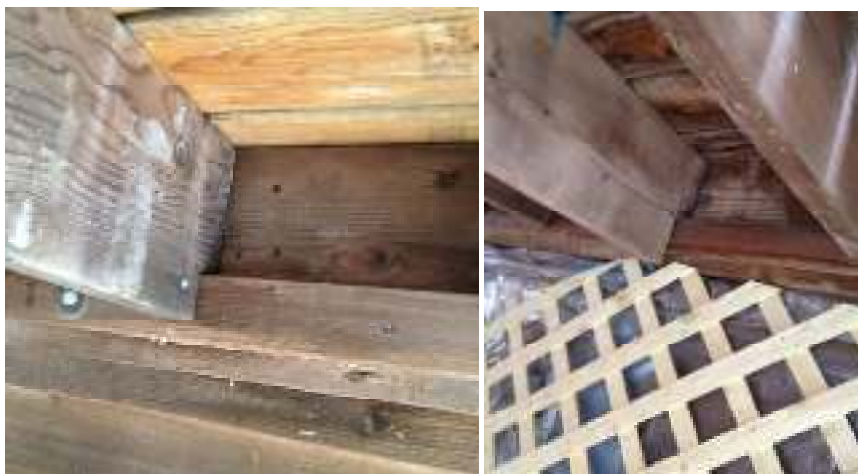
Currently the joists are toe-nailed into the ledger boards. This is unacceptable per code, is potentially unsafe and does not meet best practice criteria. Though this may be a grandfathered condition, it is unsafe in terms of handling possible lateral loads being applied to the porches – imagine a large party inhabiting a porch and the joists coming loose from the wall connection. This happened at a home in the area a few years back. Once renovation work commences on the porches, they will be subject to the current code: **IBC 2003 - 1604.8.3 Decks**. 'Where supported by attachment to an exterior wall, decks shall be positively anchored to the primary structure and designed for both vertical and lateral loads as applicable. Such attachment **shall not be accomplished by the use of toe nails or nails subject to withdrawal.**'

- Toenailed Joist Connection Typical Condition.

Solution: Install appropriate joist hangers with appropriate fasteners at all joists. If the existing joists are not pressure treated, they should not be re-used. The current notched joists would likely have to have their notches cut back flush – thereby rendering them too short to be used in conjunction with new joist hangers.

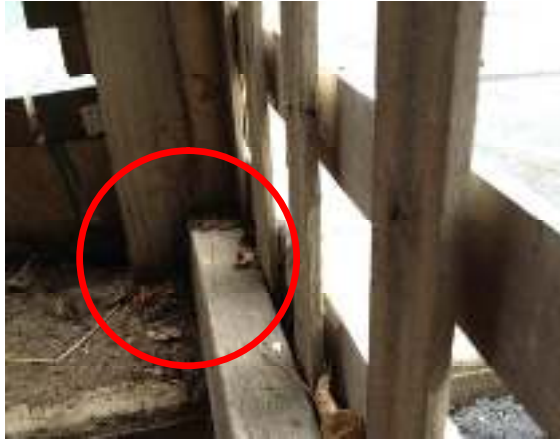
- Units 416 C, D: Outer posts rest directly on slab with no anchors. Moisture evident.

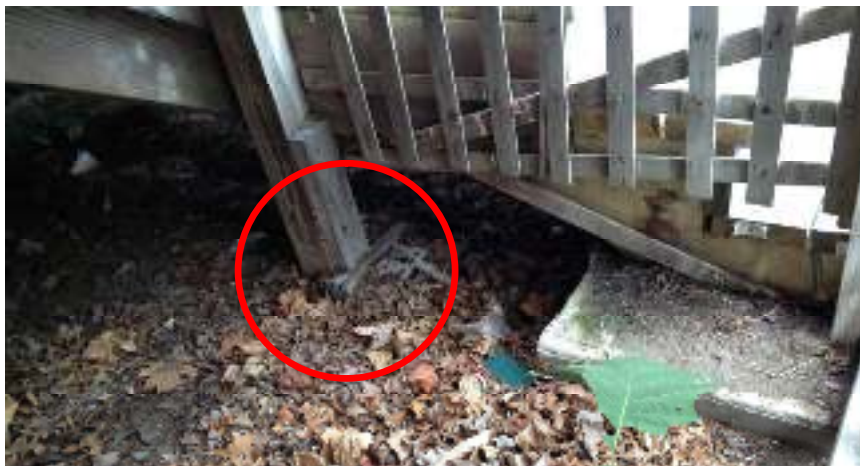
- Unit 416 C: Outer post is off center and not anchored. Not acceptable.
- Unit 416 C: Inner post is off center, sistered, and not anchored. This condition is not acceptable.

- 416C inner post condition.

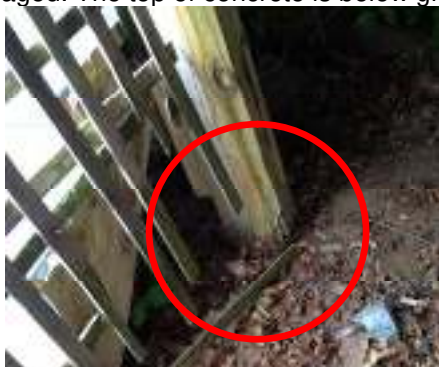
- Unit 416 D: Outer post rests on concrete stair slab, has no anchor, shows signs of water incursion.
- Unit 416 D: Inner wood post rests off concrete pier center. Base plate anchor flanges are not engaged. The top of concrete is below grade. Water incursion is evident.

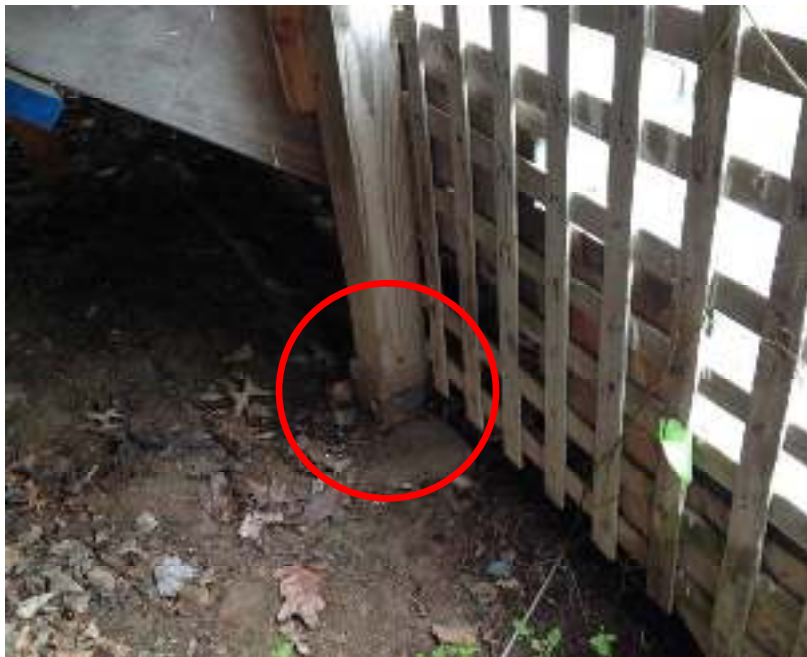
- No access gate.
- Unit 420 C: Inner post misses concrete pier entirely.
- Unit 420 D: Inner post sits on a wood block, which sits on some sort of block, that sits on what appears to be a concrete block. No anchoring mechanism evident.

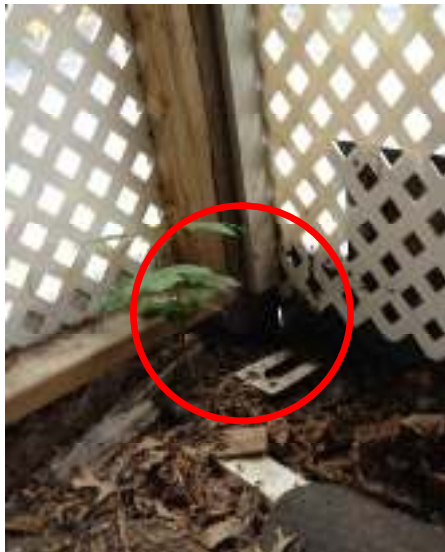
- Units have access gate.
- Units 414 A, B: outer posts are wicking moisture.

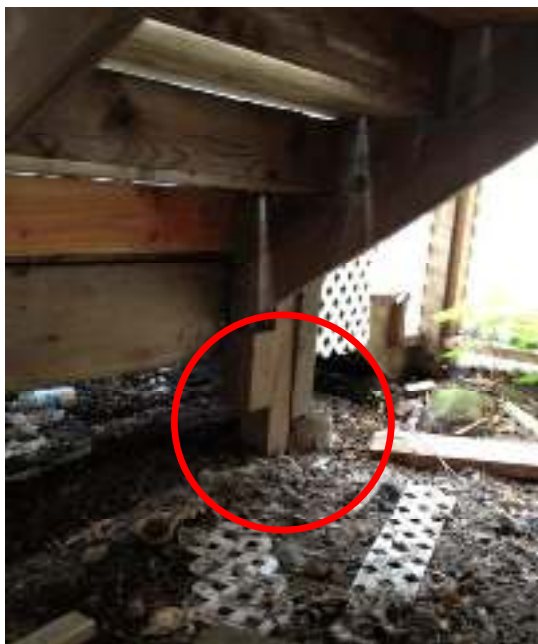
- Units 414 A, B: Inner posts are off center and are sistered. One of three adjacent posts rests directly on the ground. The top of one inner post concrete pier is below grade, anchor straps not visible.
