Fountain Hill Condo Association

## NOTICE OF UNIT OWNERS MEETING FOUNTAIN HILL CONDOMINIUM ASSOCIATION, INC.

# Fountain Hill Association

## Facility Report

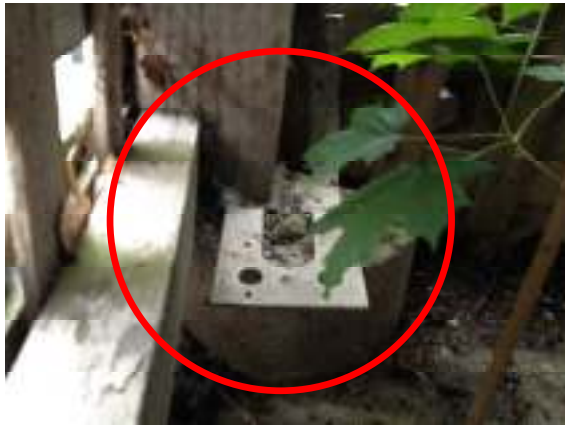
- Units 412 A, B: Have access gate.
- Unit 412 A: Outer post is off-center on a concrete pier. Anchor flanges are down. This is an anomalous condition in that most of the porches' outer piers sit directly on stair slabs.

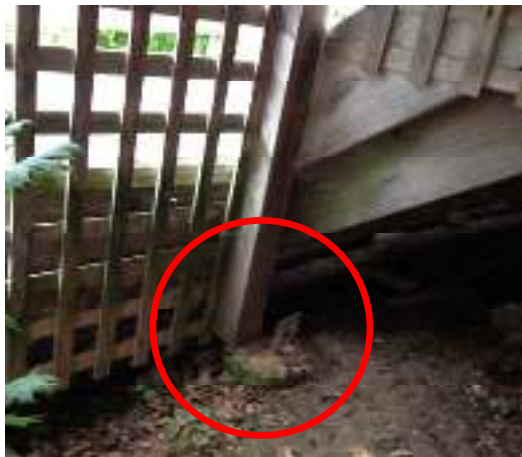
- Unit 412 A: Inner post is on the edge of its concrete pier with no anchoring.

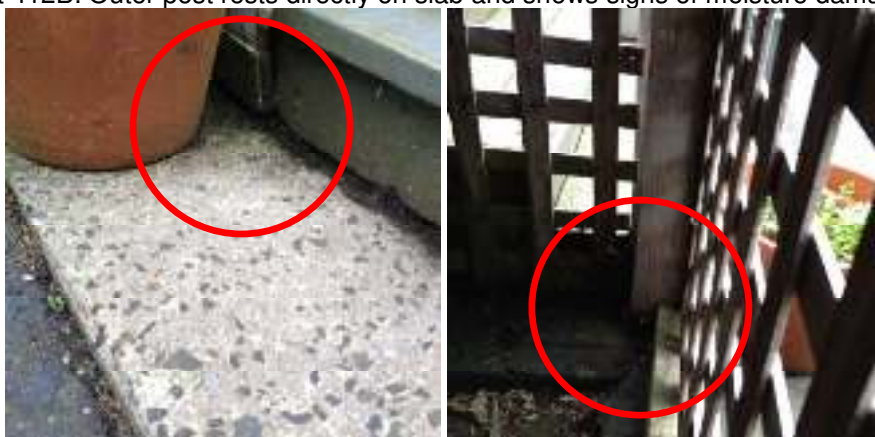
- Unit 412B: Outer post rests directly on slab and shows signs of moisture damage.

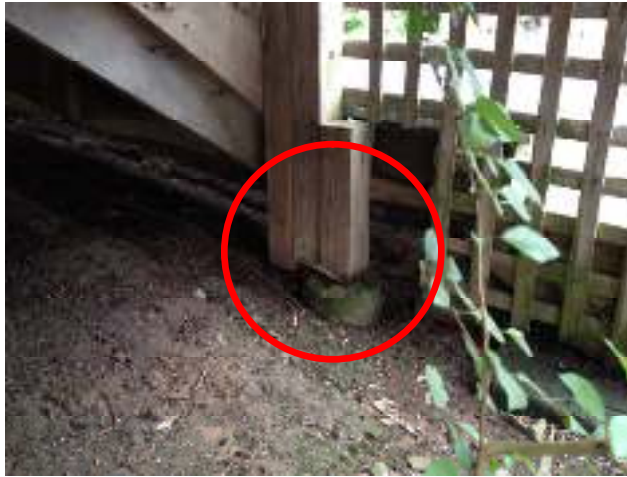
- Unit 412B: Inner post is off the concrete pier, sistered to lumber that rests on the pier without anchoring. These posts show water damage at the bases.

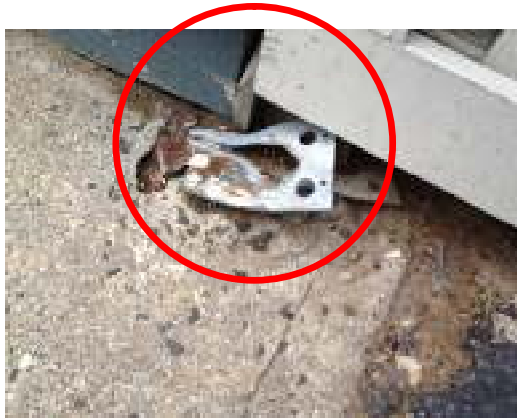
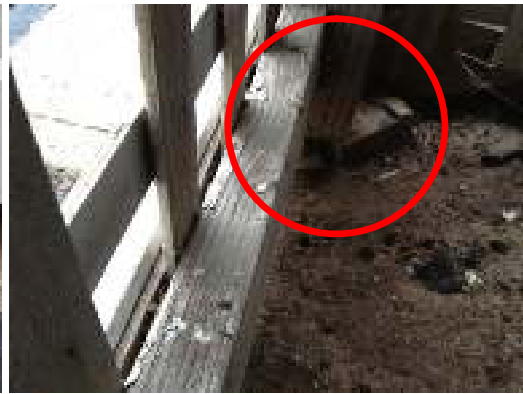
- Unit 408 A Outer post base flanges are turned down. Unclear whether or not outer post sits on concrete or not.

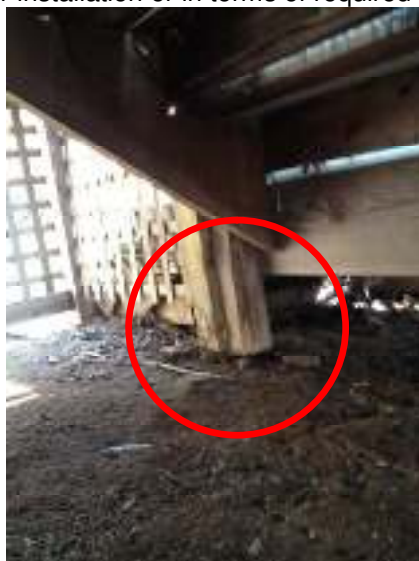
- Unit 408 A: Inner post corner appears to hit part of the concrete pier. Tie down straps are not used and are turned down. Rot is visible at the base of the wood post(s). It is not apparent that this is pressure treated lumber. This condition is not acceptable for a 30 year installation or in terms of required anchoring.

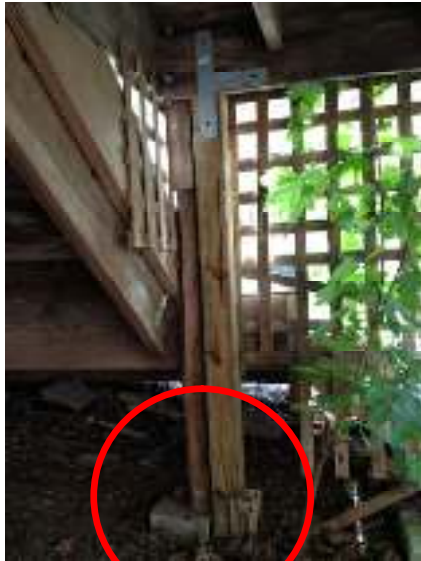
- Unit 408B: Inner post: There are two sistered inner posts at B. One post rests off-center on the top of a concrete footing pier. The top of concrete is below grade, and accordingly,

the base of the wood post shows the incursion of moisture wicking upwards. Eventually that condition will lead to failure of the point of connection at the anchor. That post looks as though it is partially connected to the anchor assembly below by nailing. The adjacent, sistered rests on some sort of concrete block and is not anchored. 408B has gate.

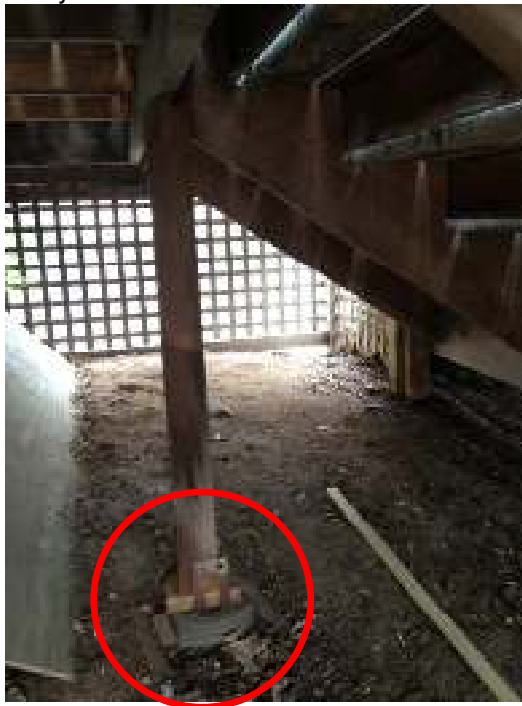
- 
- Unit 408 AB stringer post incorrectly anchored – off center on pier and nailed at half of post base only.

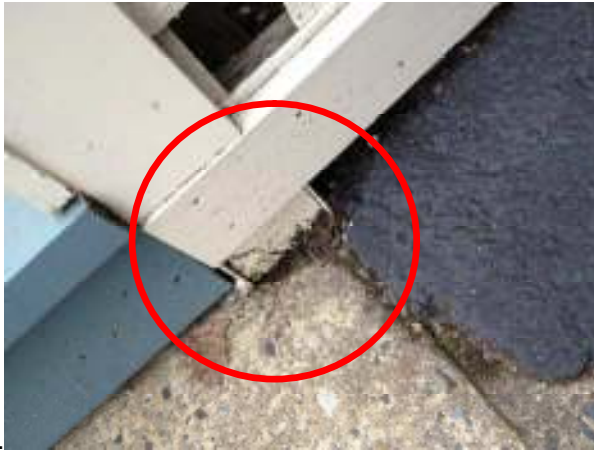
- Unit 408 C: Outer post is painted, but shows extensive rot at its base where it directly contacts the slab. The wood can be pushed in with fingers. The trim at this post does not extend down the way it does at other porches. The assumption is that bases on others are experiencing rot as well, but do not show it because they are covered by trim. Photos taken through the lattice at other porches show .

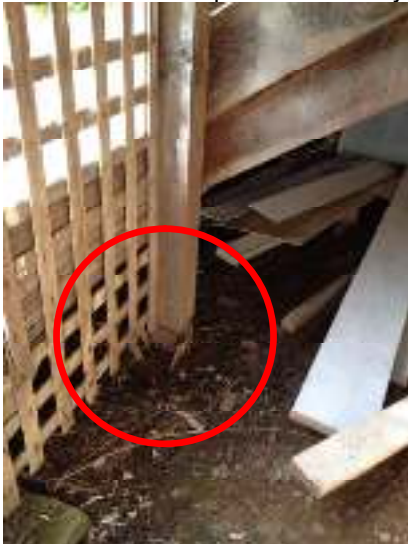
- 
- Unit 408 C: Inner wood post rests on grade. That is an unacceptable condition in regards to inevitable damage caused by moisture to the base of this post. The post is cut at the base, resting on a separate wood block – which was likely a means to adjust for height during construction. The post is not aligned with the pier and the flanges are not engaged. These conditions are unacceptable for a 30 year installation or for anchoring requirements.

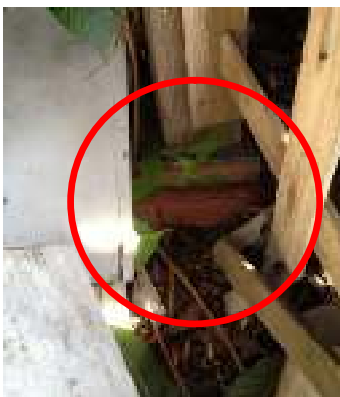
- 
- Unit 408 D: Has under-porch gate.
- Unit 408 D: Outer post at base shows incursion of moisture.
- Unit 408 D: Inner post sits on a block of wood that rests on a paver. It is not clear that the paver rests on a concrete pier. There is no anchoring at this column. This condition is not acceptable.

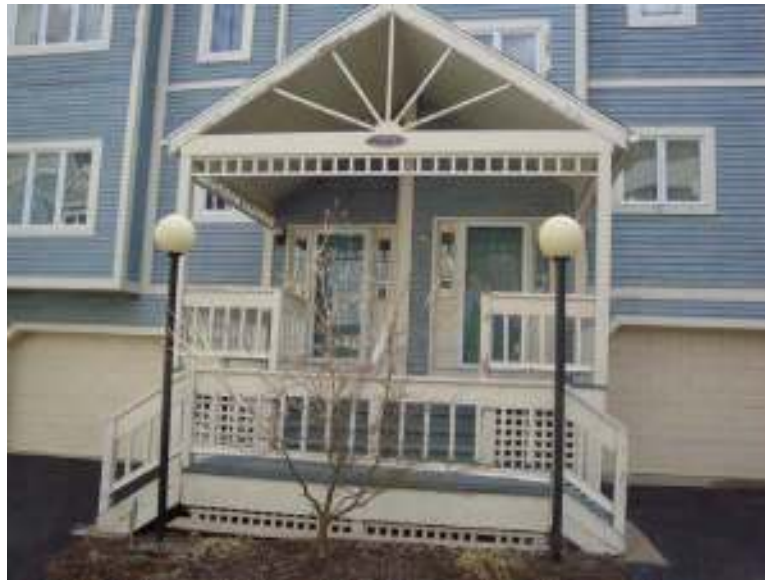
1. TYPICAL FRONT PORCH GABLE TIE BEAM

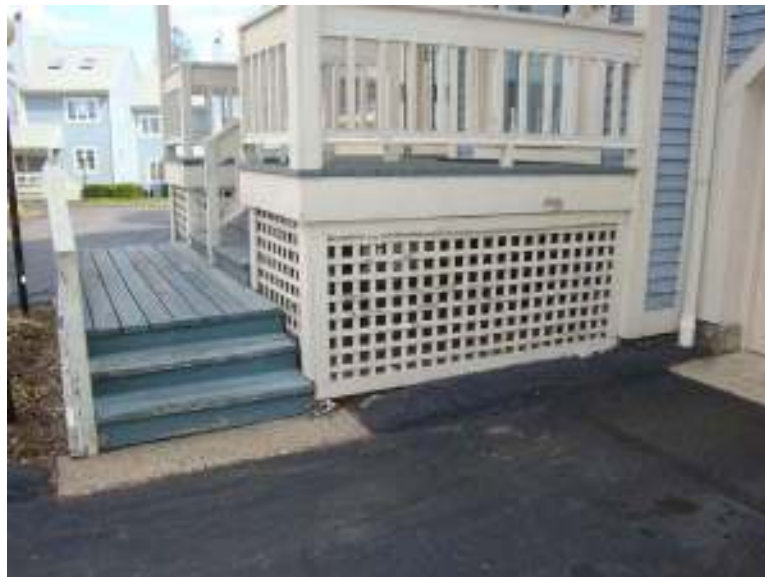
2. TYPICAL FRONT PORCH LANDING

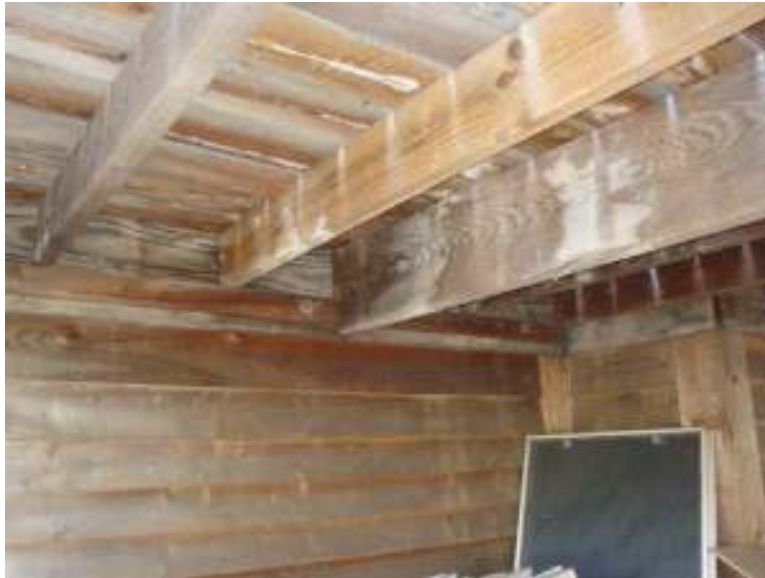
3. TYPICAL JOIST CONNECTION TO LEDGER AT BUILDING WALL

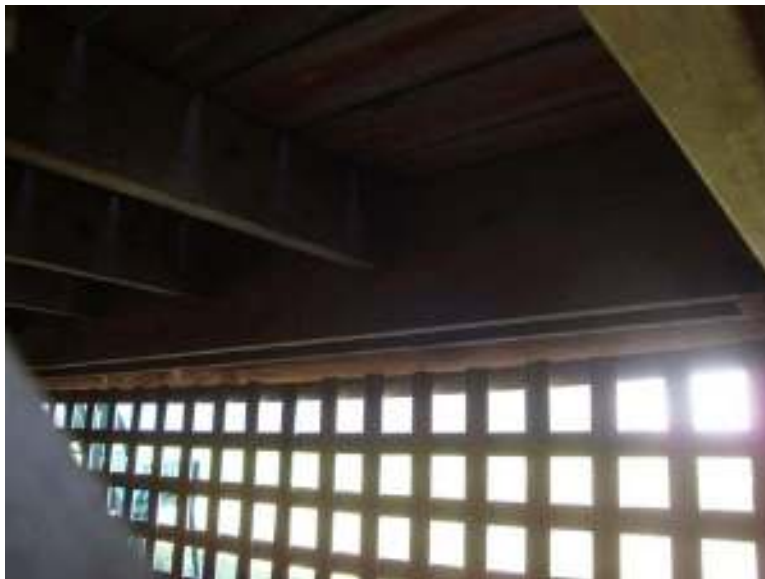
5. Loose and unstable railings. *Replace all railings.*
  6. Joists are only toe-nailed to support beams. *Add joist hangers as required throughout.*
  7. Front porch gable tie beams are water damaged to the point of having dry rot. *Replace all front porch gable tie beams.*

4. TYPICAL JOIST CONNECTION TO BEAM

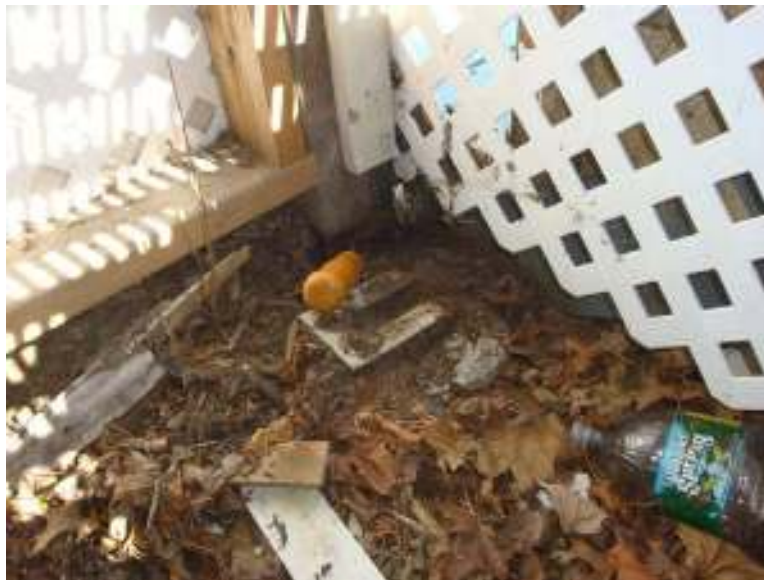
5. ROTTED AND MISALIGNED POST

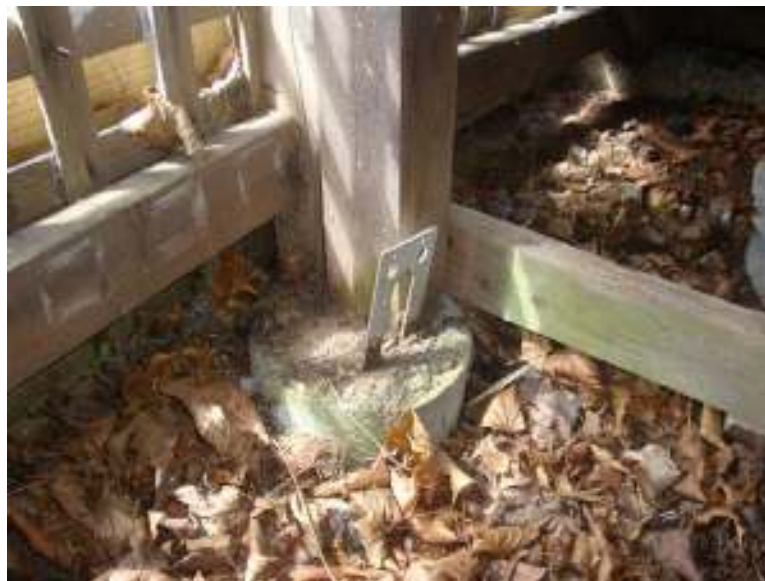
6. MISALIGNED POST AND CONCRETE POST

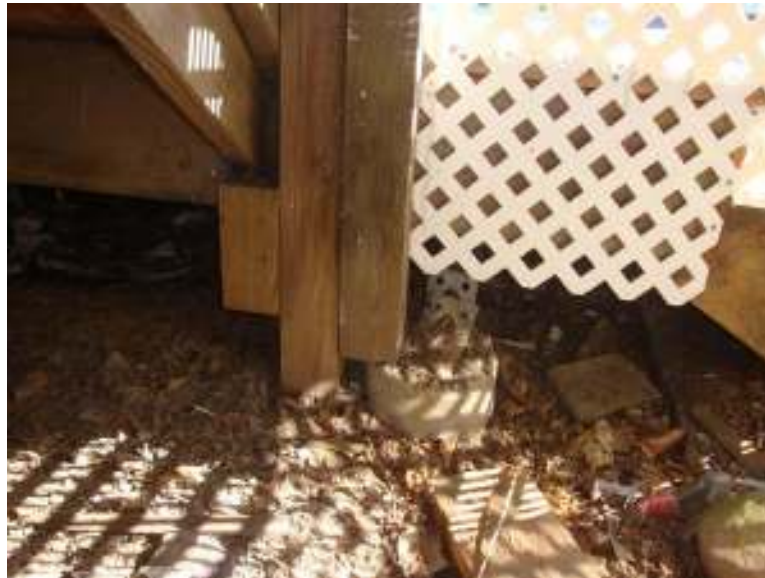
7. MISALIGNED POST AND CONCRETE POST

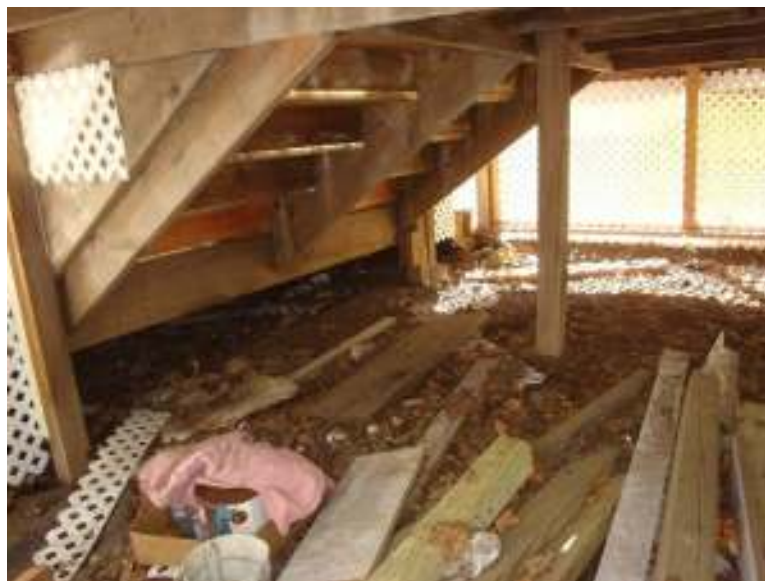
8. FRONT PORCH STAIR FRAMING

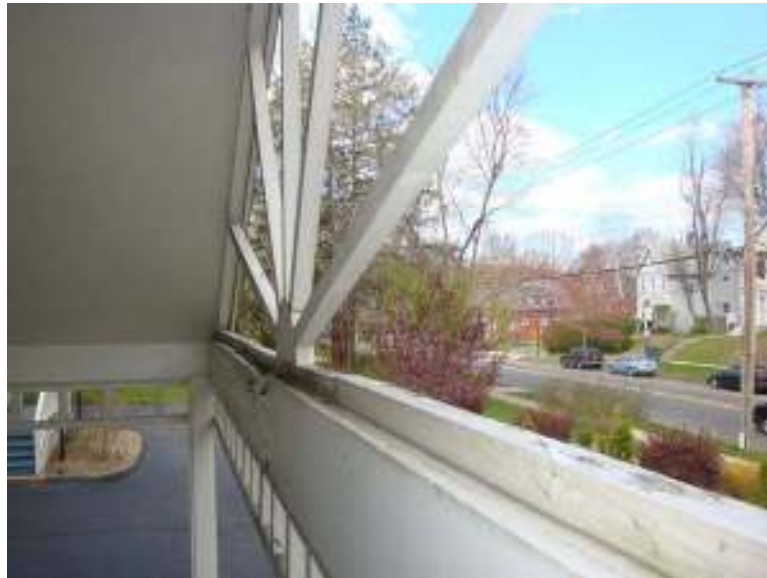
9. WATER DAMAGED GABLE TIE BEAM

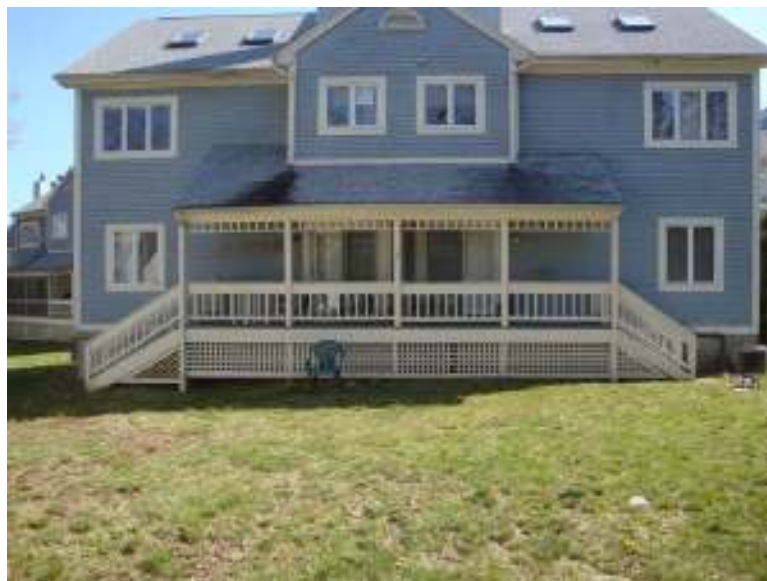
10. TYPICAL REAR DECK

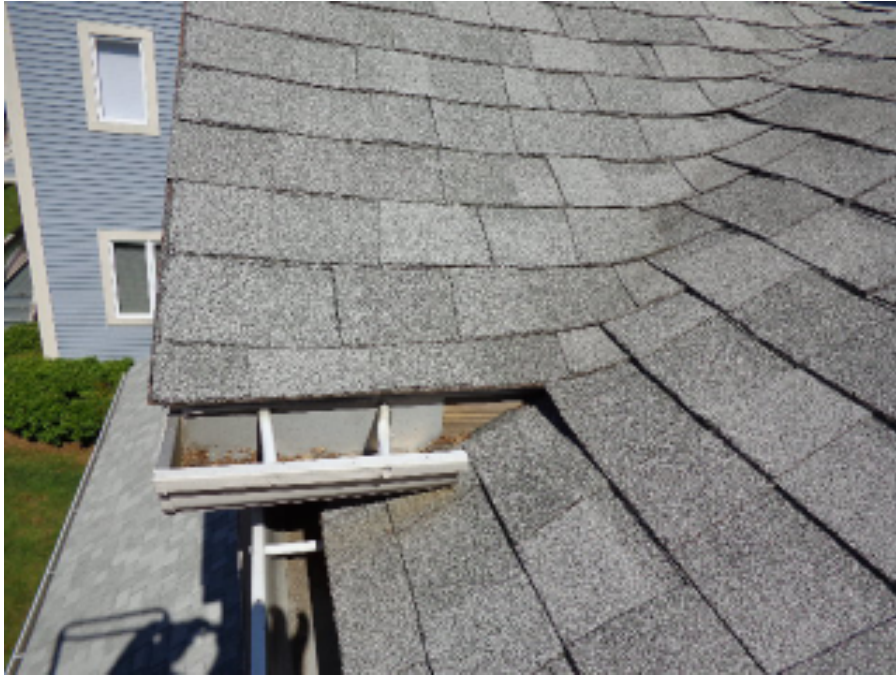
Photo #1

2. There are numerous locations of poorly flashed shingles to the structure. Please note photo #1.

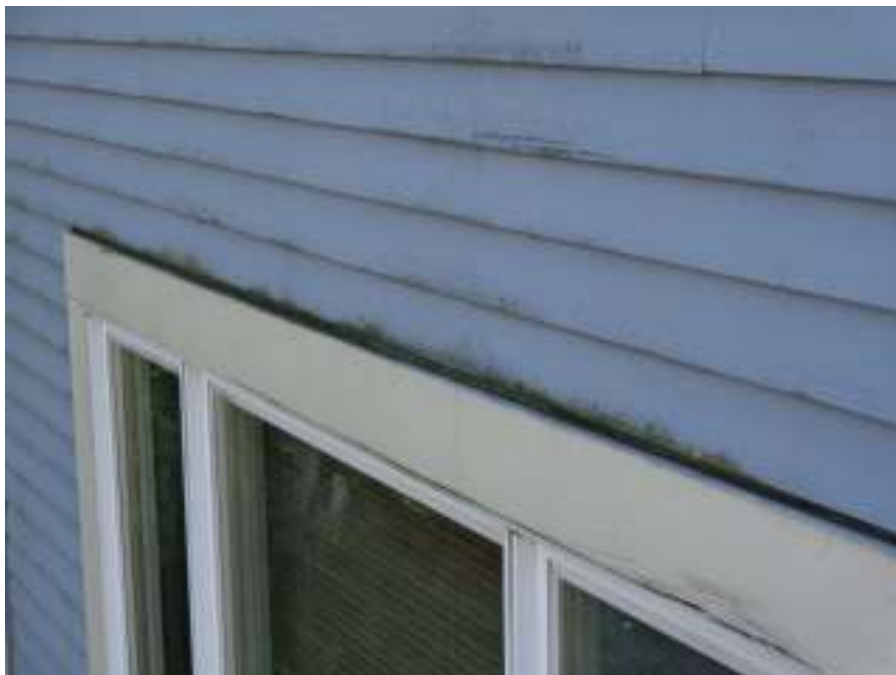
Photo #2

3. There are numerous locations where the window header flashing has been installed in such a fashion that it is sloping rather than outward. Consequently there leaves the opportunity for water to collect at those locations and possibly enter the structure. Please note photo's #2, #3

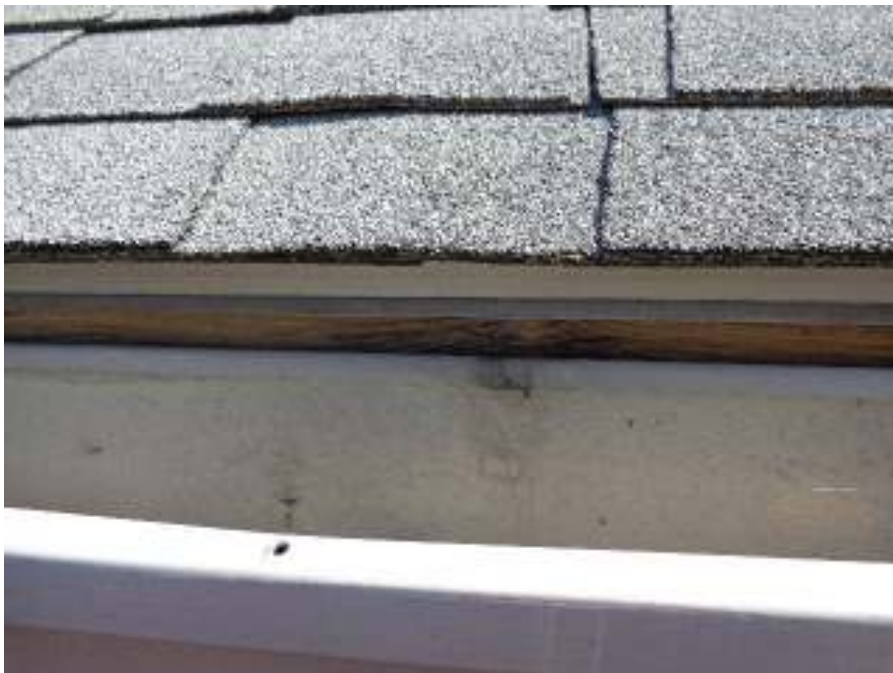
Photo #6

6. There are numerous locations of uncompleted flashings at gutter locations. Please note photo #6.

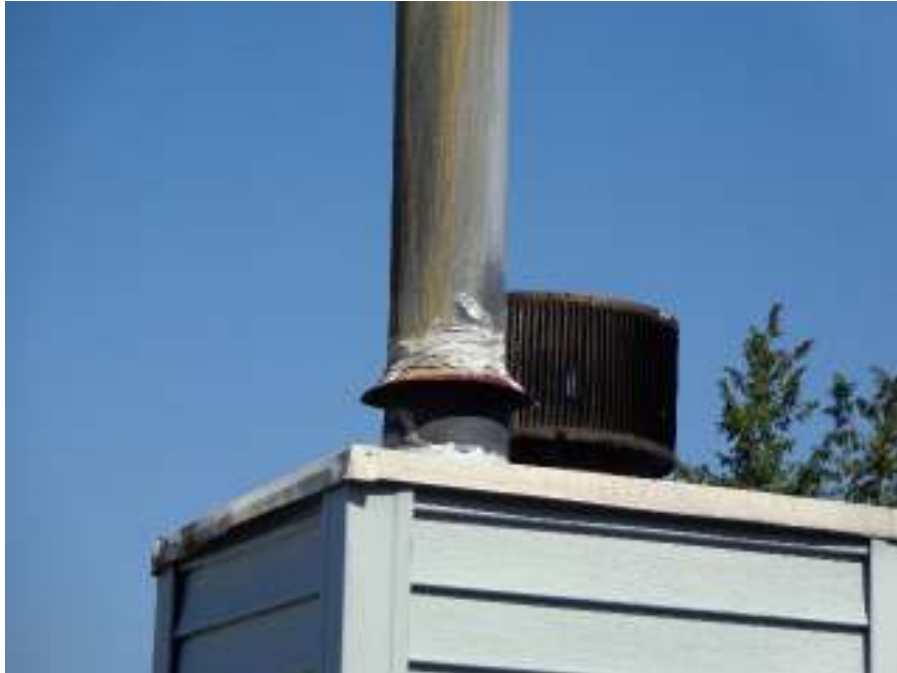
Photo #9

8. There is evidence that the metal chimney's have been repaired with sealant over the years and may still be an issue. The metal cap flashing is also poorly installed as you can see from these photo's. Please note photo's #8, #9

I would recommend you remove the existing roof, gutters and associated flashings, such as chimney caps and drip edge. Install new shingles with properly designed details, install new gutters and down spouts, install new chimney caps.

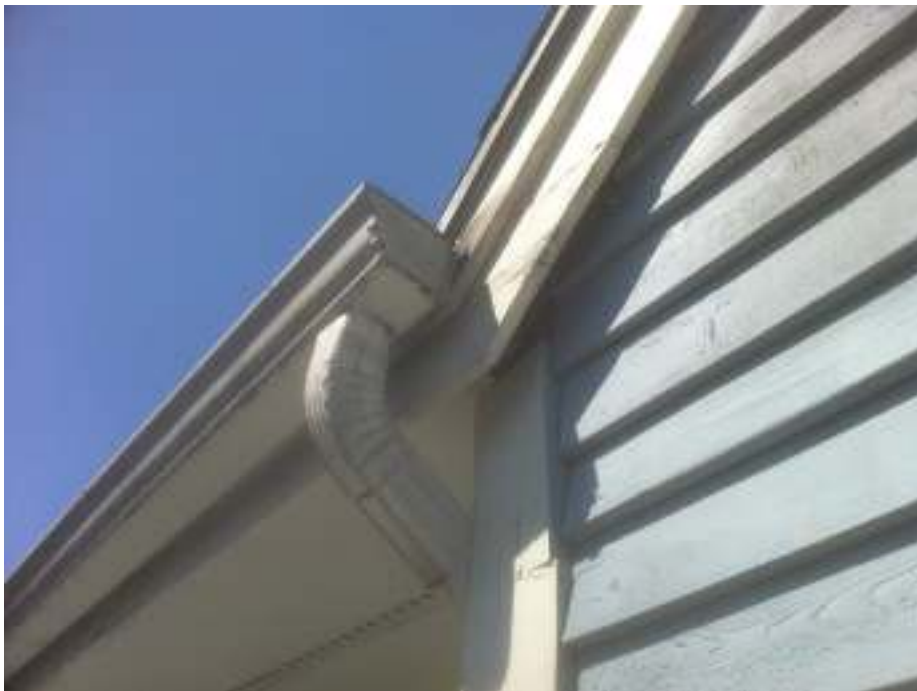
Photo #10

9. There are numerous locations that corner boards have become unattached and have not been completely finished causing some issues during wind driven rain events. Please note photo #10.

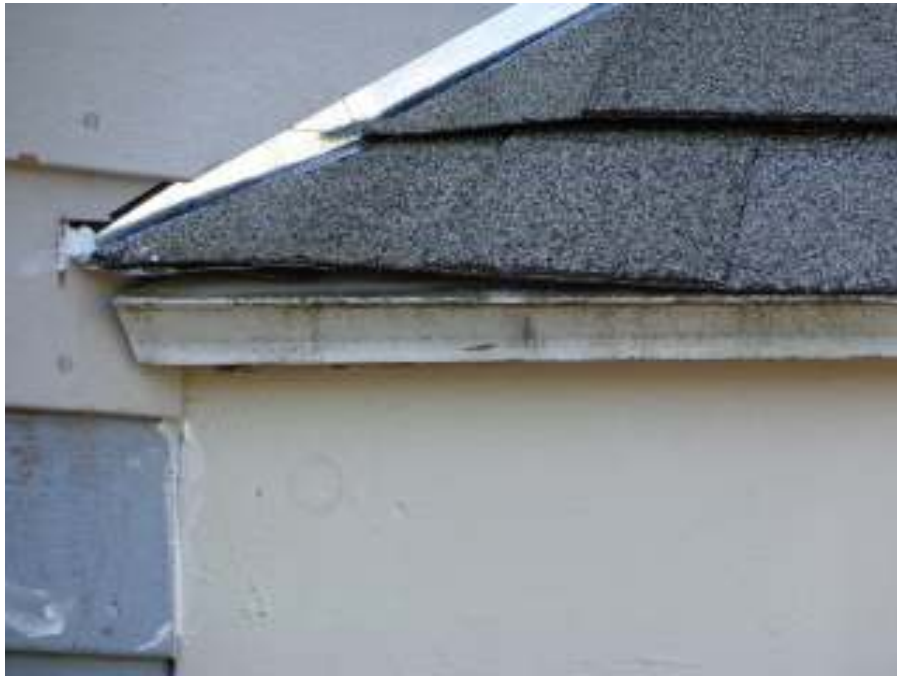
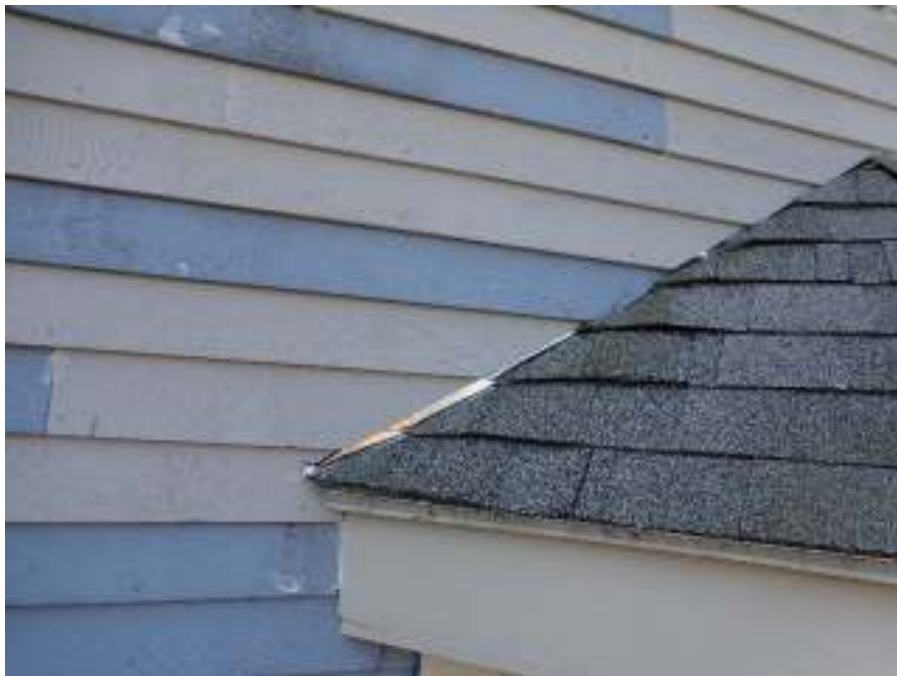
Photo #11

10. At the most recently installed counter flashing provision on a window dormer the “step flashing has not been extended down and up a sufficient amount to prevent water entry. Please note photo's #11, #12

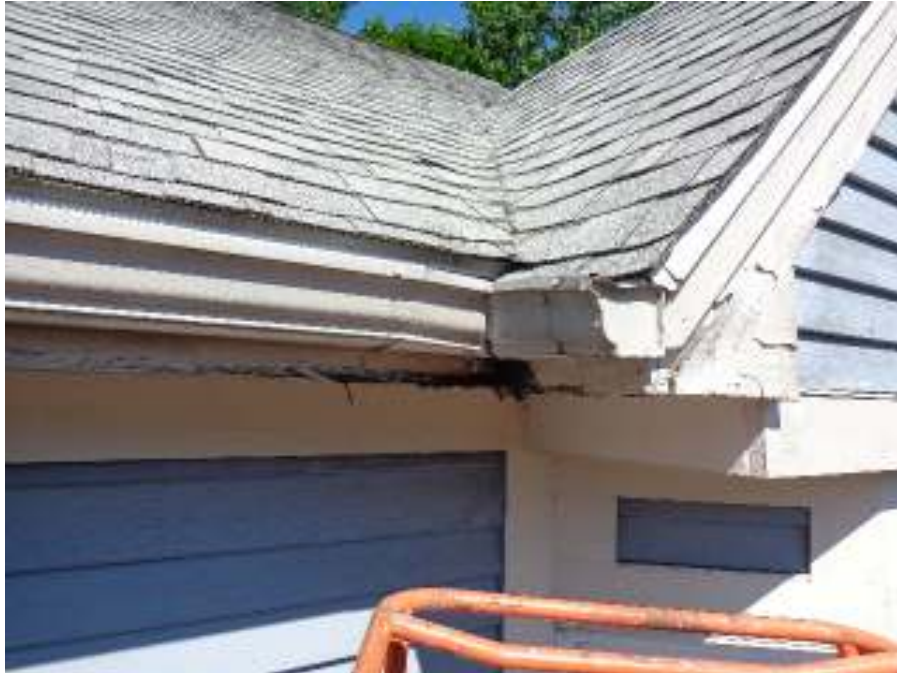
Photo #13

11. There a few locations of dry root at gutter locations. Please note photo #13

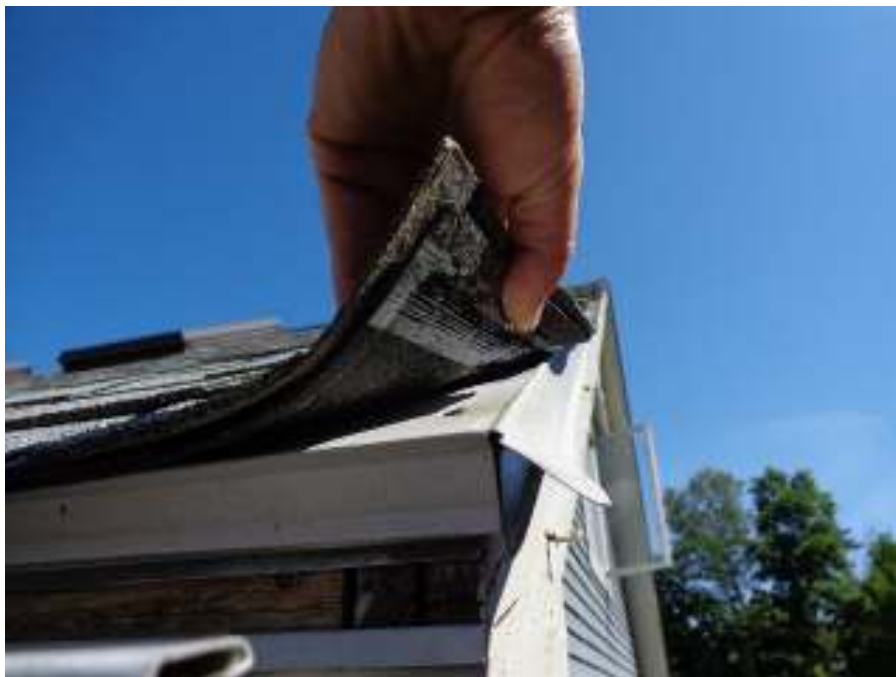
Photo #14

12. There is evidence that ice and water shield was installed, but without destructive investigation we could not verify how high it was installed. Please not photo #14.

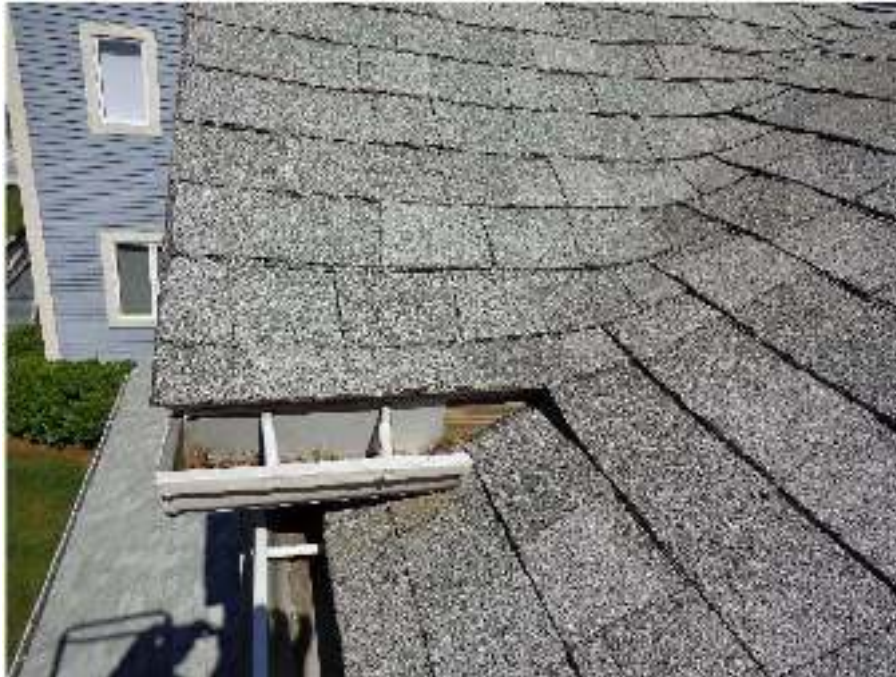
Photo #1

2. There are numerous locations of poorly flashed shingles to the structure. Please note photo #1.

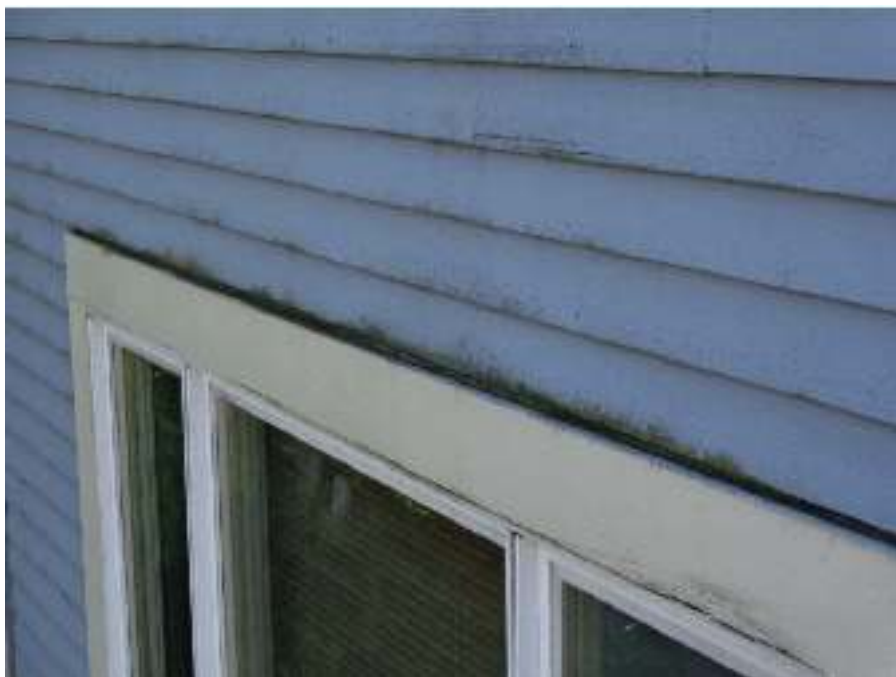
Photo #2

3. There are numerous locations where the window header flashing has been installed in such a fashion that it is sloping rather than outward. Consequently there leaves the opportunity for water to collect at those locations and possibly enter the structure. Please note photo's #2, #3

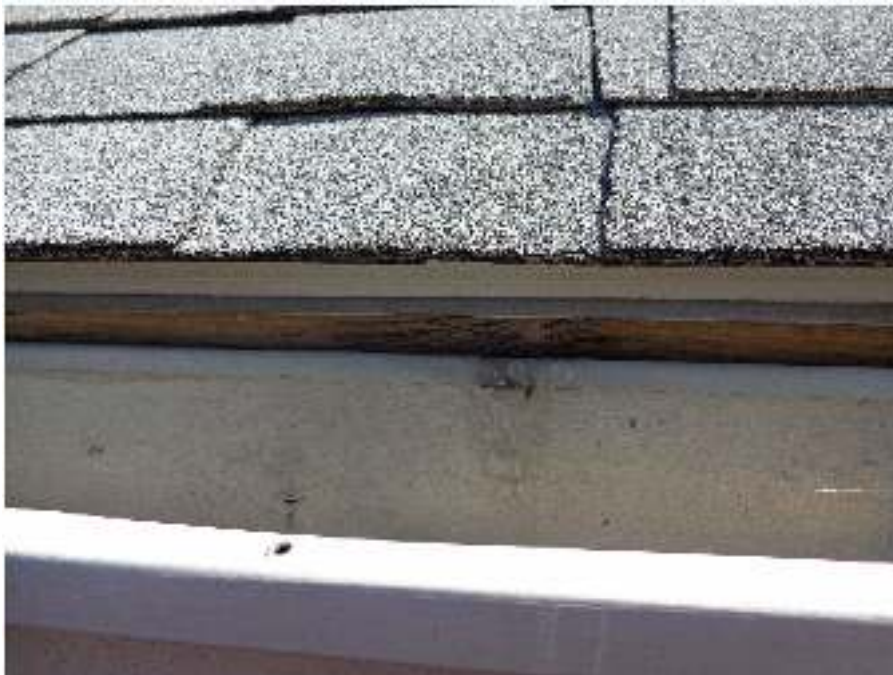
Photo #6

6. There are numerous locations of uncompleted flashings at gutter locations. Please note photo #6.

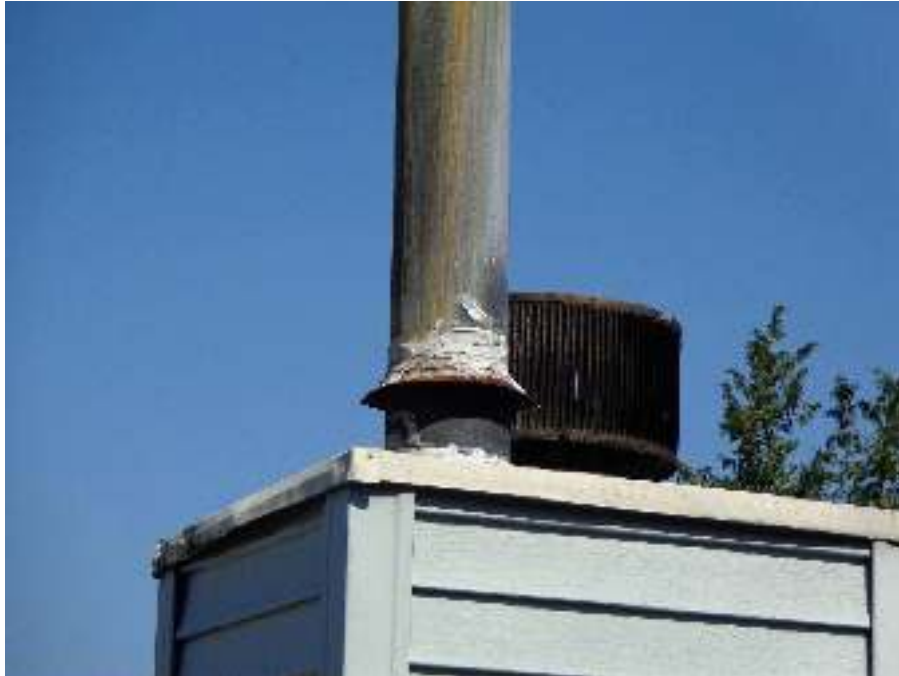
Photo #9

8. There is evidence that the metal chimney's have been repaired with sealant over the years and may still be an issue. The metal cap flashing is also poorly installed as you can see from these photo's. Please note photo's #8, #9

I would recommend you remove the existing roof, gutters and associated flashings, such as chimney caps and drip edge. Install new shingles with properly designed details, install new gutters and down spouts, install new chimney caps.

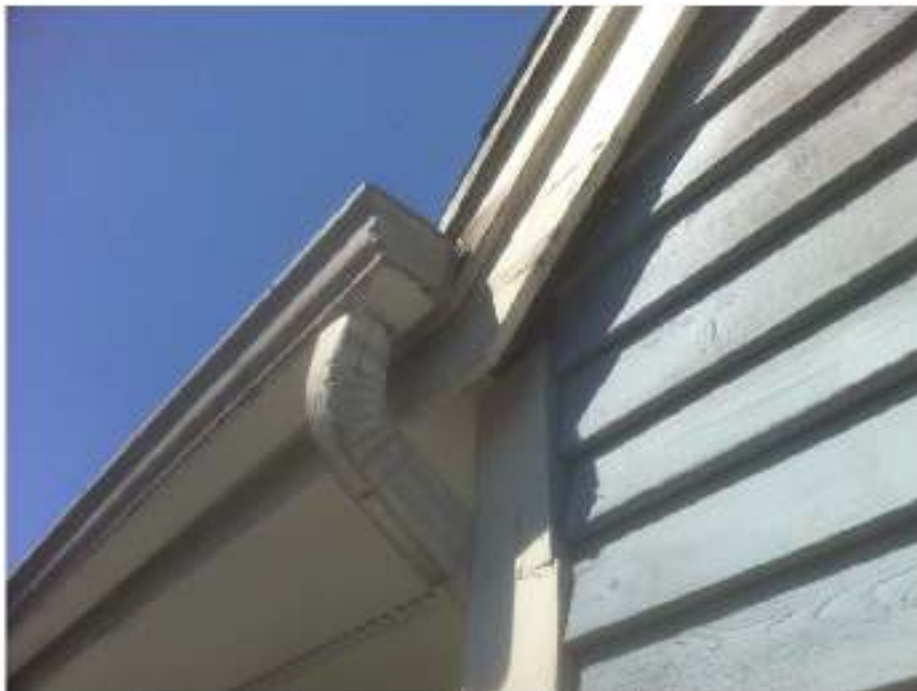
Photo #10

9. There are numerous locations that corner boards have become unattached and have not been completely finished causing some issues during wind driven rain events. Please note photo #10.

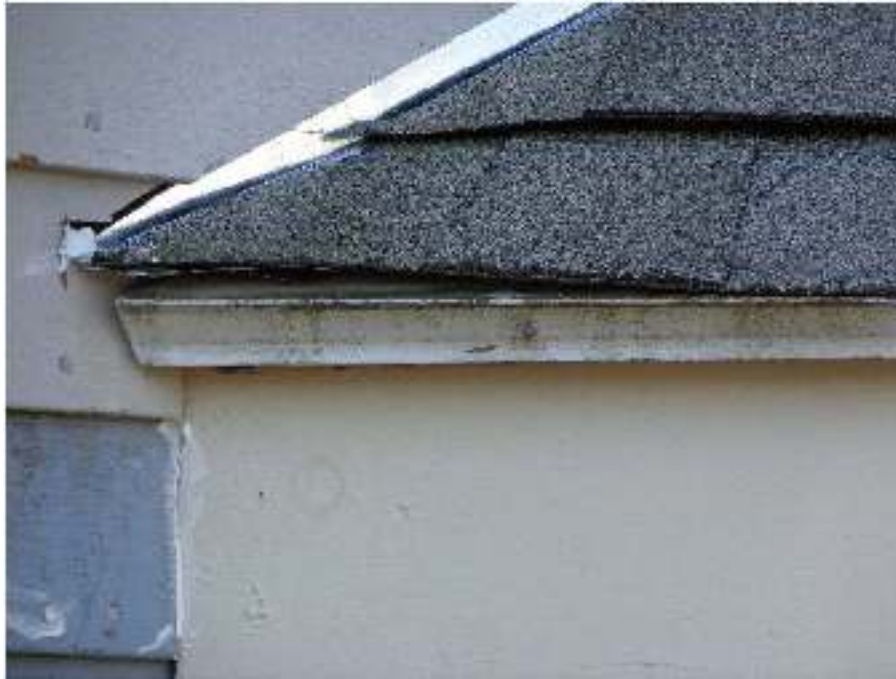
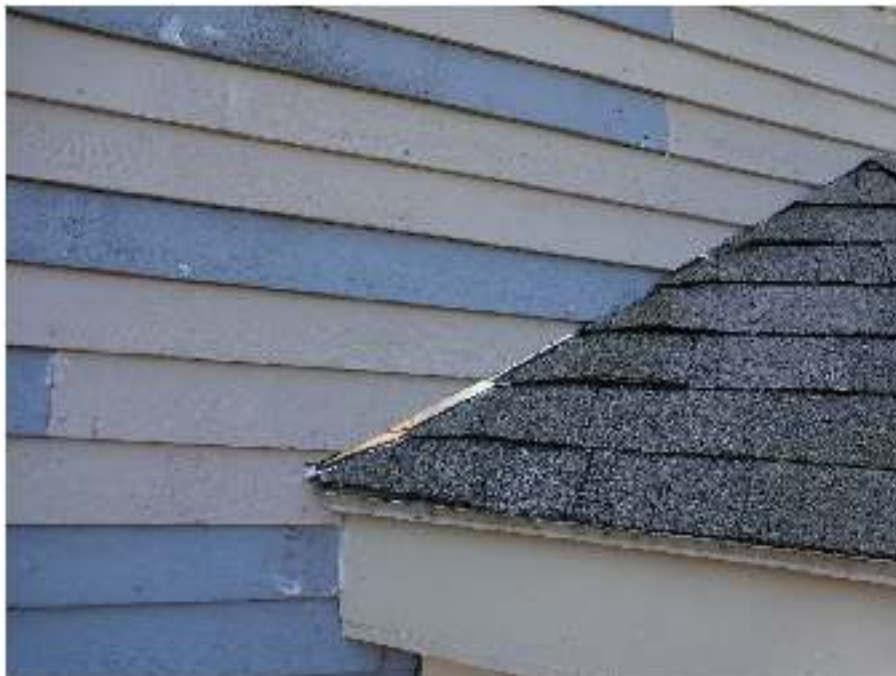
Photo #11

10. At the most recently installed counter flashing provision on a window dormer the "step flashing has not been extended down and up a sufficient amount to prevent water entry. Please note photo's #11, #12

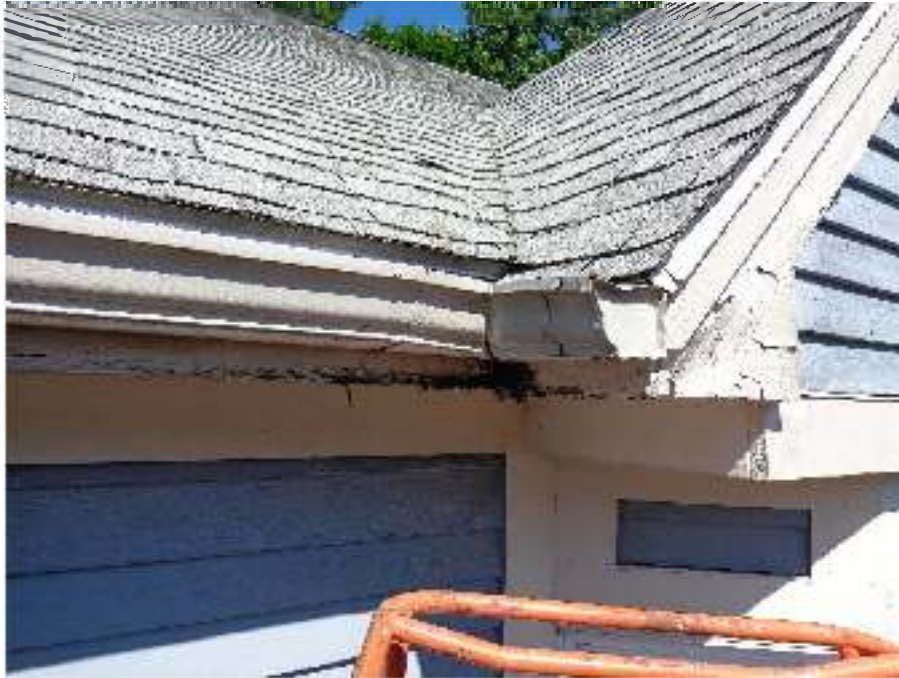
Photo #13

11. There a few locations of dry root at gutter locations. Please note photo #13

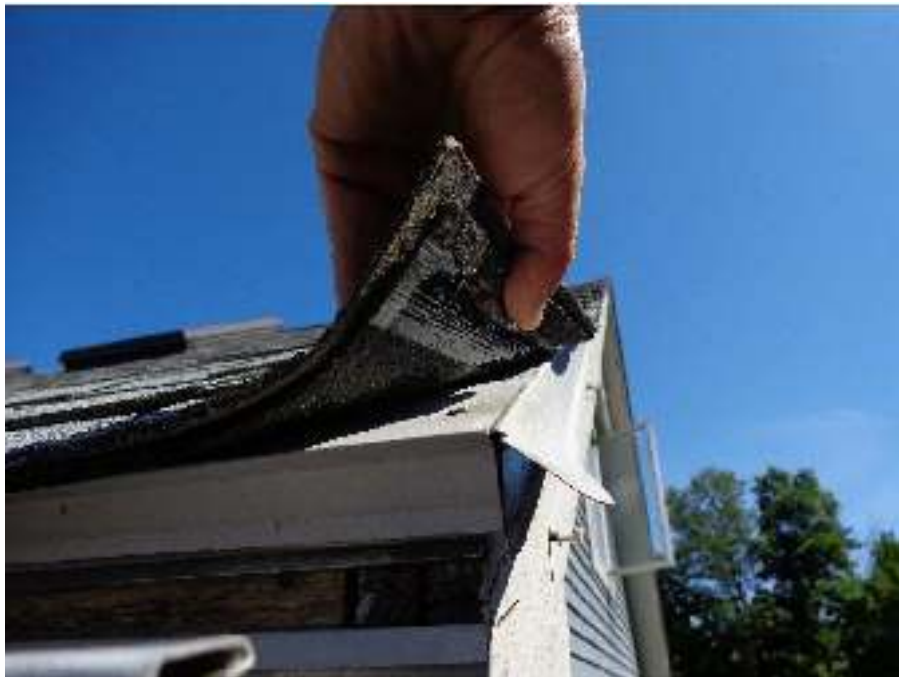
Photo #14

12. There is evidence that ice and water shield was installed, but without destructive investigation we could not verify how high it was installed. Please not photo #14.

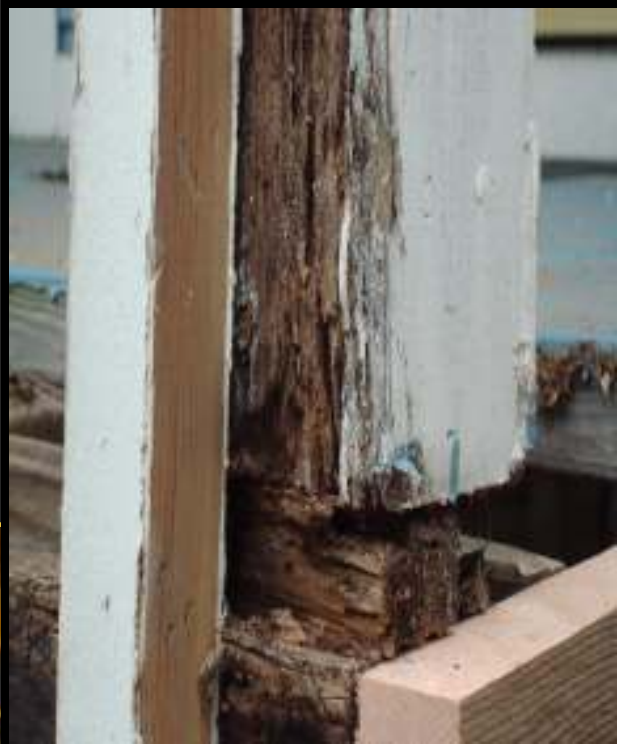
# Decking: Structural Damage

Front and rear decks were improperly built without adequate structural support and continue to cause damage to the buildings. Front and rear decks rotted shortly after the first owners arrived and have been replaced several times. Every front and rear deck needs to be rebuilt correctly with adequate structural support to prevent further damage.

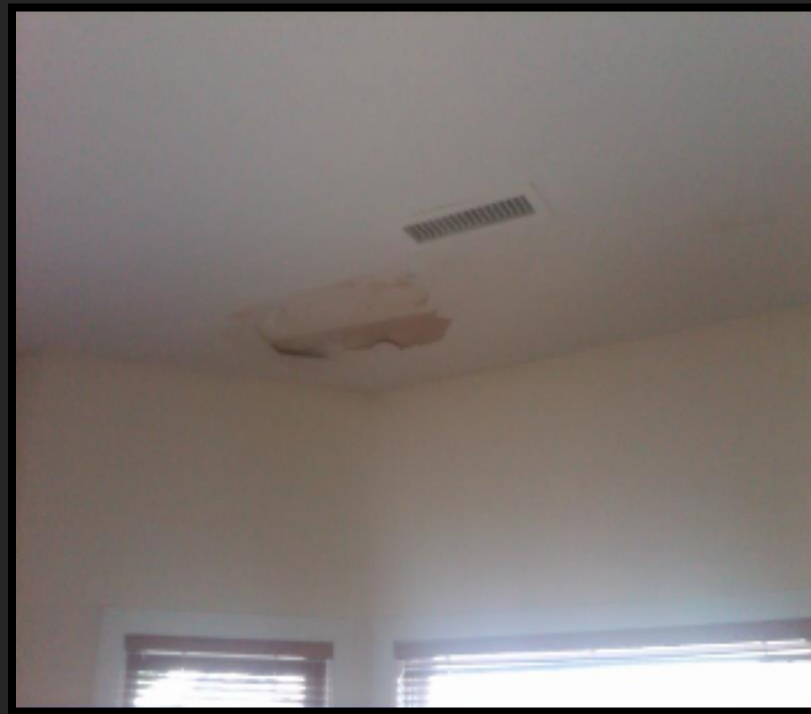
# Roof: Water Damage

Complaints about leaky roofs began shortly after the first owners moved in. Ten years ago, in an attempt to correct the problem new shingles were added to the old roof without correcting flashing and other known issues underneath the original roof. The entire roof needs to come off, damaged and rotted wood underneath needs to be replaced, proper flashing needs to be corrected before a new roof is installed.

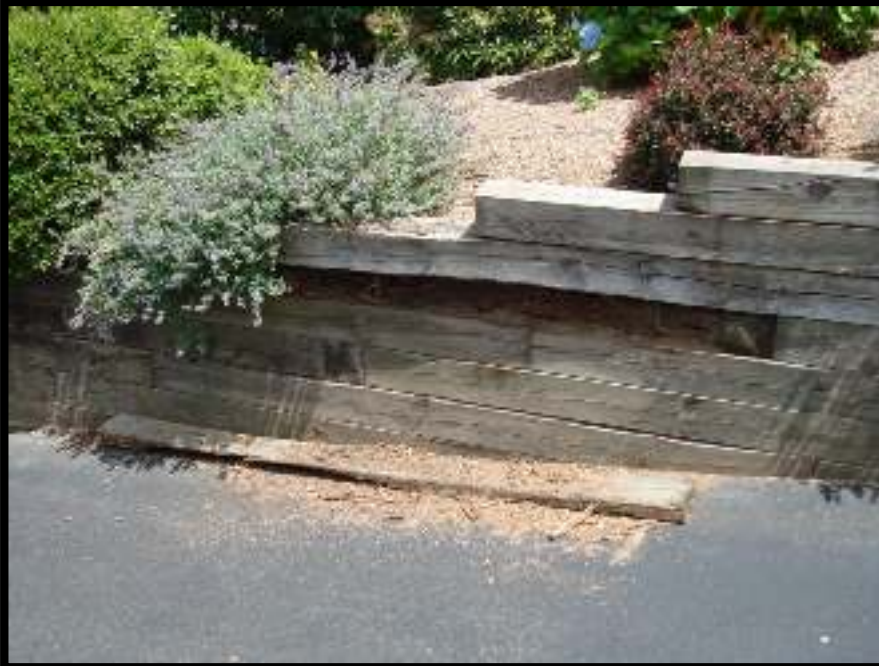
# Retaining Walls: Rotted

Wooden retaining walls have rotted and should be replaced with stone or removed.
