Fountain Hill Condo Association

## NOTICE OF UNIT OWNERS MEETING FOUNTAIN HILL CONDOMINIUM ASSOCIATION, INC.

# Fountain Hill Association

## Facility Report

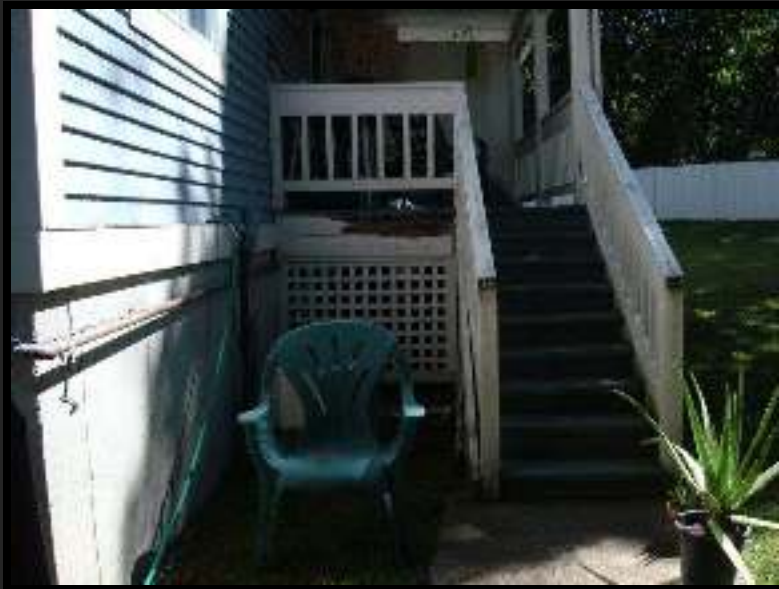
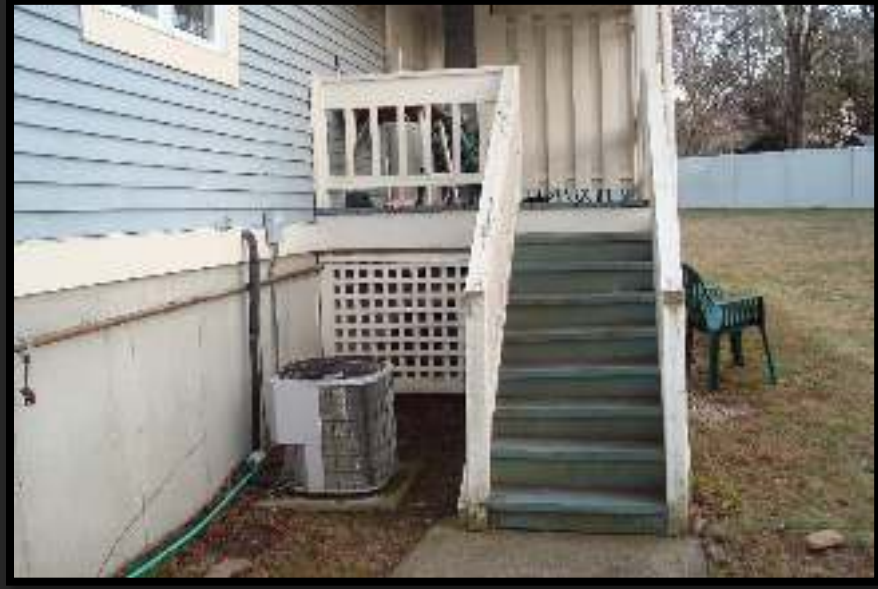
# Rear Decks: Security Risk / Size

The rear stairs to the deck presents a security risk and the small size renders the deck unusable. Increasing the size of the deck, removing the stairs, and improving lighting in the rear will provide homeowners with a secure outdoor space that can be used as an extension of the home.

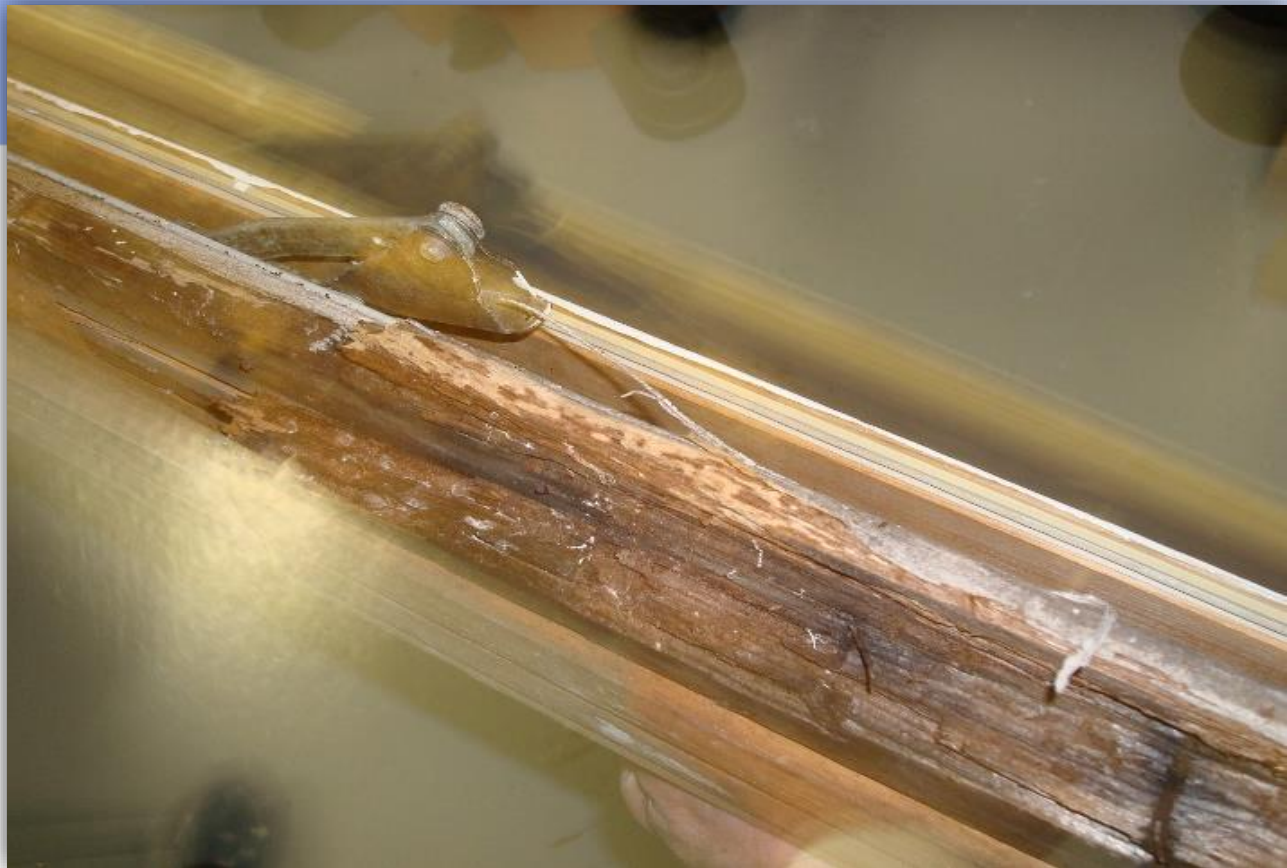
# Windows

Window sills have significant water and insect damage. Many windows do not open

# Replace Windows

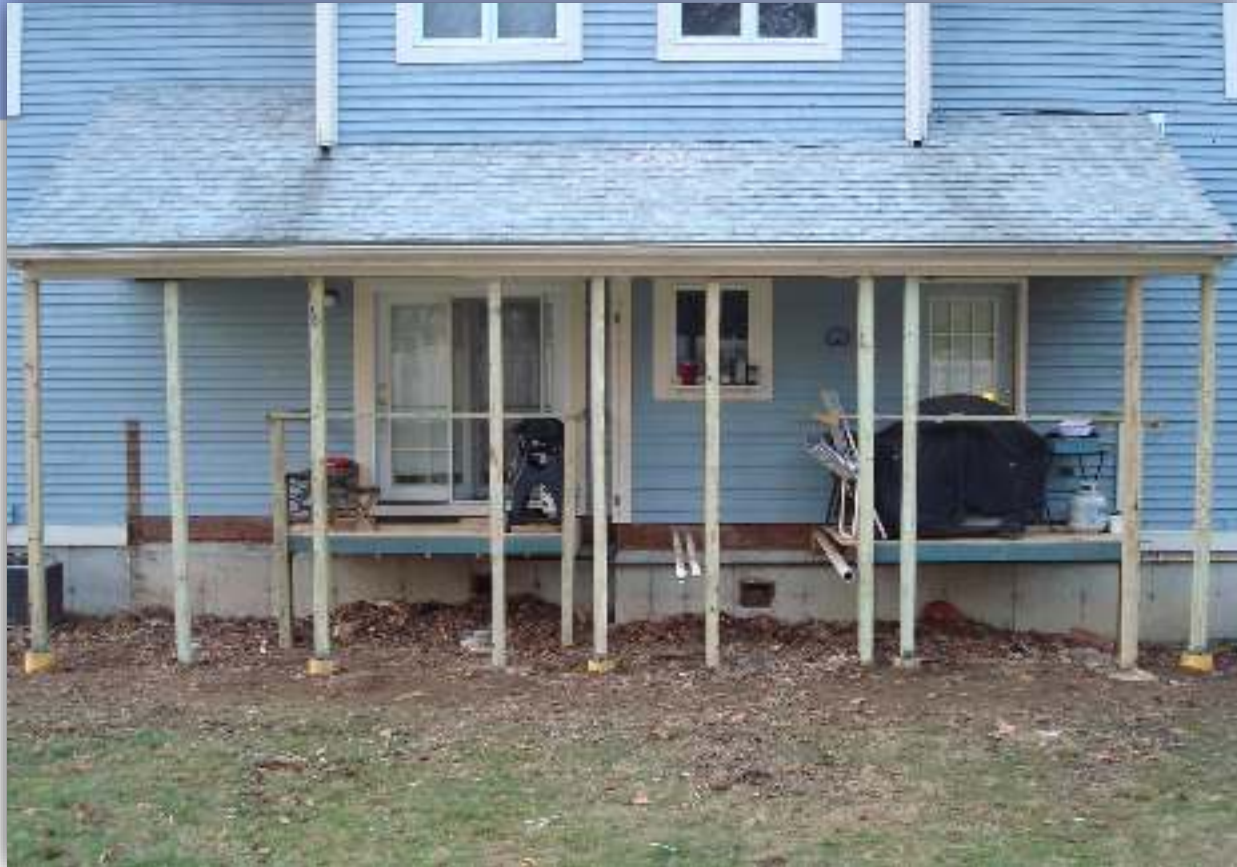
# Deck Support

Front and rear decks do not have adequate structural support and are causing damage to the buildings

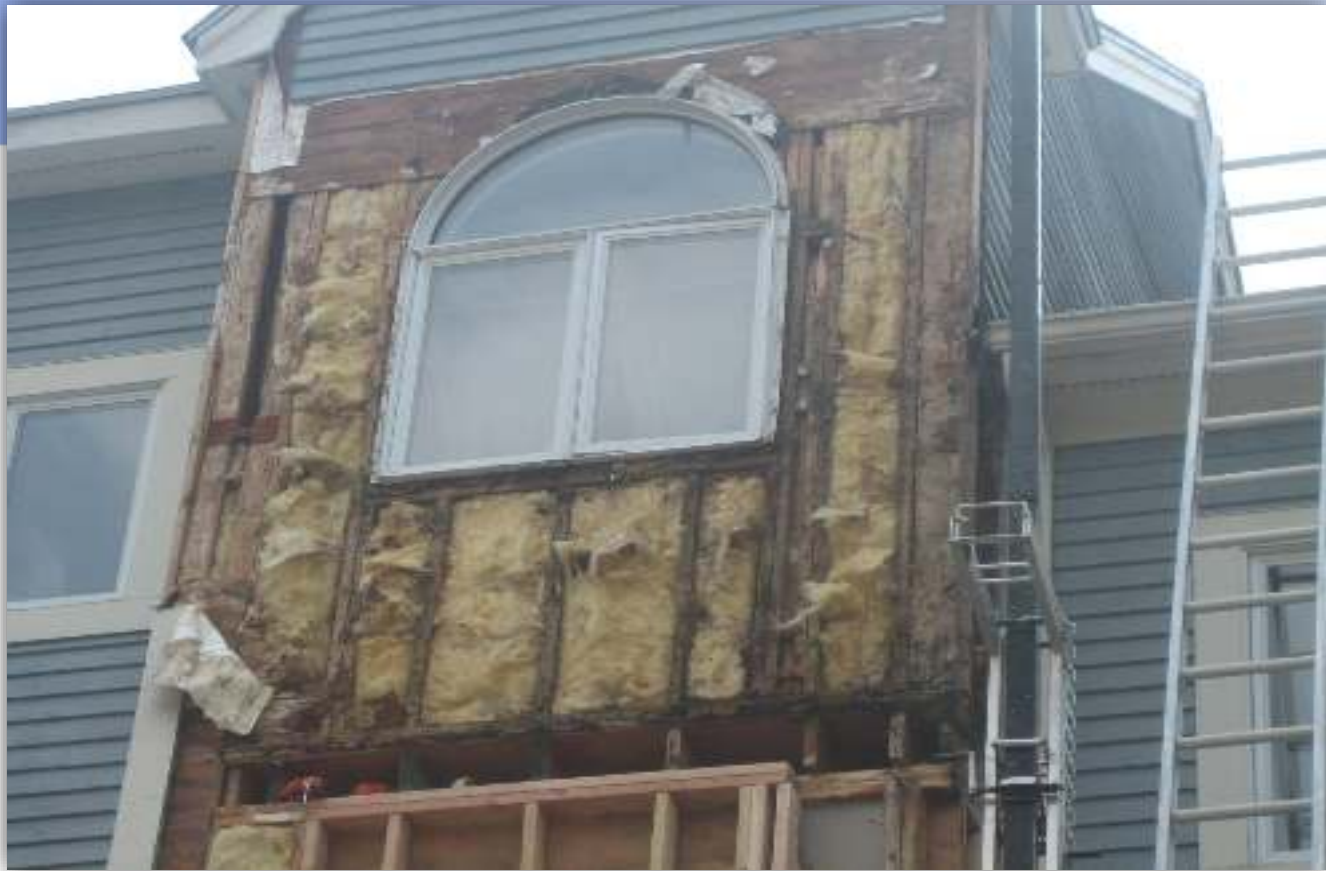
# Continuous Wood Replacement

Carpenter Ants and Bees cause  
extensive damage each year

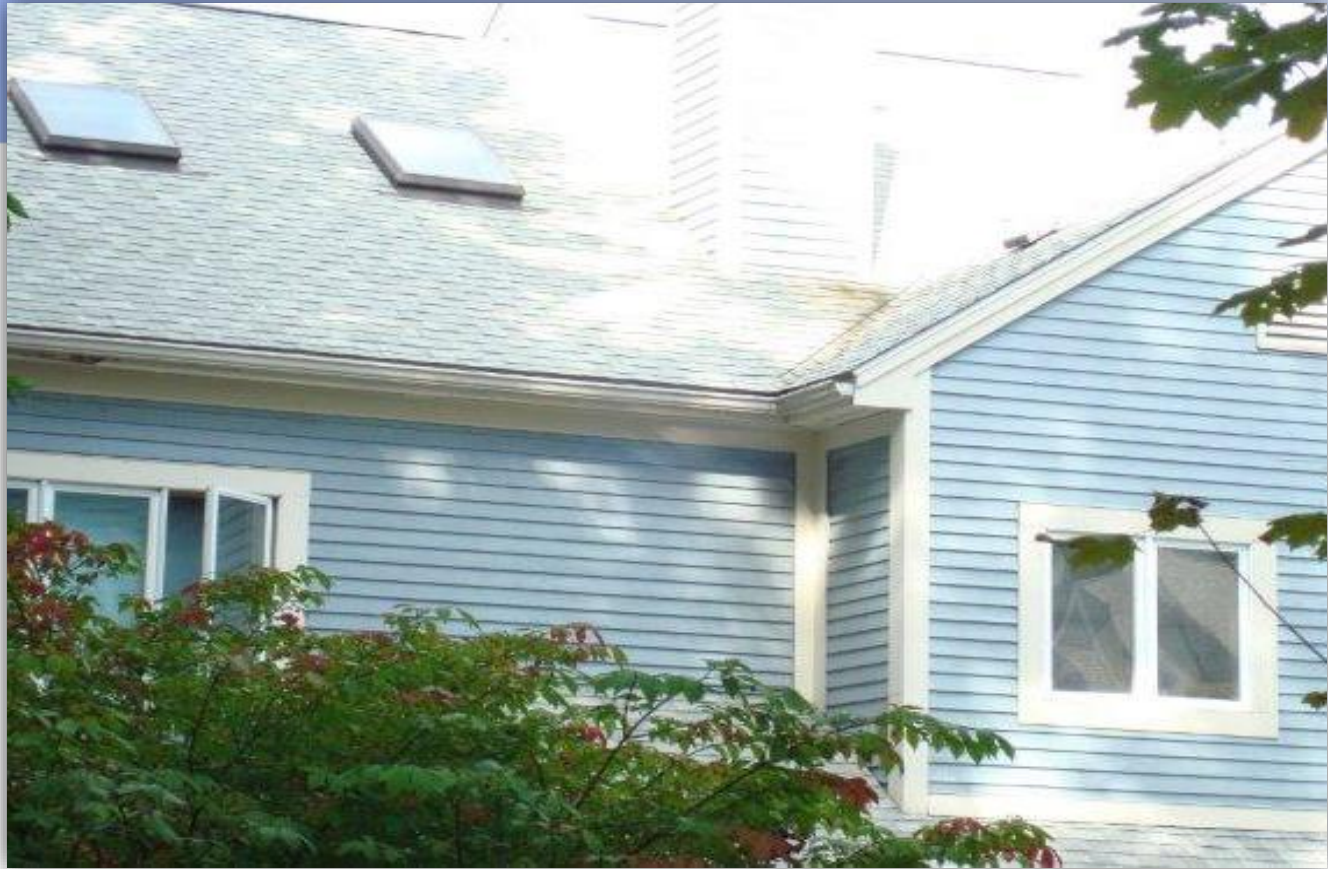
# Water Damage From Roof

Roof Leaks Continue To Cause  
Damage

# Replace Roof

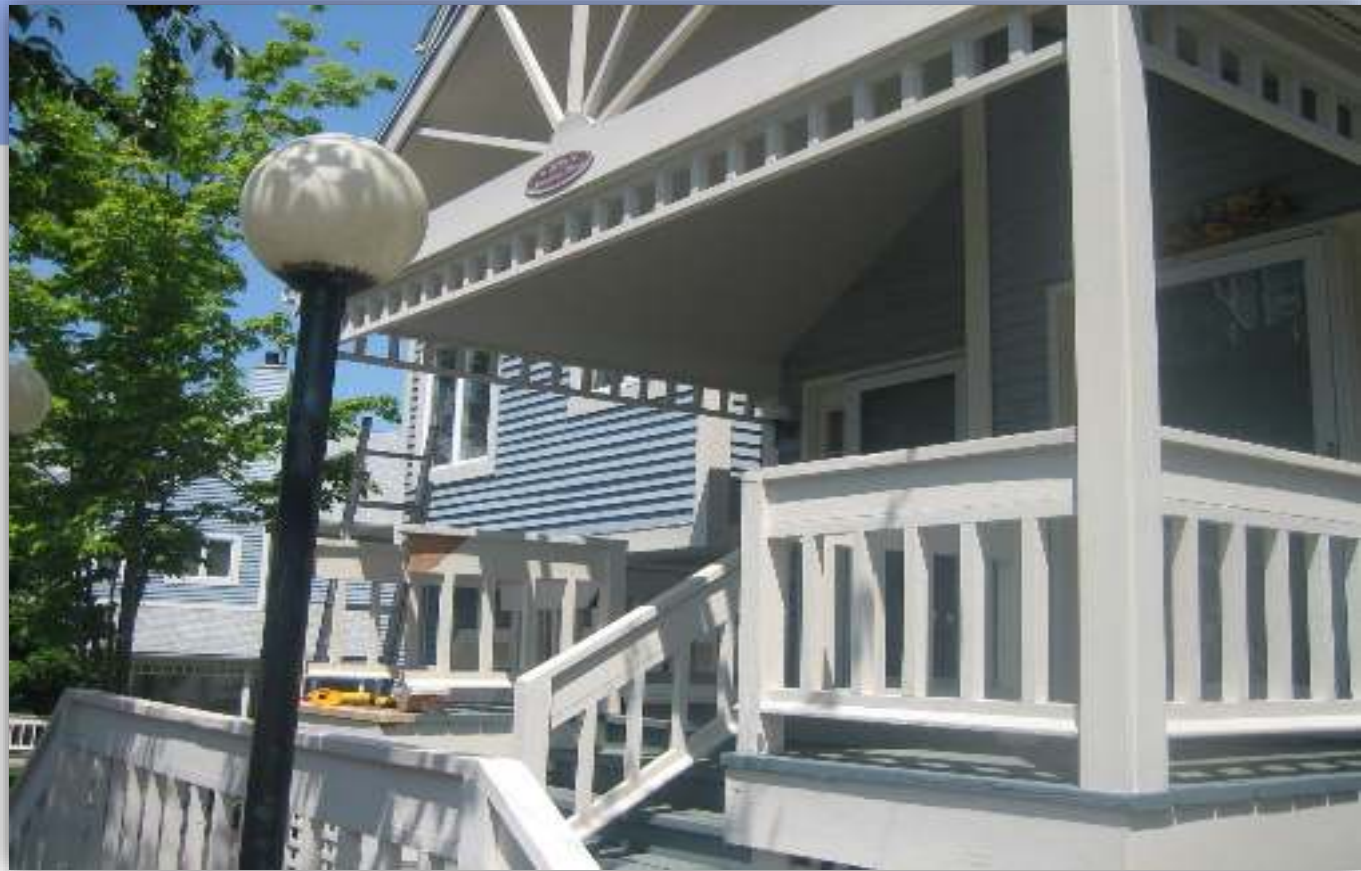
Outdoor lighting needs rewiring and fixtures and poles need to be replaced
